**Valentine Gold Project
Baseline Study Appendix 1:
Dam Safety**

Baseline Study Appendix 1: Dam Safety
(BSA.1)

Attachment 1-A Dam Breach Assessment and Inundation Study – Valentine Gold Tailings Management Facility (2020)

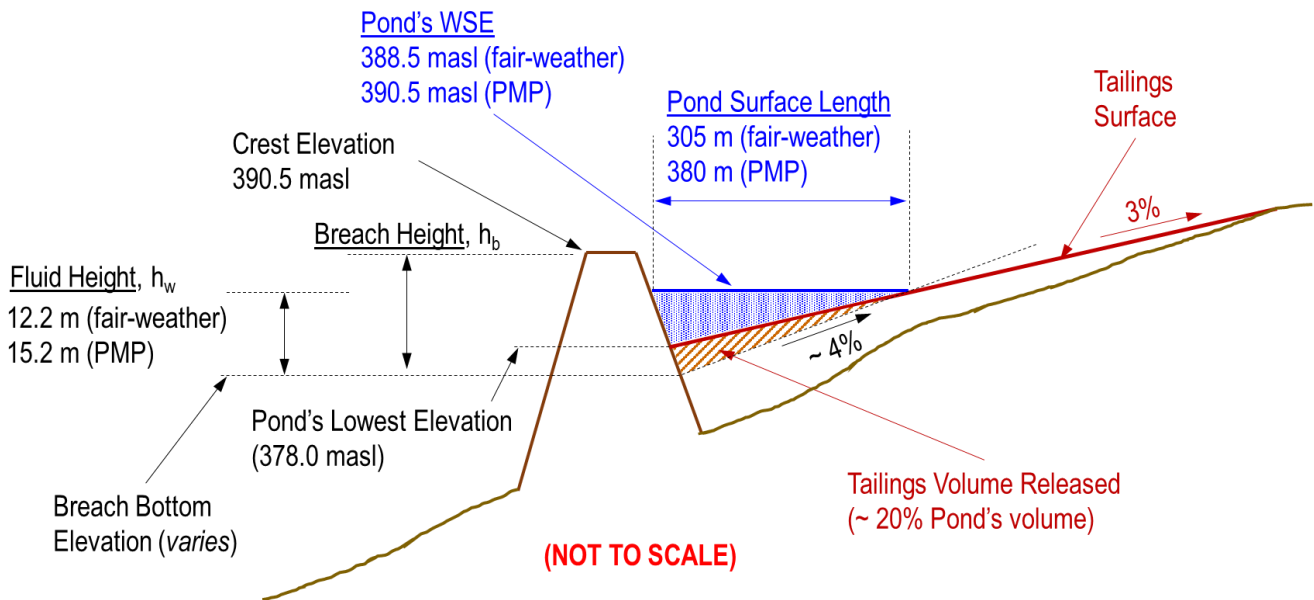
Schematic 2: Conceptual Breach Channel Profile

In the event that a tailings dam is breached, the erosive forces of the mobilised tailings will erode the tailings beneath such that the breach channel bottom (invert) will be lower than the bottom of the tailings pond. The breach bottom under the fair-weather and PMF conditions was predicted as 1.7 and 2.7 m below the pond bottom, respectively (Schematic 2). This estimate is reasonable given the relatively small volume of the tailings pond, the low erodibility of rockfill and the thickened state of the tailings.

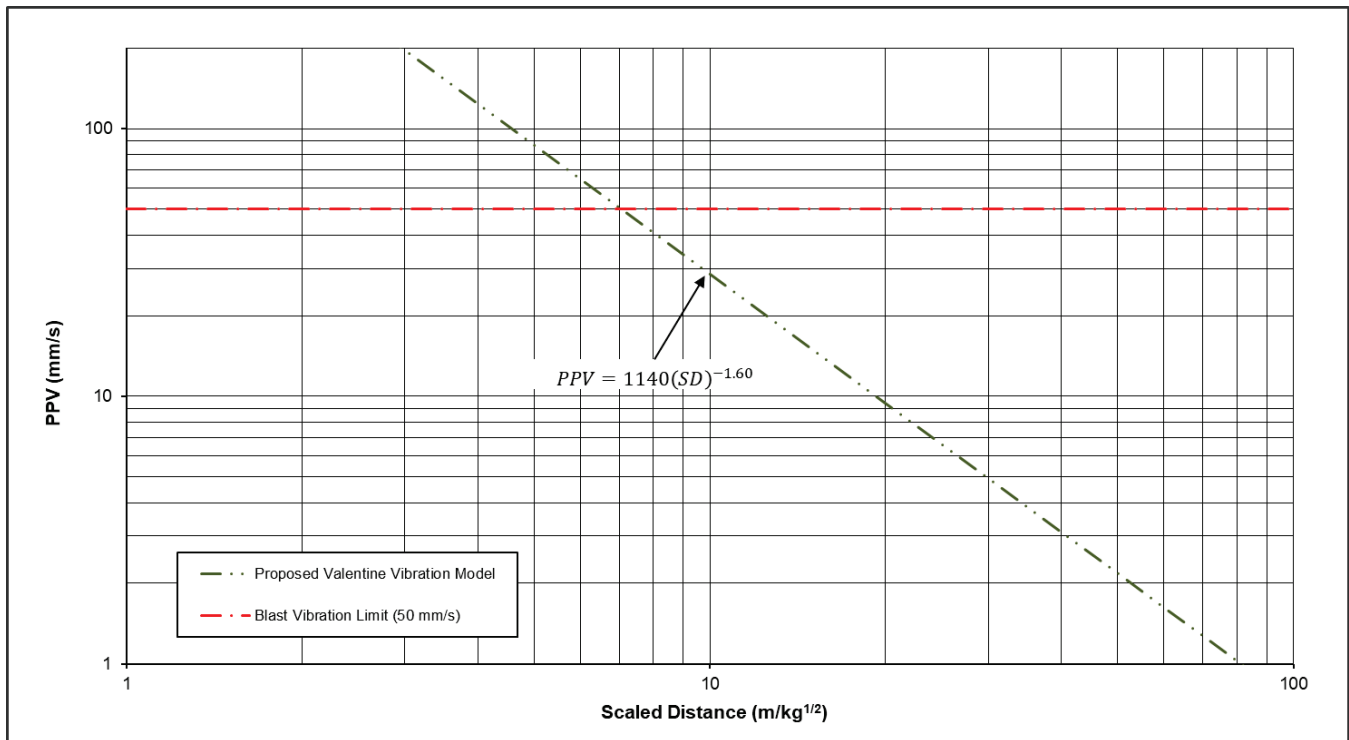
Figure 2: Ground Vibration Attenuation Models for the Valentine Project Open Pits.

The proposed vibration attenuation models for Valentine project open pits are plotted on Figure 2.

As shown in Figure 2, the estimated minimum SD required for the open pit blasting operations at the Marathon and Leprechaun pits to remain within the recommended limit of 50 mm/s is 7.06 m/kg^{1/2}. The analysis presented within this report assumes this as a worst-case scenario. That is, the shortest separation distance with the largest explosive charge weight per delay period.

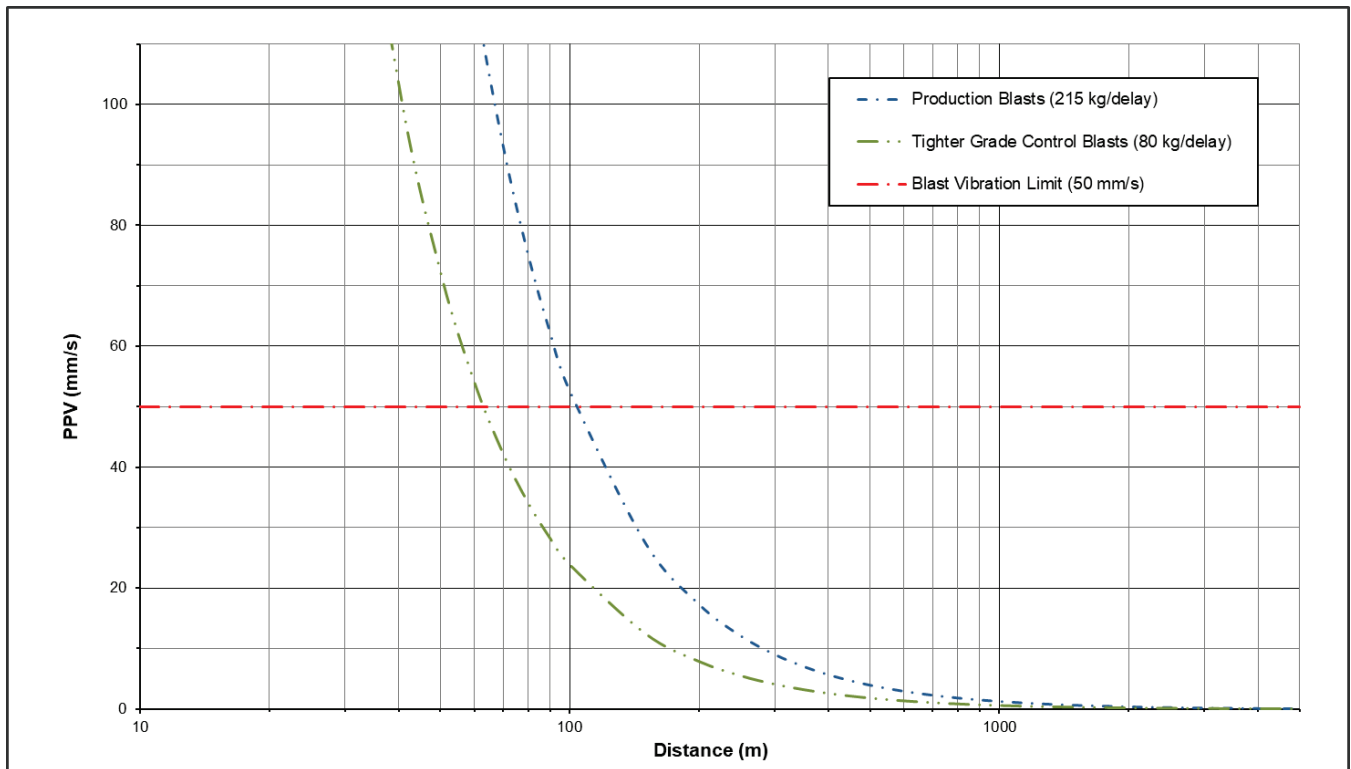
Figure 3: Estimated Peak Particle Velocity (PPV) for a Range of Distances from the Leprechaun and Marathon Open Pits

Golder conducted a preliminary ground vibration estimate, which is displayed in Figure 3. The estimate shows the vibration amplitudes for a range of separation distances for the proposed Leprechaun and Marathon open pits based on the blast design parameters provided by Marathon. The data is also summarised in Table 5.
