# Dam Breach Assessment and Inundation Study

## *Valentine Gold Tailings Management Facility*

**Golder Associates Ltd.**

20141194 (600) – Rev 0

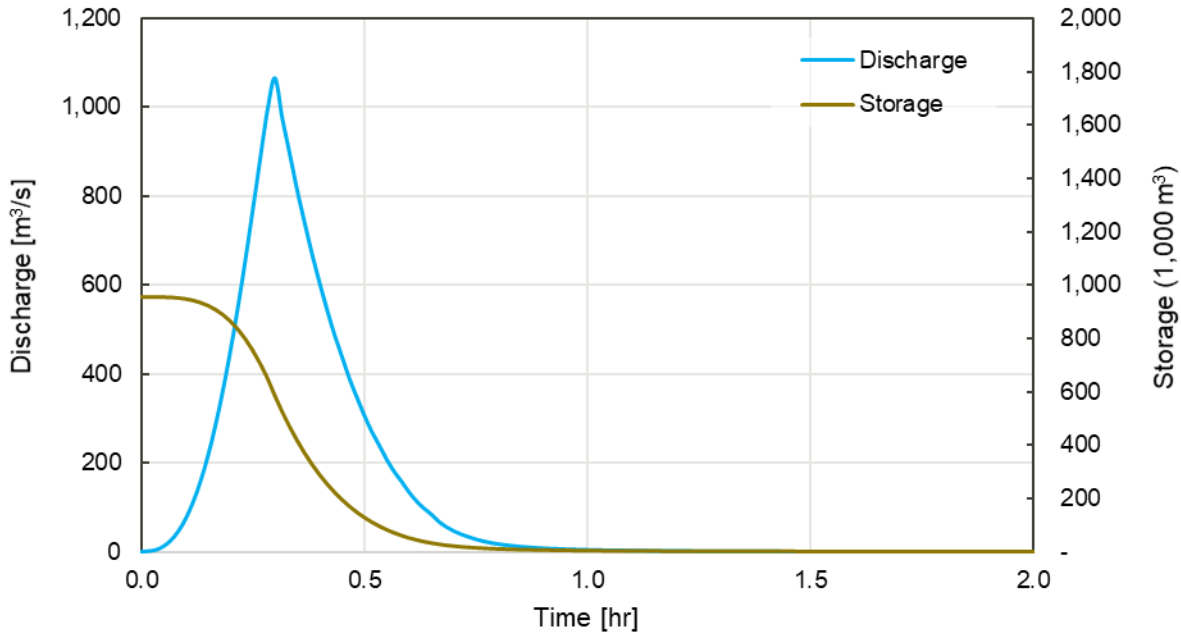
Graph 1: HEC-HMS TMF Location A Breach Outflow Under Fair-Weather Conditions – Piping Failure (Scenario A-FW)

Under fair-weather conditions (Scenario A-FW), the breach peak outflow from a piping failure at Location A reporting to Victoria River is 1,067 m<sup>3</sup>/s. Under the flood-induced failure at Location A (Scenario A-PMF), the peak breach outflow is 1,735 m<sup>3</sup>/s for the piping failure mode. The generated outflow hydrographs are presented on Graph 1 and Graph 2.

The peak outflows resulting from the hypothetical failure simulation corresponding to the fair-weather and flood-induced scenarios are presented in Table 4. The peak discharge from the breach is governed mostly by the volume of water in the TMF Pond.

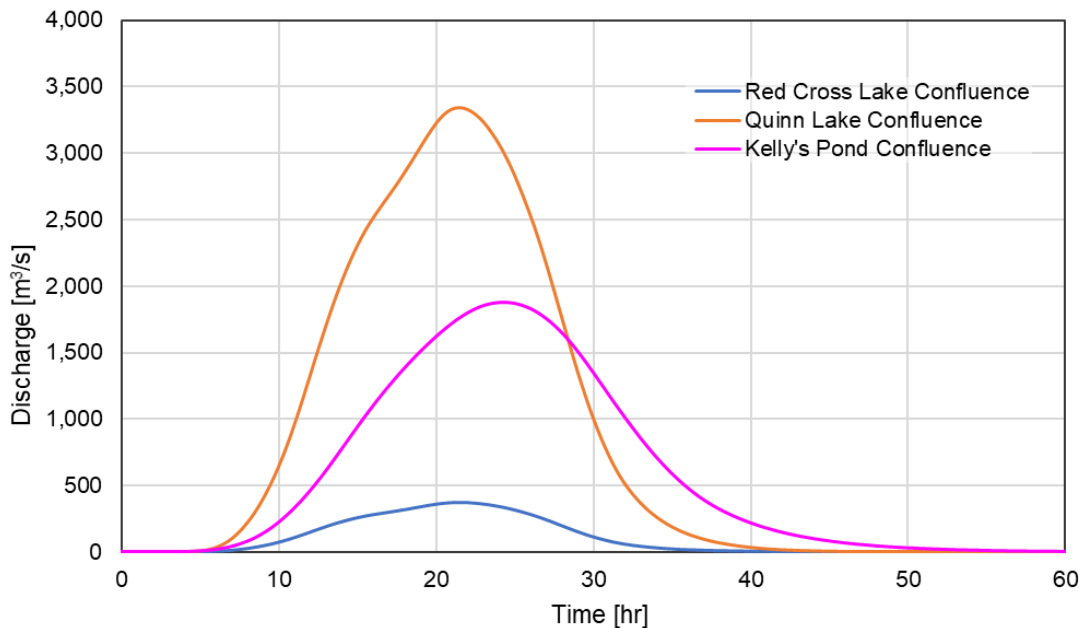
**Graph 3: PMF Lateral Inflow Hydrographs Routed at Downstream Locations Along Victoria River**

Under fair-weather conditions, the prorated baseline flows estimated for the two subwatersheds were apportioned according to the same ratios defined for the PMP baseline conditions (10% and 90% of runoff from the headwater subwatershed at the confluence of Red Cross Lake and Quinn Lake, respectively, and 100% of the runoff from the downstream subwatershed at the confluence of Kelly's Pond).

The setup of the hydrological model during the PMP event assumes that the flow through the dams along the Victoria River are unregulated. It is also assumed that no outflow from Victoria Lake into Victoria River will occur during the PMP event.

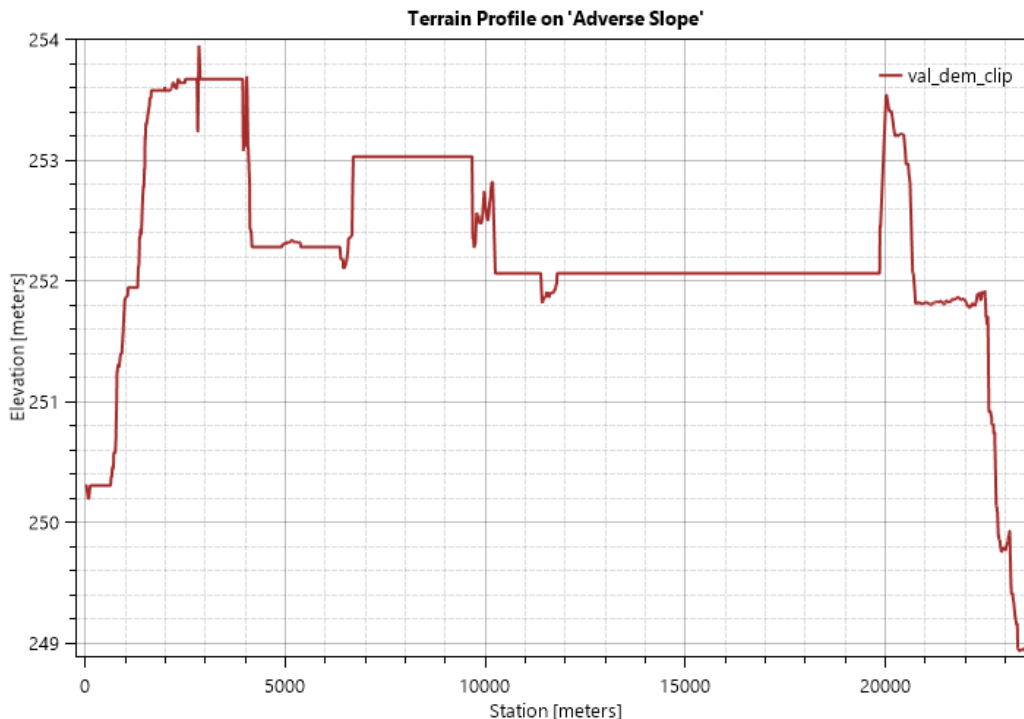
**Graph 4: Adverse Slopes in the Terrain Data**

The resolution of the downstream topographic information provides low accuracy as there were both sudden and gradual increases of up to 3 m in bottom elevation along a 20 km reach of the Victoria River approximately 4 km downstream of Crossing 1 (Graph 4). Although it is not unusual to encounter adverse slopes (uphill) in digital terrain data (especially where crossings are present), this particular case does not coincide with crossings. This resulted in severe ponding within the river, even during low flow scenarios.

Several attempts were made to correct the issue regarding the sudden increases and adverse slopes. The terrain was updated by lowering the ground elevation along this reach by means of a 5 m wide channel at the river's thalweg with 1:1 average side-slopes to facilitate the propagation of the flood wave in the hydraulic model.
