Pilot Study to Develop an Action Plan on Indicators for Monitoring Corrosion Control in Drinking Water

**Pilot Study to Develop an
Action Plan on Indicators
for Monitoring Corrosion
Control in Drinking Water**

Final Report (Re-issue)	<i>MPC</i>	06/03/2009	<i>MPC</i>
Final Report	Mike Chaulk	05/28/2009	Mike Chaulk
Draft (Second Submission)	Mike Chaulk	04/24/2009	Mike Chaulk
Draft (First Submission)	Mike Chaulk	03/31/2009	Mike Chaulk
<i>Issue or Revision</i>	<i>Reviewed By:</i>	<i>Date:</i>	<i>Issued By:</i>

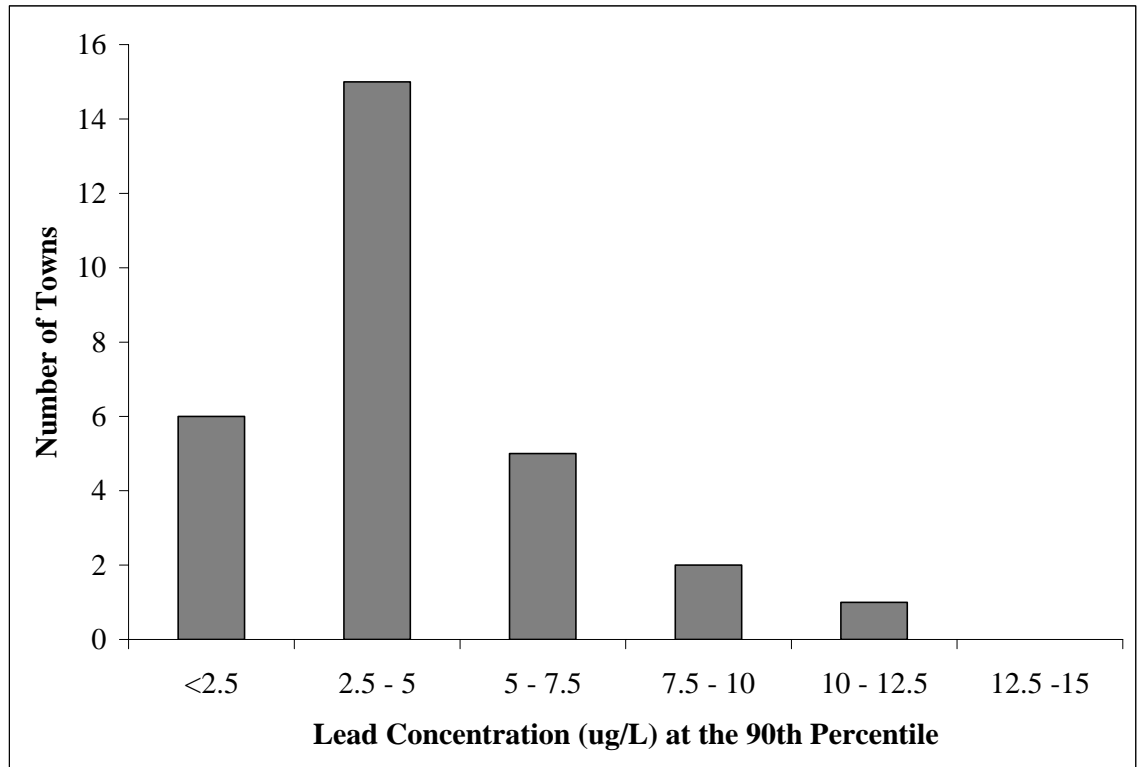
Figure 3.1: Distribution of 90th Percentile Lead Concentrations Among Residential Samples (Newfoundland and Labrador, Winter 2009)

The 90th percentile lead concentration was calculated for all of the communities sampled during this project. The number of towns with 90th percentile concentrations in ranges from <2.5 to 15 are shown in Figure 3.1 below.

Most of the towns that participated in the study had 90th percentile values below 5 µg/L. This means they were in compliance with both the USEPA and Ontario regulations. Seven towns had 90th percentile lead concentrations between 5 and 10 µg/L; putting them out of compliance according to Ontario regulations. One town had a 90th percentile concentration above 10 µg/L, putting it out of compliance with both the USEPA and Ontario regulations.

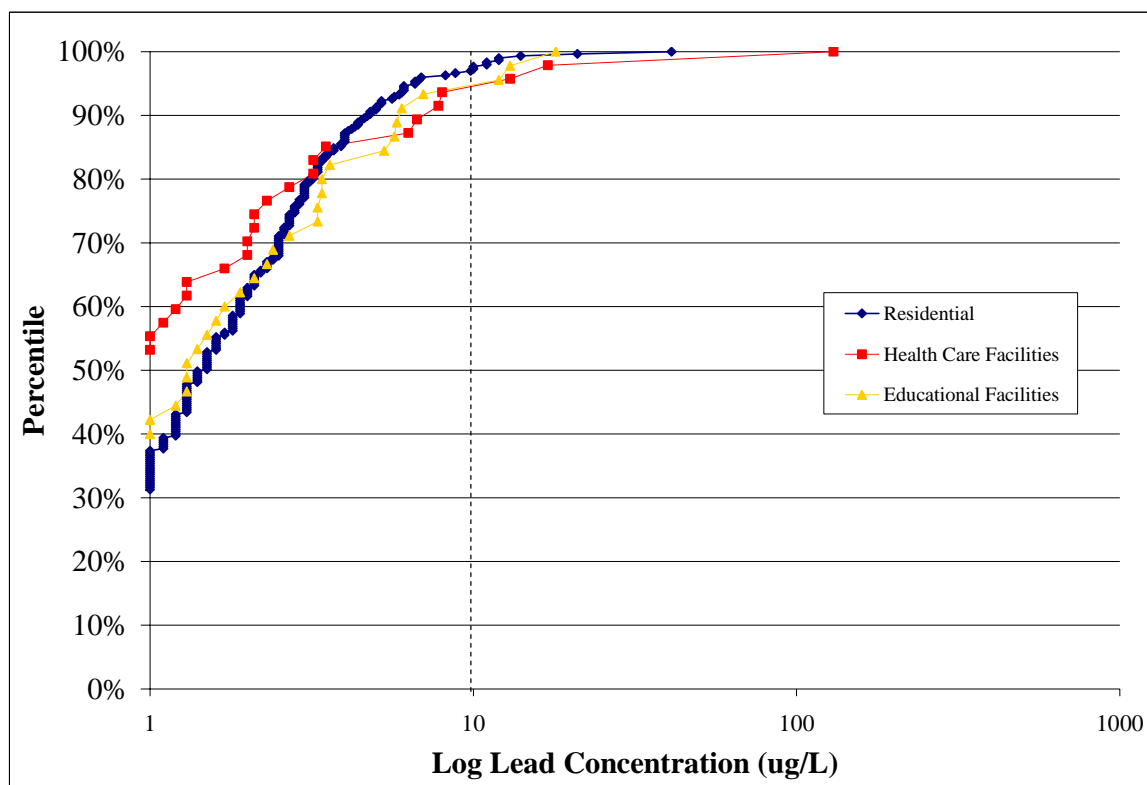
Figure 3.2: 90th Percentile Lead Concentrations for Residential Buildings, Health Care Facilities and Educational Facilities

90th percentile concentrations were also determined for the entire sets of residential, educational and health care sites. These are shown in Figure 3.2 below:

The residential samples for the entire province had a 90th percentile lead concentration of 4.8 µg/L. The educational facilities and the health care facilities had 90th percentile concentrations of 5.9 µg/L and 6.7 µg/L respectively. This may indicate that the non-residential samples were more likely to have elevated lead levels than the residential samples. This would make sense because the taps in non-residential buildings are less likely to be used on a regular basis. However, the difference between residential and non-residential 90th percentile lead levels may simply be as a result of there being many more residential than non-residential sample points.

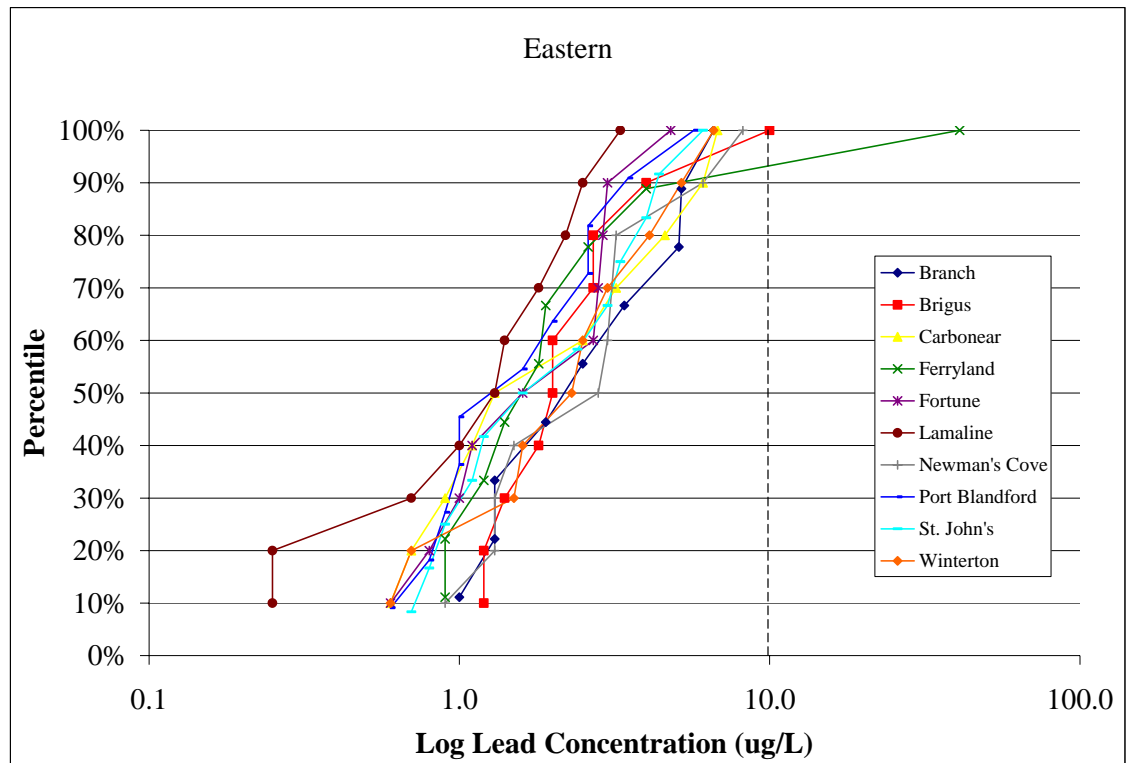
Figure 3.3: Determination of 90th Percentile Lead Concentration for Towns in the Eastern Region of Newfoundland and Labrador (Winter 2009)

Figure 3.3 shows the lead concentrations measured in the tap water from various residential sample locations in the communities participating in this study located in the eastern region of the province.

None of the towns in this region had a 90th percentile lead concentration above the limit of 10 µg/L. The 90th percentile concentration ranged between 2.5 µg/L in Lamaline to 6.1 in Carbonear and Newman's Cove. Two towns, Ferryland and Winterton, had one residential lead sample reading above the limit.

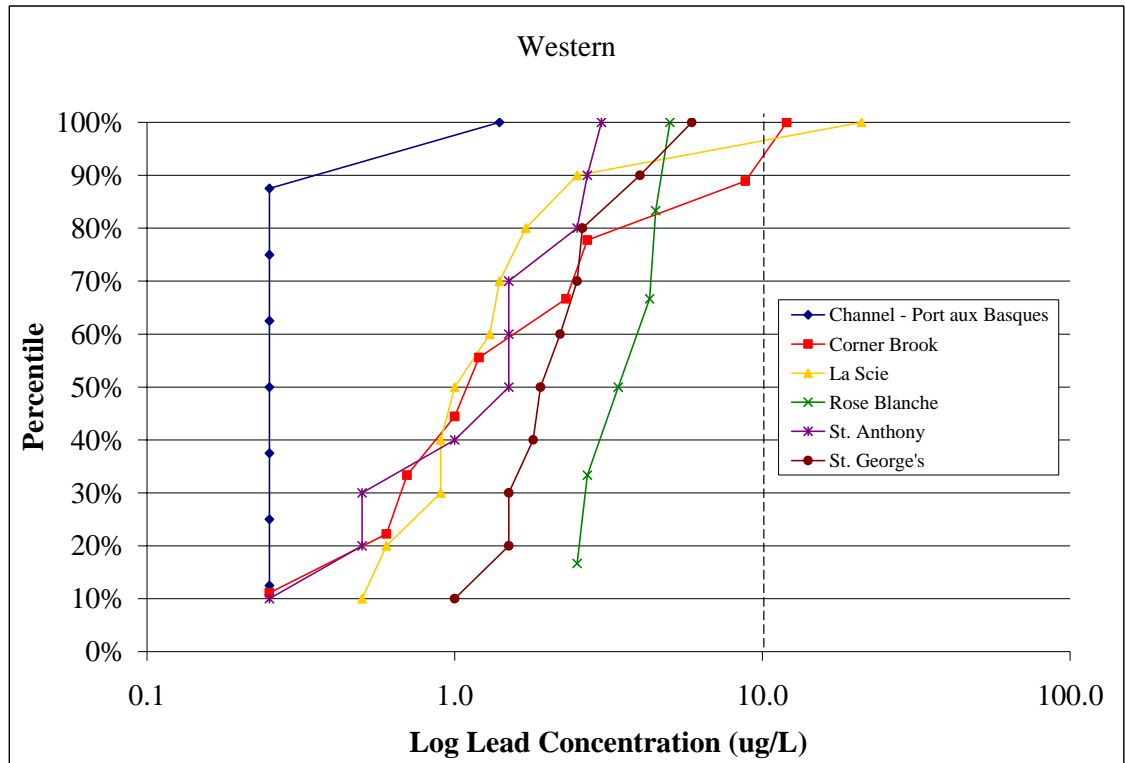
Figure 3.5: Determination of 90th Percentile Lead Concentration for Towns in the Western Region of Newfoundland and Labrador (Winter 2009)

Figure 3.5 shows the lead concentrations measured in the tap water from various residential sample locations in the communities participating in this study located in the central region of the province.

None of the communities sampled in the western region of Newfoundland had 90th percentile lead concentrations above the 10 µg/L. Corner Brook came close, with a 90th percentile reading of 8.8 µg/L. The remainder of the towns in this region had 90th percentile concentrations ranging from undetectable in Channel – Port aux Basques to 4.5 µg/L in Rose Blanche.

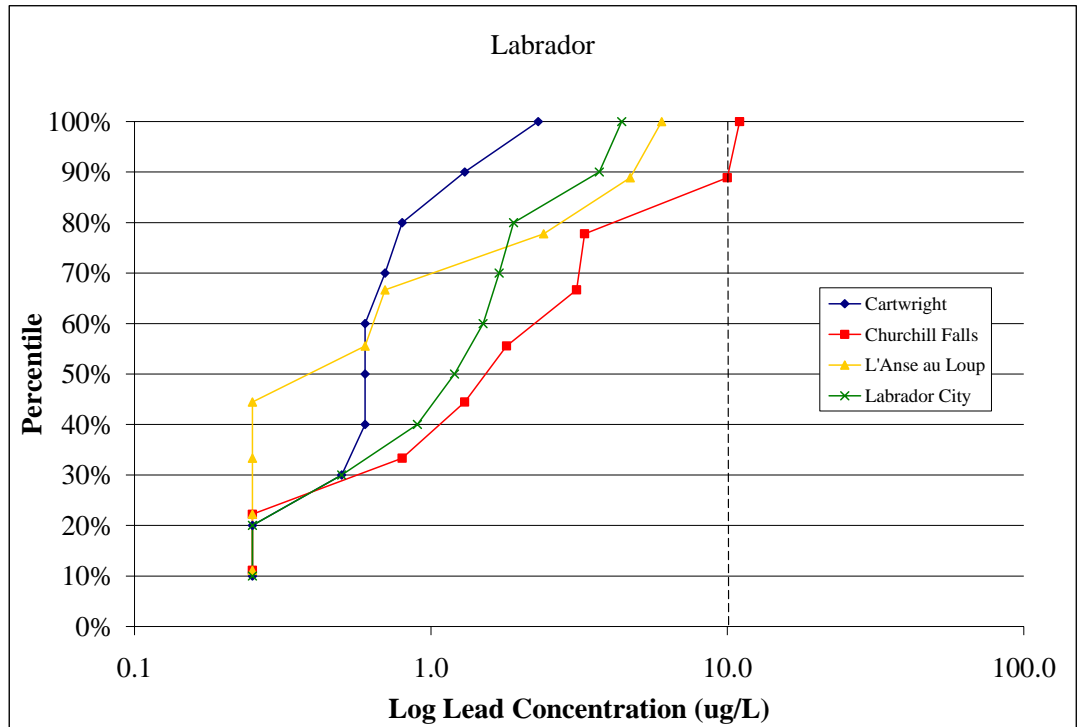
Figure 3.5: Determination of 90th Percentile Lead Concentration for Towns in Labrador (Winter 2009)

Figure 3.6 shows the lead concentrations measured in the tap water from various residential sample locations in the communities participating in this study located in the central region of the province.

Churchill Falls was the only community with a 90th percentile lead concentration at or above the 10 µg/L limit at exactly 10 µg/L. The other three communities had 90th percentile readings ranging from 1.3 µg/L in Cartwright to 4.7 µg/L in L'Anse au Loup.

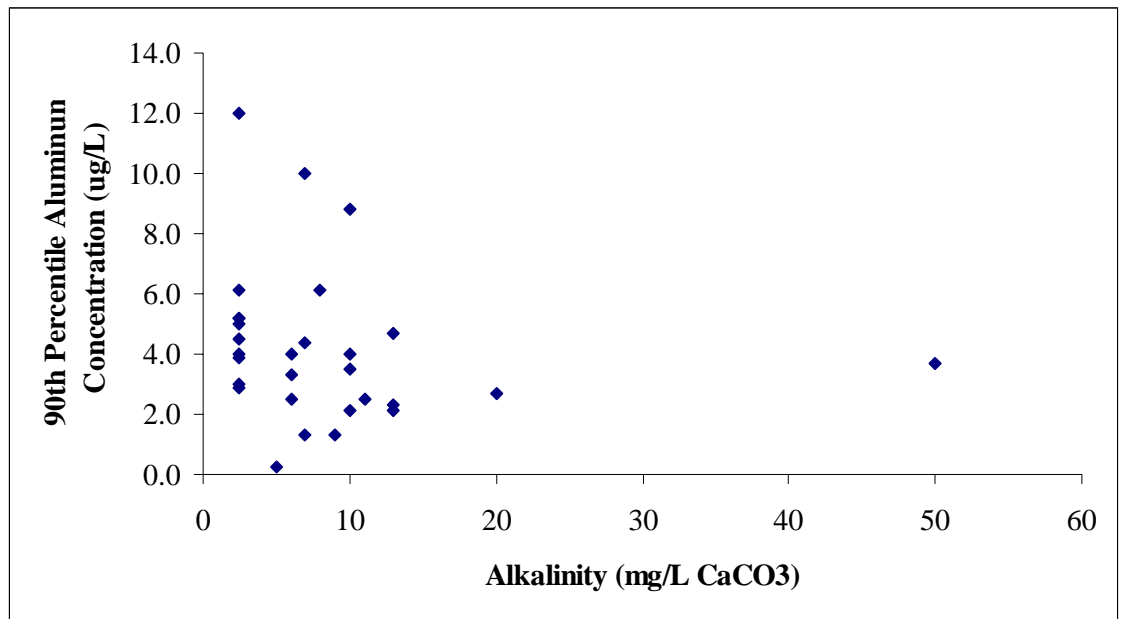
Figure 4.2: The Influence of Alkalinity on 90th Percentile Lead Concentrations in Tap Water in Communities in Newfoundland and Labrador.

Alkalinity measurements from the sampling program conducted in Newfoundland and Labrador have been compared to the 90th percentile lead concentration in various communities and shown in Figure 4.2:

No definite trend was apparent between the level of alkalinity measured in the RCap and the 90th percentile lead concentration of the town. However, the highest lead readings did occur in towns with very low alkalinity measurements. In some cases, the low level of alkalinity present in the water may have influenced the amount of lead that ended up at the tap. However, the prevalence of low alkalinity water in Newfoundland suggests that although it may be an exacerbating factor, low alkalinity in and of itself is unlikely to be the main cause of the high lead readings found in some individual buildings.

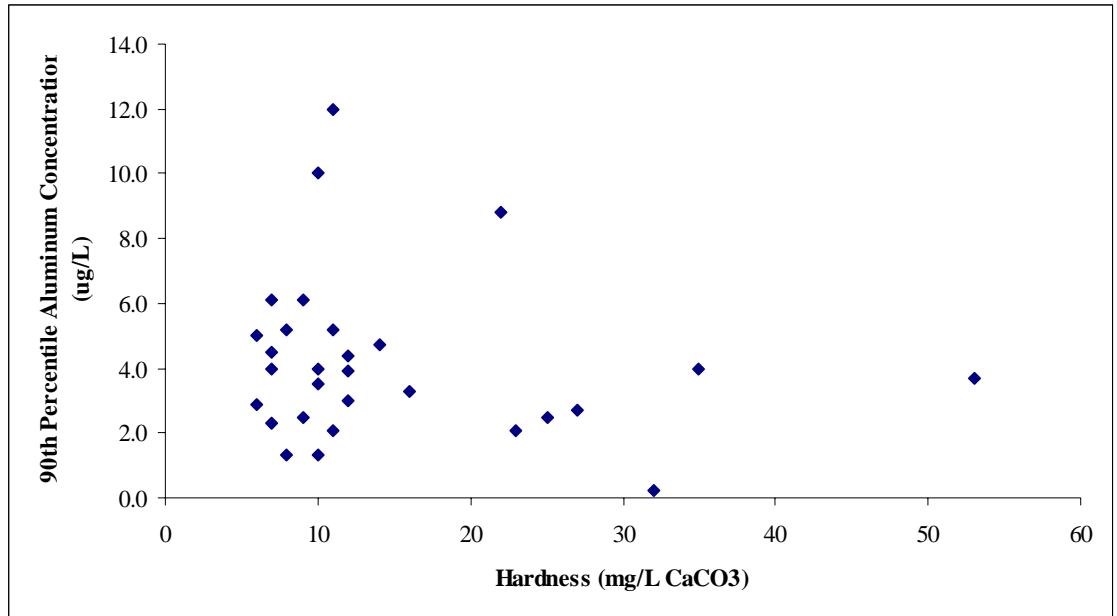
Figure 4.3: Comparison of Water Hardness and 90th Percentile Lead Levels in Tap Water from Newfoundland and Labrador

Hardness is the measure of divalent ions present in a given water sample. Most hardness in the water is caused by calcium ions. Until recently, it was widely thought that calcium ions in the water formed a protective film on pipes that could prevent corrosion. More recently however, this has been shown to be an ineffective mechanism for corrosion control (Schock, 1989; Health Canada, 2007). 90th percentile lead levels are compared to community water hardness measurements in Figure 4.3 below:

The highest lead levels occurred in towns where the RCap showed a particularly low level of hardness. However, otherwise, no strong link could be drawn between hardness and the amount of lead present at the tap.

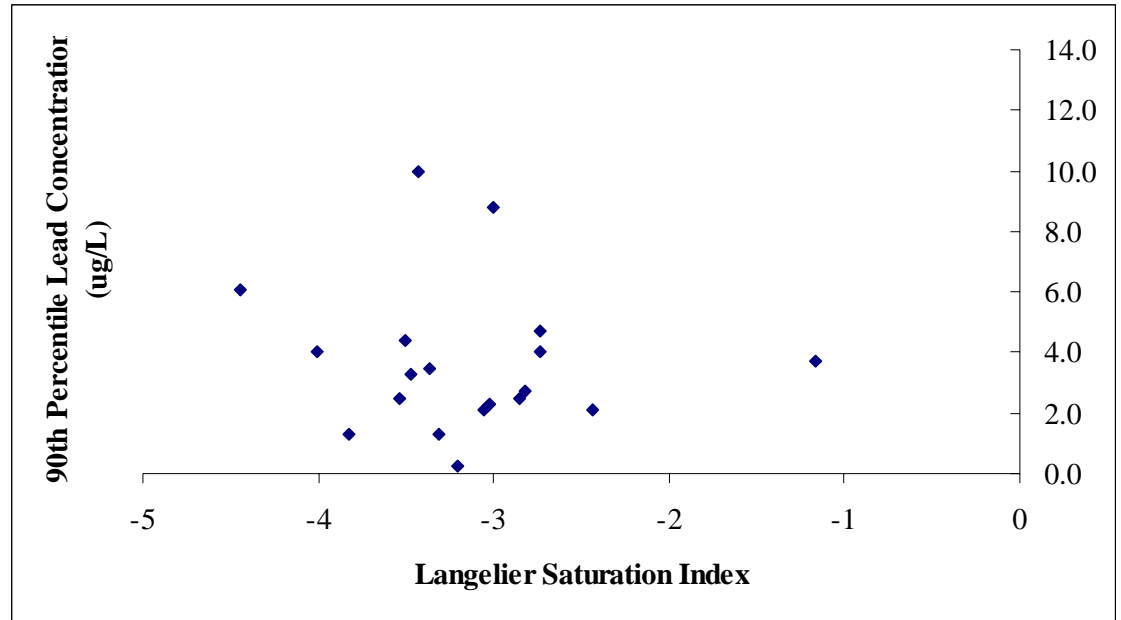
Figure 4.4: Langelier Saturation Index (LSI) Compared to 90th Percentile Lead Concentration in Residential Tap Water Samples.

It was not possible to calculate the LSI in some of the communities visited during the study because the ions in the water samples taken for the RCAP were not balanced. The values that were obtained are presented along with the corresponding 90th percentile lead concentrations in Figure 4.4 below.

Alkalinity and hardness are known not to be strongly or reliably correlated to lead concentrations in tap water (Lee et al., 1989; Schock, 1989), therefore it was not surprising that the LSI did not have a direct relationship with the amount of lead in the tap water samples.

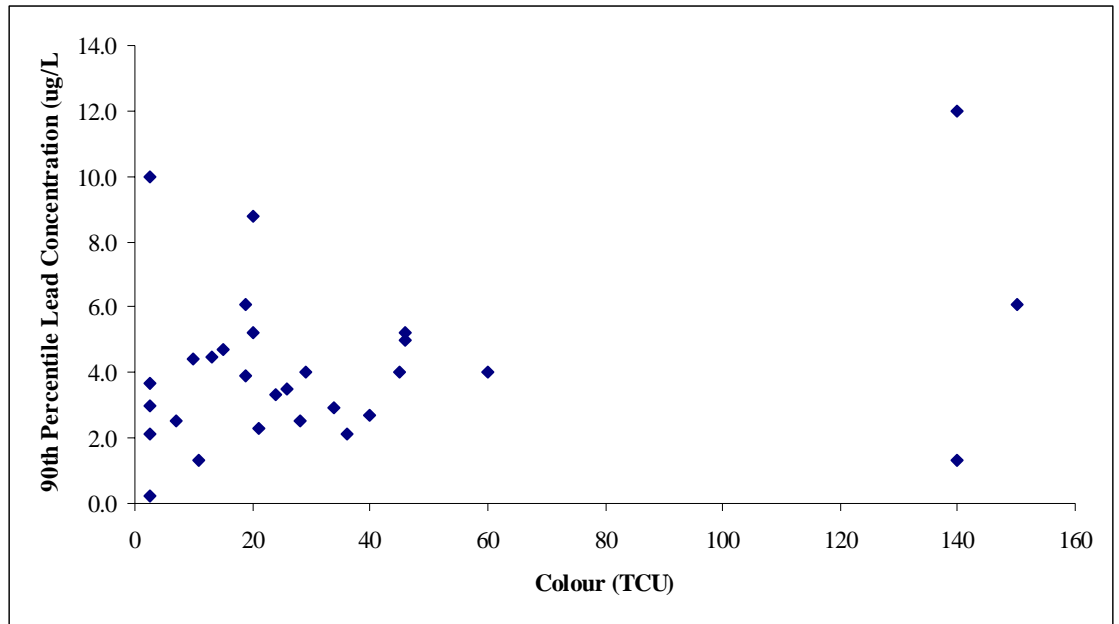
Figure 4.6: 90th Percentile Lead Concentration as a Function of TOC

The historical records of water quality provided by the Department of Environment and Conservation indicate that most of the communities that participated in this study have coloured water. 90th percentile lead concentrations in the various towns are compared to TOC levels from the RCAs conducted during the sampling program in Figures 4.6 below:

TOC level did not seem to be tightly correlated to the 90th percentile lead concentrations in the various towns. The town with the highest concentration of TOC also had a high average lead concentration, however, many towns with low levels of TOC also had high concentrations of lead.

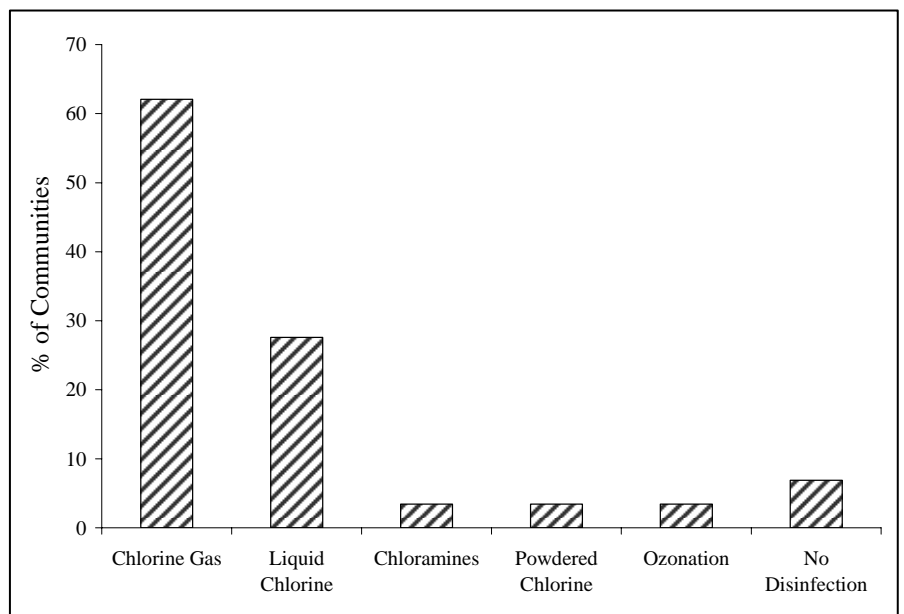
Figure 4.8: Self-reported Disinfection Strategies Used in Newfoundland and Labrador in the Winter of 2009

The disinfection strategy used by a municipality can have an effect on the amount of lead that reaches the customer at the tap because disinfection has a strong impact on water chemistry. Figure 4.8 shows the relative distribution of disinfection strategies throughout the province:

Most of the communities participating in this project use liquid or gaseous chlorine to disinfect their water. In both cases, this refers to free chlorine (Cl_2). The systems in the towns of Branch and La Scie do not have any form of disinfection. Researchers are somewhat at odds about the effects of chlorine disinfection on pipe corrosion.
