REPORT ON

Inventory and Assessment of Dams in Newfoundland and Labrador Year Two

Report Number: 1668487-01-Rev 0

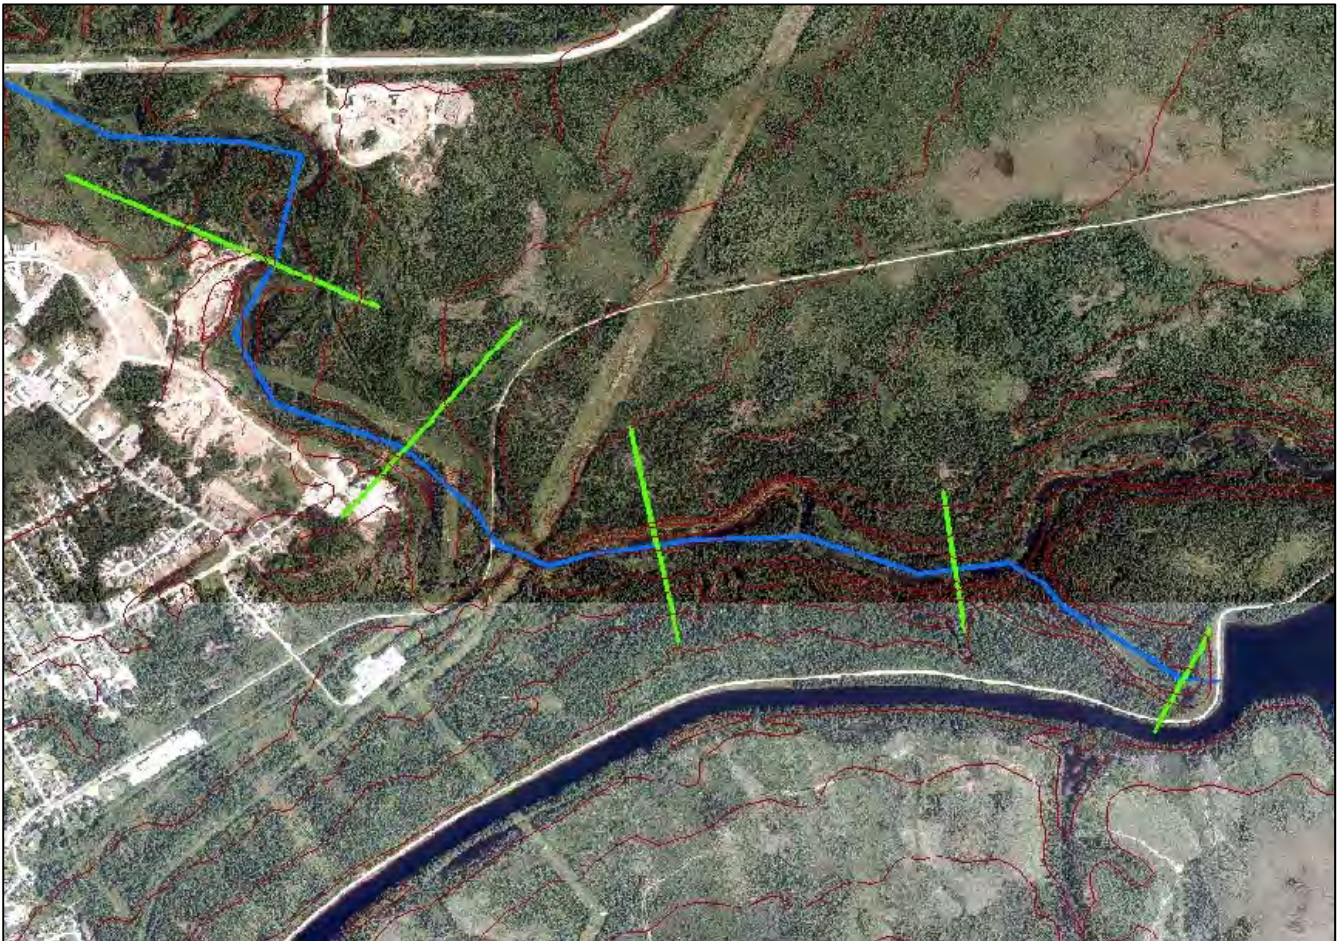
Figure 1: Cross sections (green) along initial portion of assumed flow path (blue) from Deep Bank Dam breach. Elevation contours shown in dark red.

At each cross section, the distance downstream from the dam should be measured and the corresponding breach wave height determined from the calculations in Table 29. The wave height is used to count up from each side of the flow-path to the contour that corresponds with the wave height, where a point should be drawn that represents the floodwater extents at that distance downstream. It should be noted that the more detailed the contour map, the more accurate the inundation boundaries will be. Once completed for each cross section, all boundary points should be joined to form a polygon that delineates the inundation zone, as seen in Figure 2. The full inundation map for the Deep Bank Dam breach scenario is shown in Figure 10 of **Appendix H**. For comparison purposes with the following methods, Figure 11 of **Appendix H** includes a close up view of the resulting inundation area throughout the Town of Deer Lake.

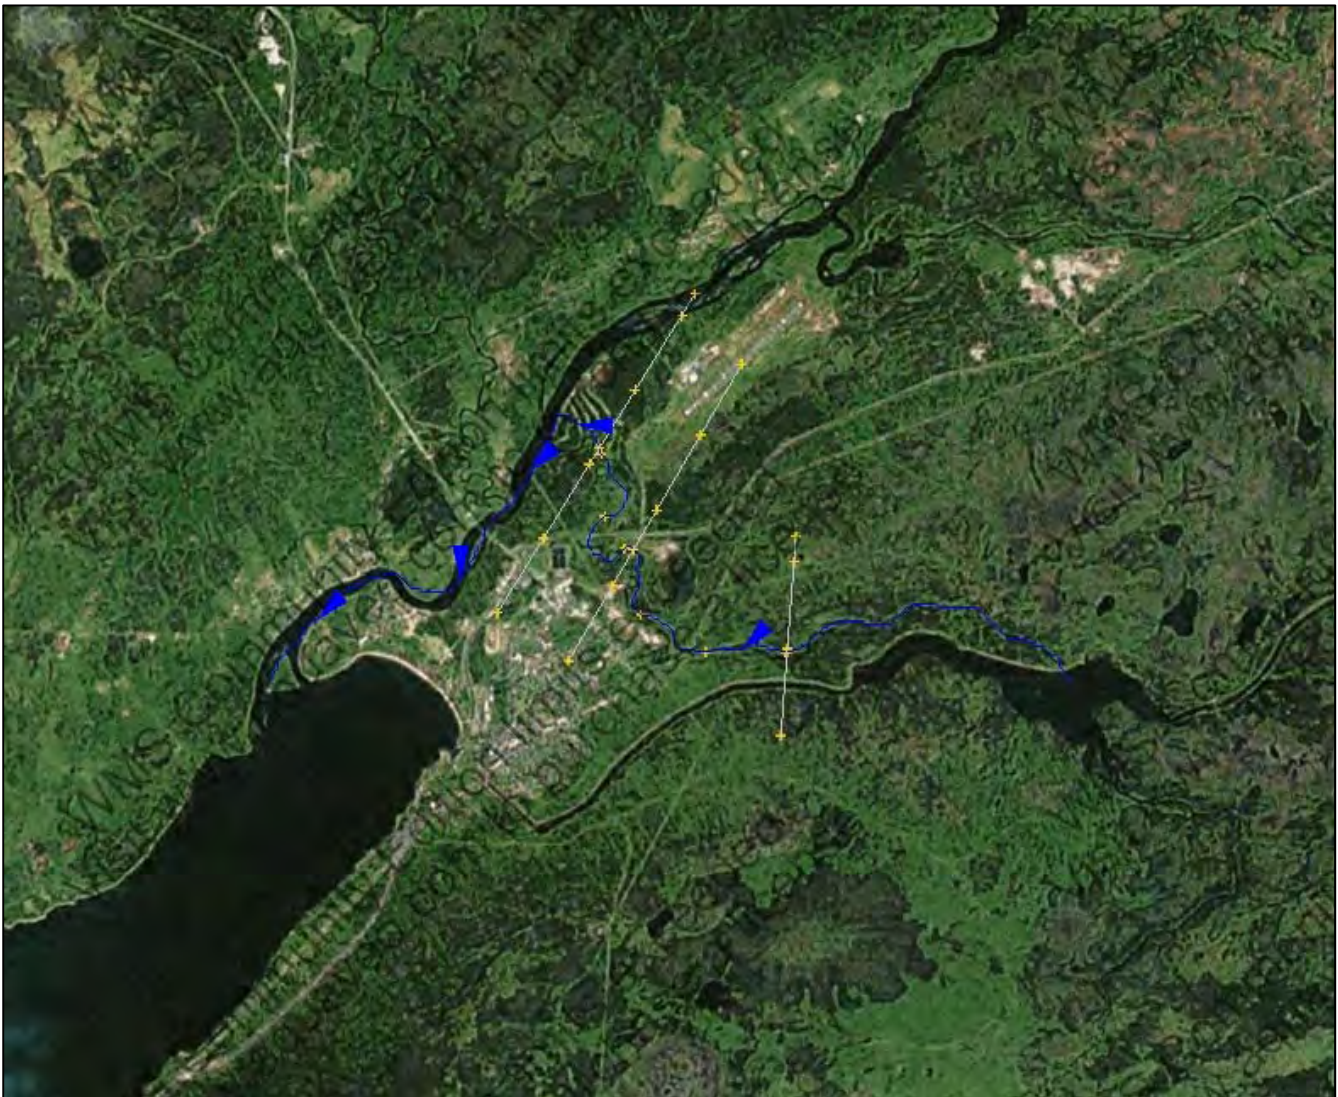
Figure 3: Screenshot from SMPDBK program showing flow-path (blue) and cross sections (light grey).

To model the hypothetical Deep Bank Dam breach using WMS, a basemap and elevation data were first obtained through the WMS program to create a digital elevation model (DEM) of the area of interest. Based on the DEM, WMS runs an internal program called TOPAZ which computes flow directions for individual DEM cells and creates streamlines based on these directions. The user then isolates a single stream centerline using the results from TOPAZ, which represents the main flow-path the floodwater would follow from the breach location (Aquaveo, 2015). The final step in setting up the model is to create cross sections along the stream centerline. The cross sections should intersect the stream channel perpendicularly, and while there is no specified minimum number of cross sections that must be drawn, the more cross sections that are included, the more refined the final result of the model will be. For the purposes of this project, the stream centerline isolated was Glide Brook, extending from the location of Deep Bank Dam, and through the northeast portion of Deer Lake until the brook joins the Humber River. Three (3) cross sections were cut through the centerline, as shown in Figure 3.

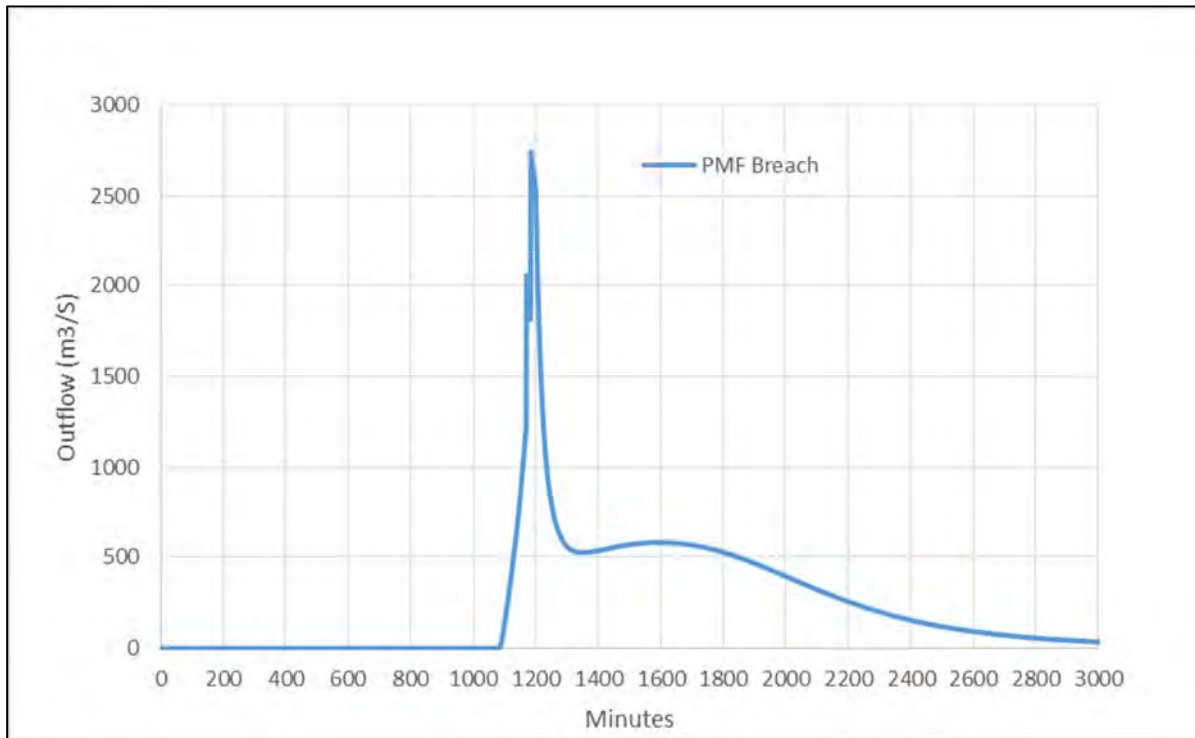
Figure 6: Deep Bank Outflow Hydrograph

The resulting outflow hydrograph has a peak discharge of 2,744 m³/s and is shown in Figure 6.

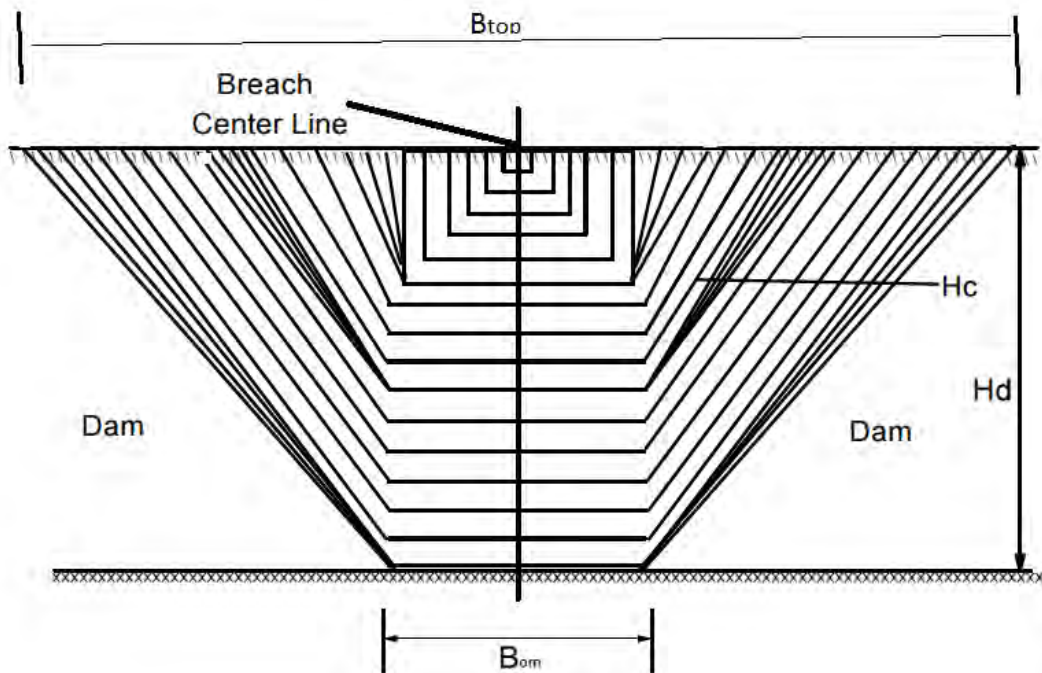
Figure 1: Front view of dam breach formation sequence.

embankment would fail at a particular location, the breach is typically modelled as initiating along the section of dam with the maximum height. A generalized trapezoidal breach progression is illustrated in Figure 1.

BREACH couples the conservation of mass of the reservoir inflow, spillway outflow, and breach outflow with the sediment transport capacity of the unsteady uniform flow along an erosion formed breach. The growth of the breach, as shown in Figure 1, is dependent on the dam's material properties and the assumed location of the downstream face of the dam.
