**Regional Water Resources Study  
of the Notre Dame Bay Area and  
Central Newfoundland Region**

**Inventory of Water Supply Systems**

**REGIONAL WATER RESOURCES STUDY  
OF THE  
NOTRE DAME BAY AREA AND  
CENTRAL NEWFOUNDLAND REGION  
INVENTORY OF WATER SUPPLY SYSTEMS**

Prepared by  
**Nolan, Davis & Associates (1986) Limited  
St. John's, Newfoundland**

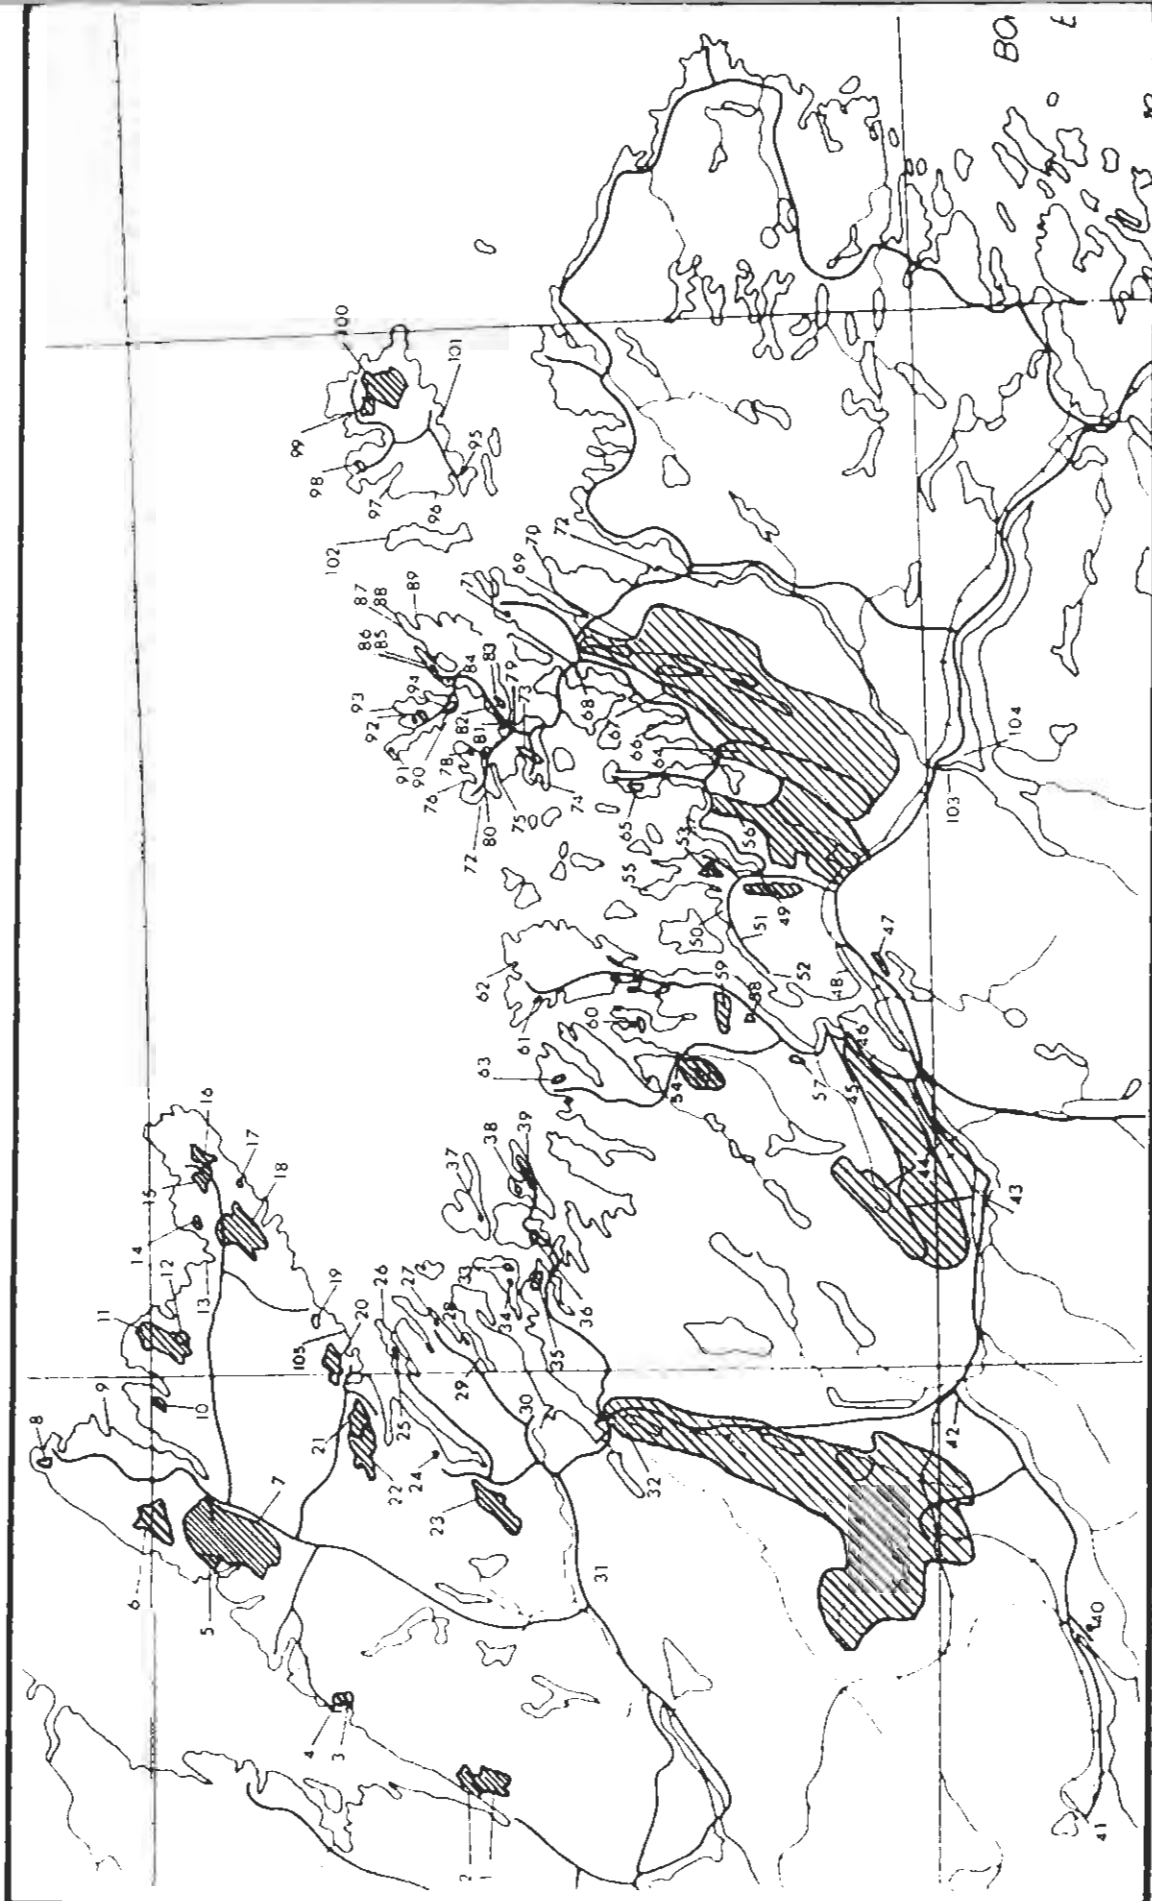
DEPARTMENT OF ENVIRONMENT AND LANDS  
 WATER RESOURCES STUDY OF THE NOTRE DAME BAY AREA  
 CENTRAL NEWFOUNDLAND REGION

A list of incorporated communities in the study area is given on Table A-1. Their locations and water supply drainage areas are shown on Figure A-1.

Numbers of communities shown on Figure A-1

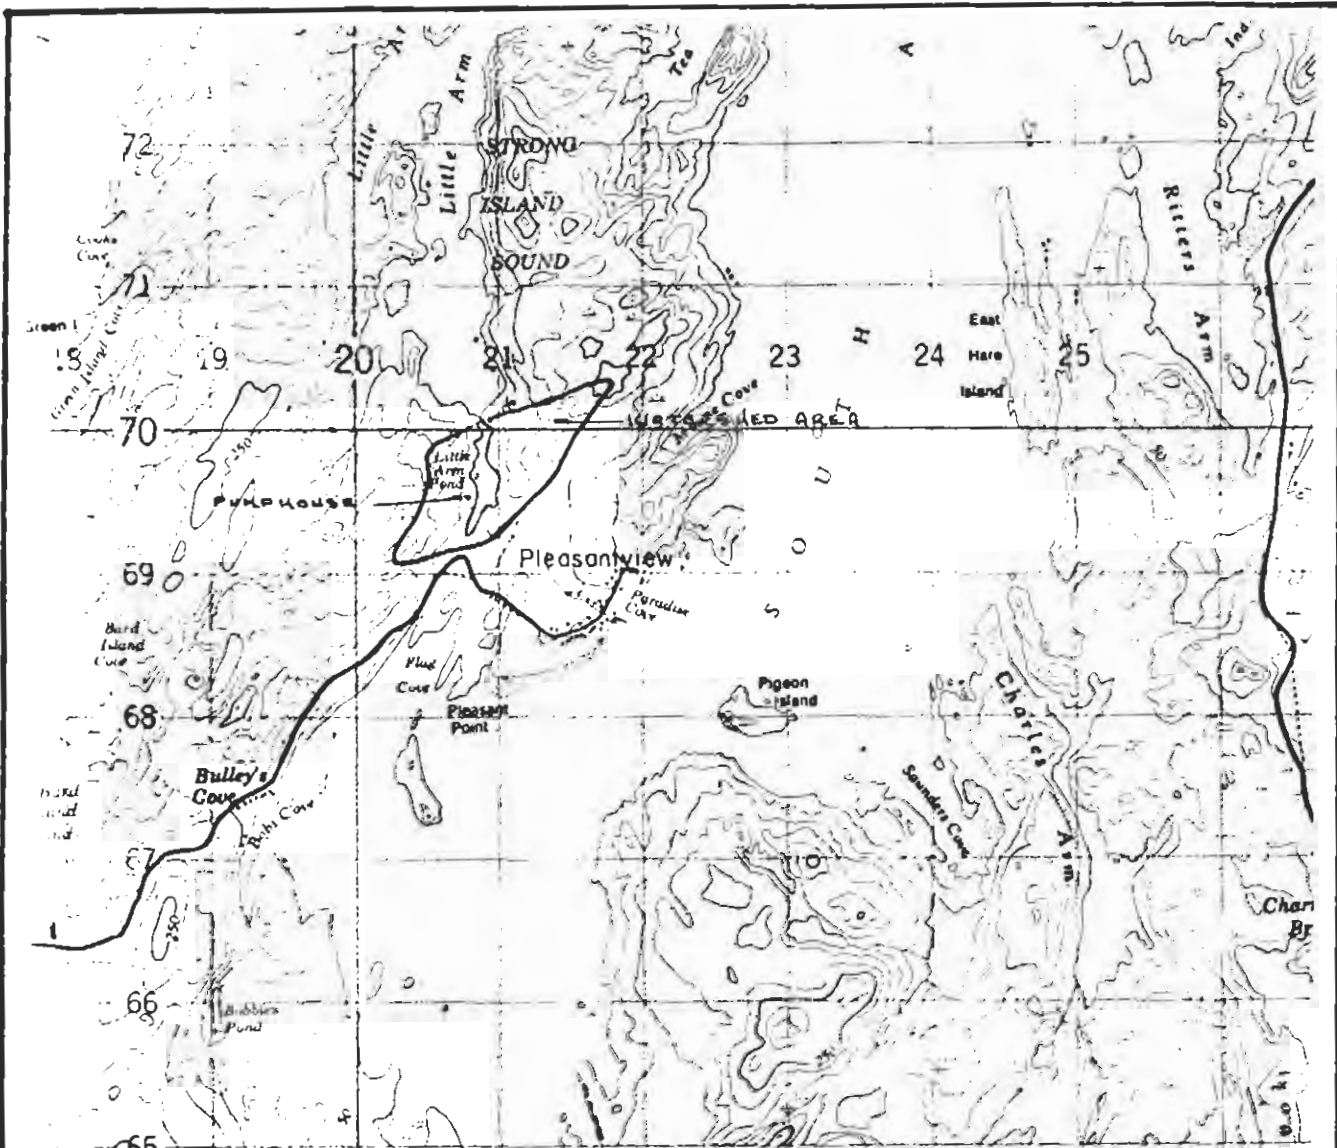
**PLEASANTVIEW**

DEPARTMENT OF ENVIRONMENT AND LANDS  
 WATER RESOURCES STUDY OF THE NOTRE DAME BAY AREA—CENTRAL NEWFOUNDLAND REGION.
