Water Treatment Facility Effectiveness in Newfoundland and Labrador

Drinking Water Safety Workshop, Gander Annette Tobin, P.Eng annettetobin@gov.nl.ca March 22-24, 2016

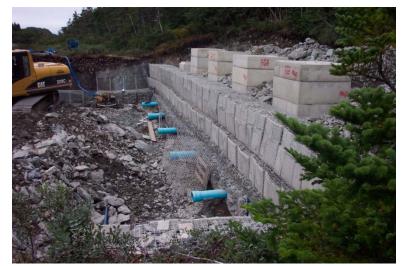
Construction of Buried Infiltration Gallery

- An intake structure in which the intake is buried or contained within a berm
- A perforated intake pipe is placed and permeable material is backfilled on top or around it creating a barrier to filter water before it reaches the intake pipe

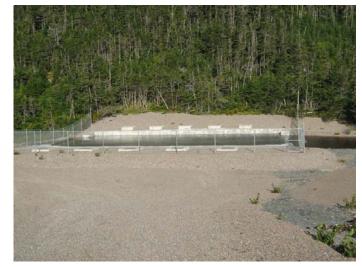
Finished Infiltration Gallery

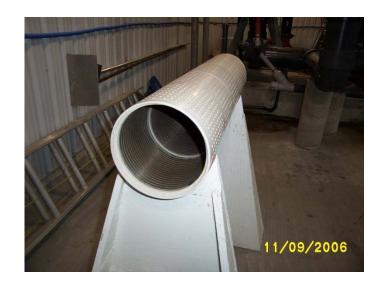
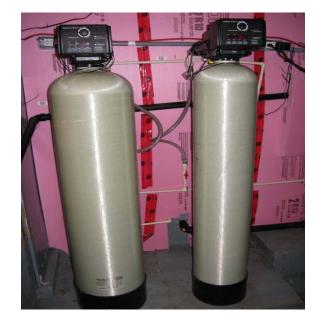
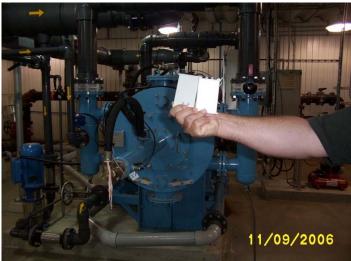
Filter Types in NL

- Media filter (Sand, anthracite & GAC)
 - Retaining and adsorbing
- Mesh filter
 - Single-layer Retaining
- Thread filter
 - Multi-layer Retaining

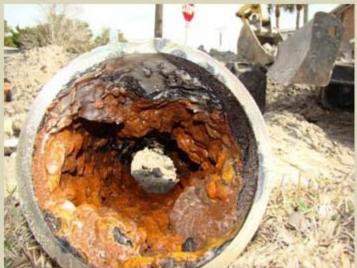
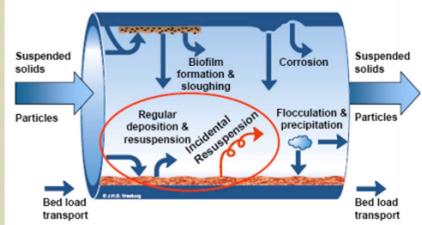
- Only 2 communities showed <u>significant</u> decreases
- About 11 communities showed increases from the pre-filter water to filtered water
- Why?
 - Corrosion of distribution system pipes over the years
 - Re-suspended sediments in pipes

"Mass Balance Model", J.H.G. Vreeburg (2004)

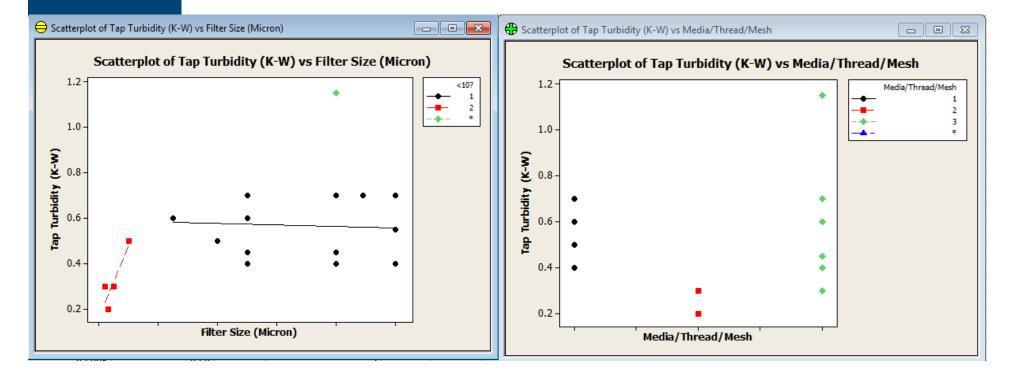
Filtered Tap Turbidity vs. Filter Size & Type

- 1 10 microns group
 - Red dots
 - Lower turbidity
 - Follow a linear trend
 - More effective

- 11 100 microns group
 - Black dots
 - Higher turbidity
 - Mesh filters showed the highest turbidity

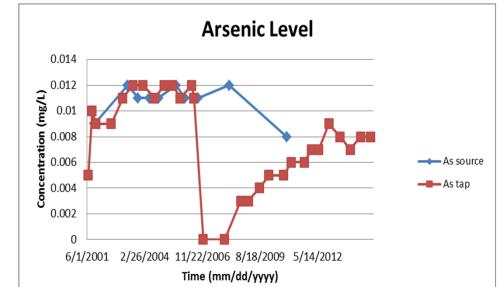
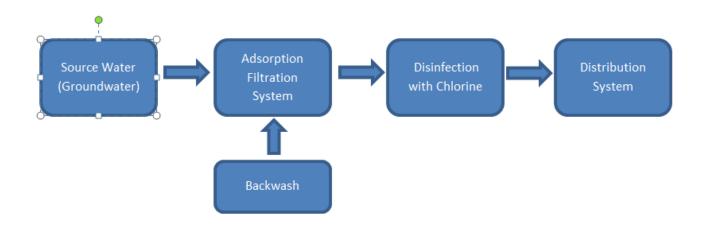
- 10 systems in NL
- GCDWQ for arsenic is 0.01 mg/L
- AdEdge Ad-33
 Adsorption
 System

Significant decrease in Arsenic observed

Arsenic levels tend to increase over time as media is spent

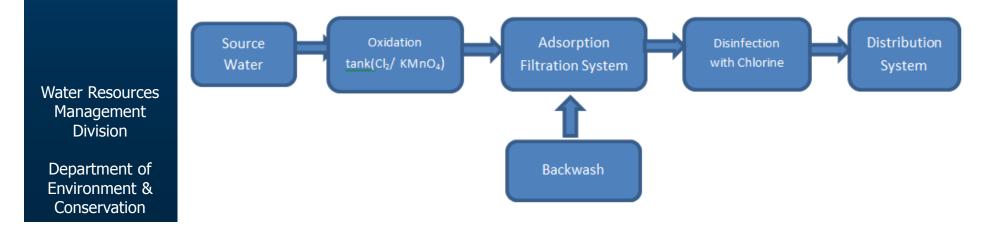
- GCDWQ
 - Iron- 0.3 mg/L
 - Manganese- 0.05 mg/L
- Health Canada looking at revising Mn guideline:
 - proposed MAC of 0.1 mg/L
 - Affects 76 public drinking water systems
 - Proposed AO of 0.02 mg/L
 - Affects 232 public drinking water systems
- Greensand adsorption removal system

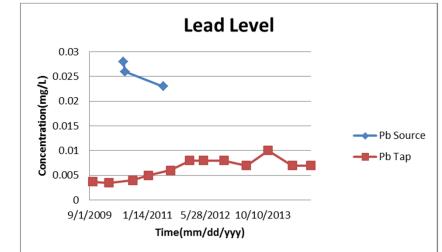
- One system in NL
- GCDWQ is 0.01mg/L
- Significant decrease in Lead observed
- 1 micron cartridge filter replacement time varies but usually it is done every 6-8 weeks

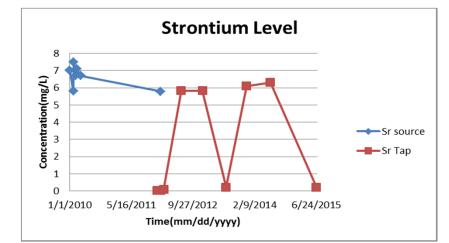
- One system in NL
- HC drinking water guidance value of 4.4mg/L
- Ion exchange using a sodium resin
- Significant decrease in Strontium observed
- Values above 4.4 mg/L observed
 - Sodium resin needs to be regenerated regularly

Town	Percent Removal
Bay St. George South	58.82%
