# WATER DISTRIBUTION SYSTEM IMPROVEMENTS

DEPARTMENT OF PUBLIC WORKS & PARKS  
ENVIRONMENTAL SERVICES DIVISION

# Overview

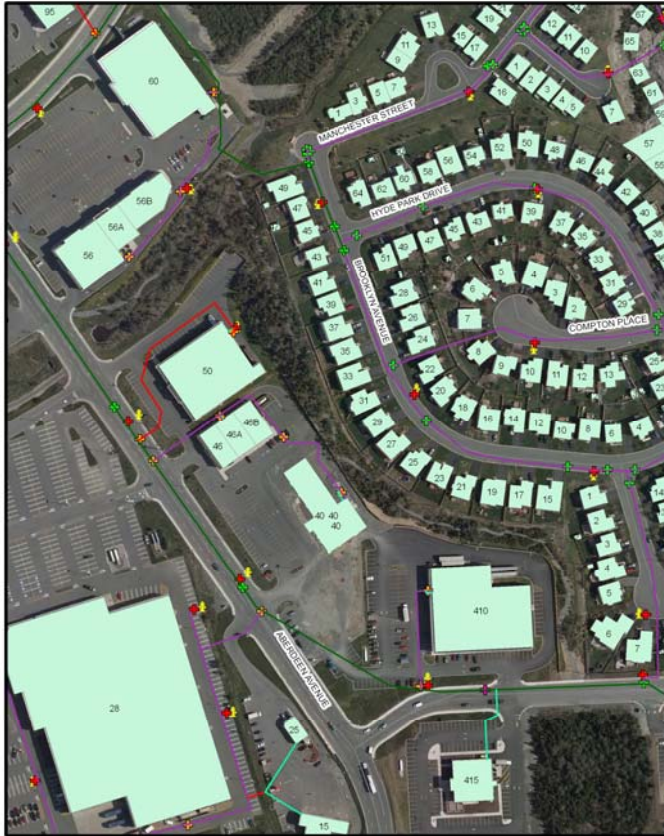
## CSJ Infrastructure

- Water Mains  $> 300\text{mm}$ 
  - 74 km
- Water Mains  $\leq 300\text{mm}$ 
  - 516 km
- Fire Hydrants
  - City Owned = 3055
  - Private = 446
- Water Main Valves
  - Valves  $> 9940$

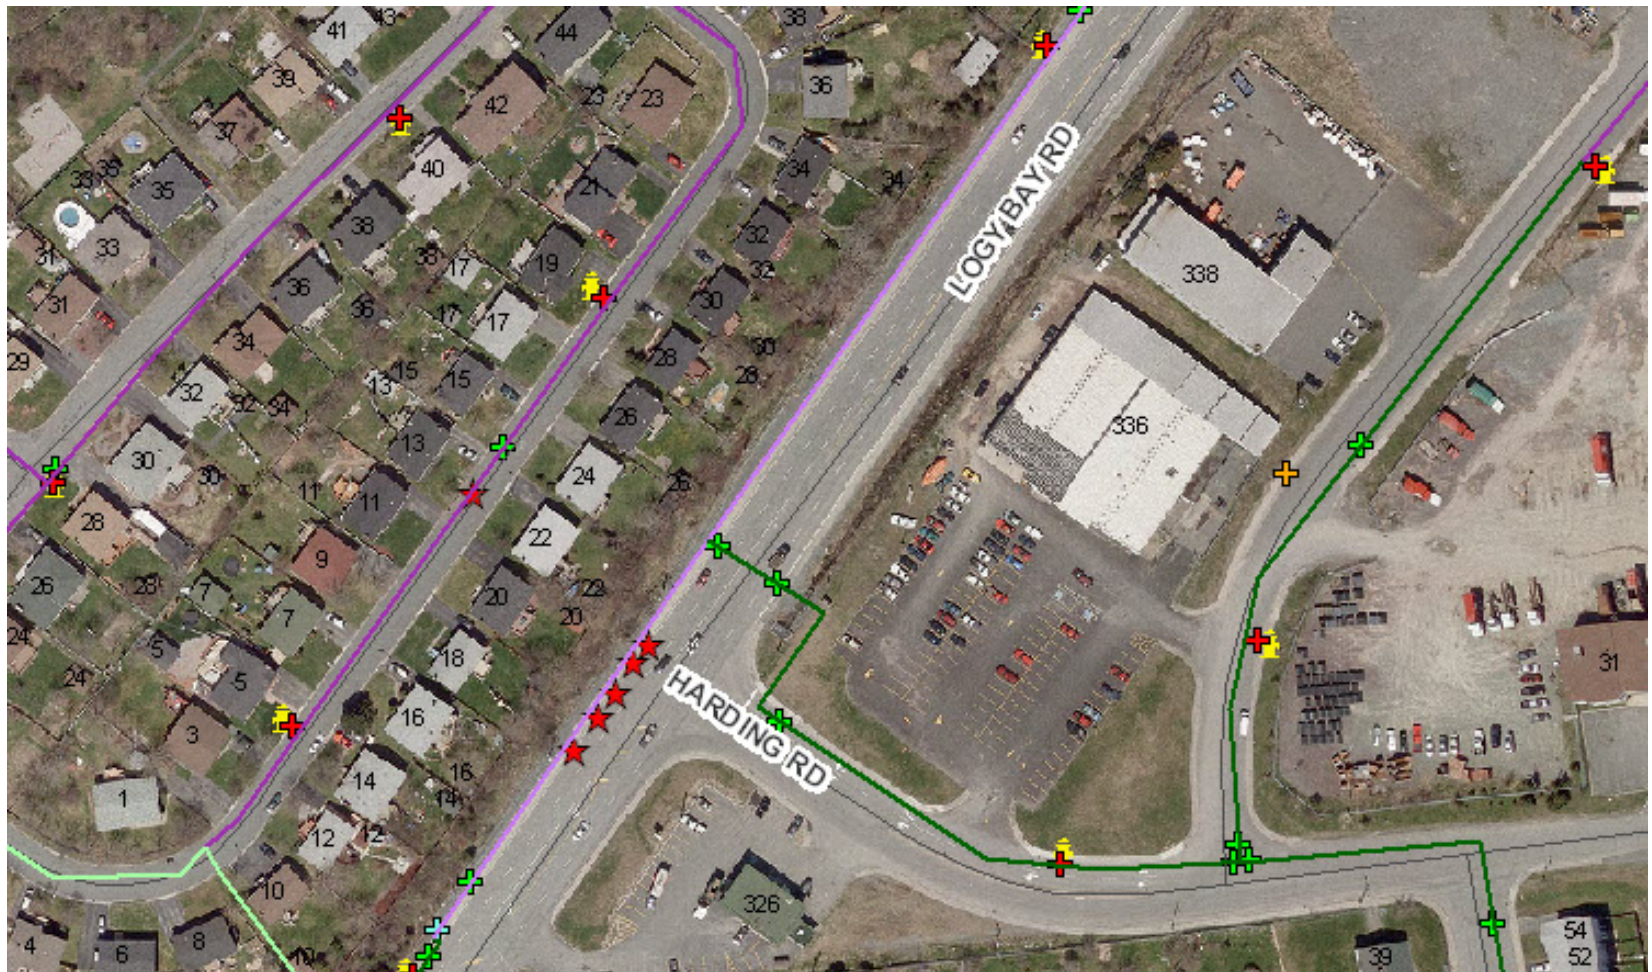
# Case Study – Logy Bay Road

- Location – Logy Bay Road at Harding Road
- Water Main Diameter – 400mm
- Water Main Material – Ductile Iron
- Year Installed - 1985
- Recorded Water Main Breaks – 5 between 2001 and 2006
- Comments – Reported corrosion along bottom of pipe with numerous small holes.

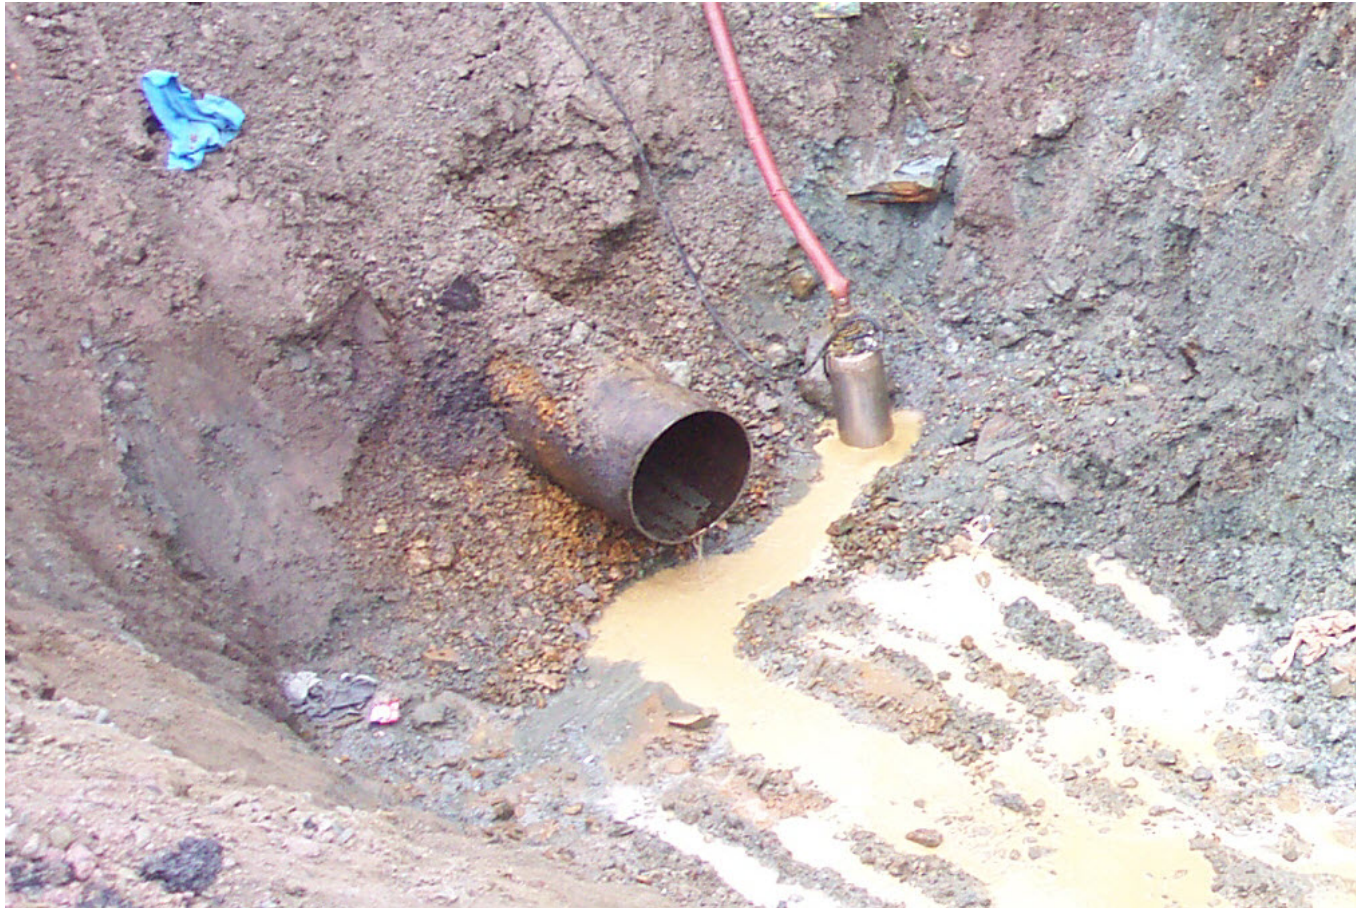
# Case Study – Logy Bay Road

- Similar results found at all 6 locations
- Common theme between all sites:
  - Water Main installed adjacent to an existing watercourse or within re-routed watercourse.
- No reported problems since construction completed.
- All water mains replaced using PVC DR18

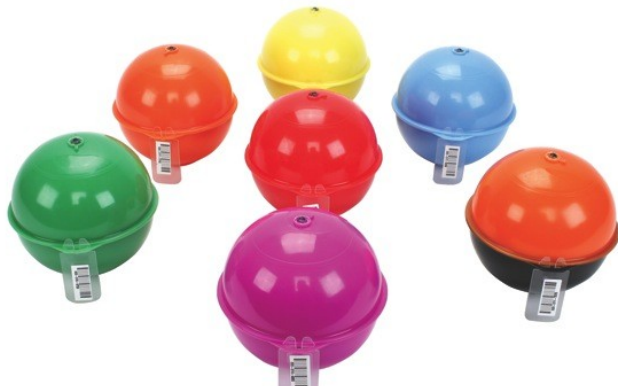
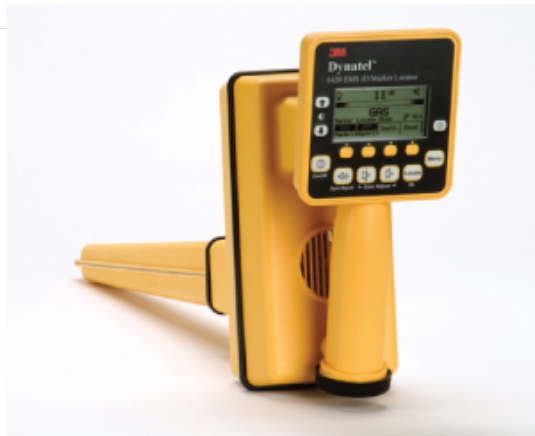
## 3M Locating System

- Marker Balls capable of being programmed with 6 lines of data;
- Different types of balls for various infrastructure
- Locator will communicate with GPS unit

- PVC pipe cannot be traced or located using traditional methods.
- Most municipalities use tracer wire.
- CSJ has selected 3M Locating System

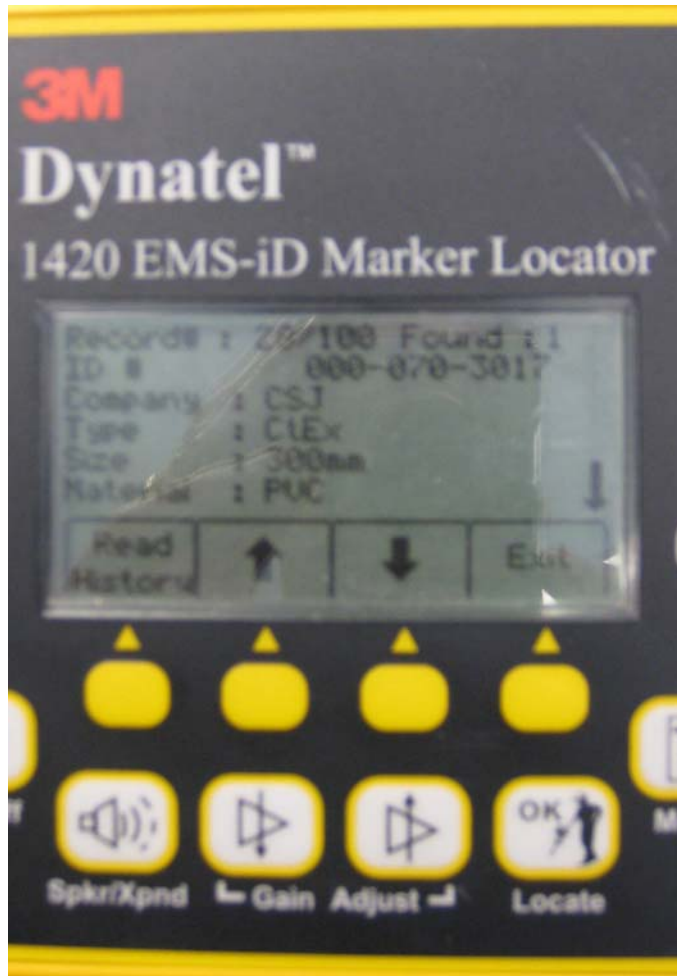
Typ. Data on Marker Ball:

- Company
- Type
- Size
- Material
- Date
- Description

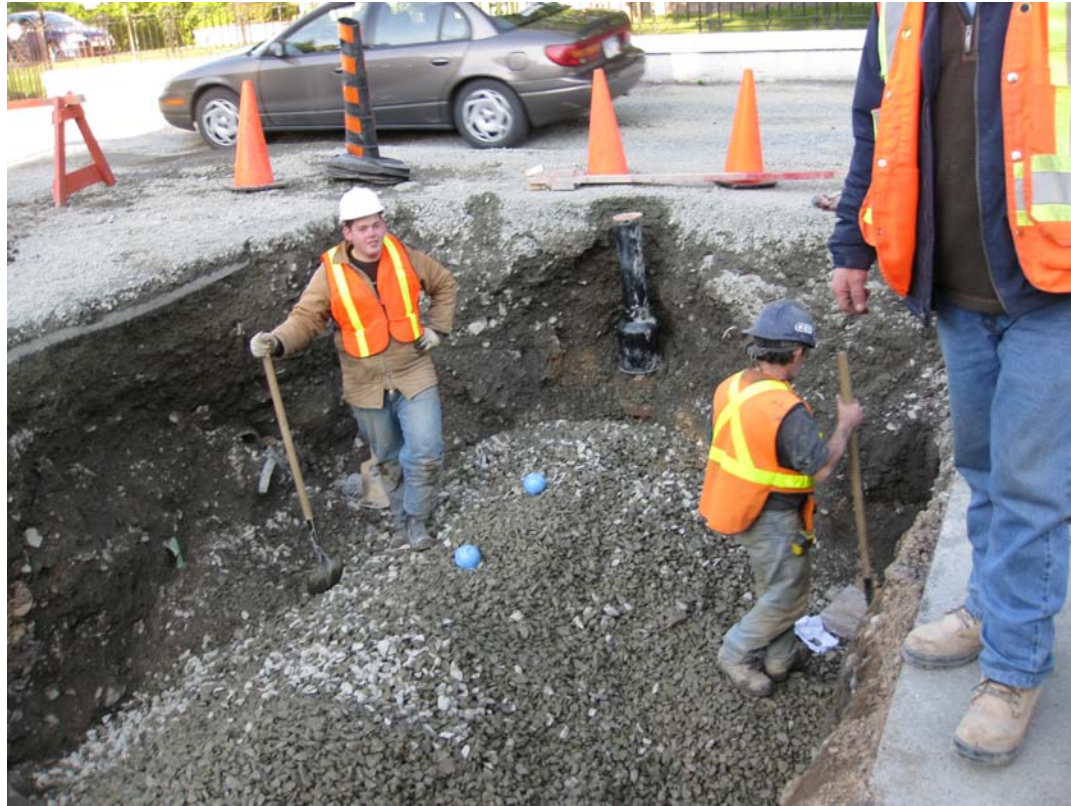
## Marker Ball Locations:

- Bends
- Tees
- Reducers
- Corporations
- Curb Stops
- Stub Ends of Pipe
- Connect to Existing
- Max. 30m Spacing

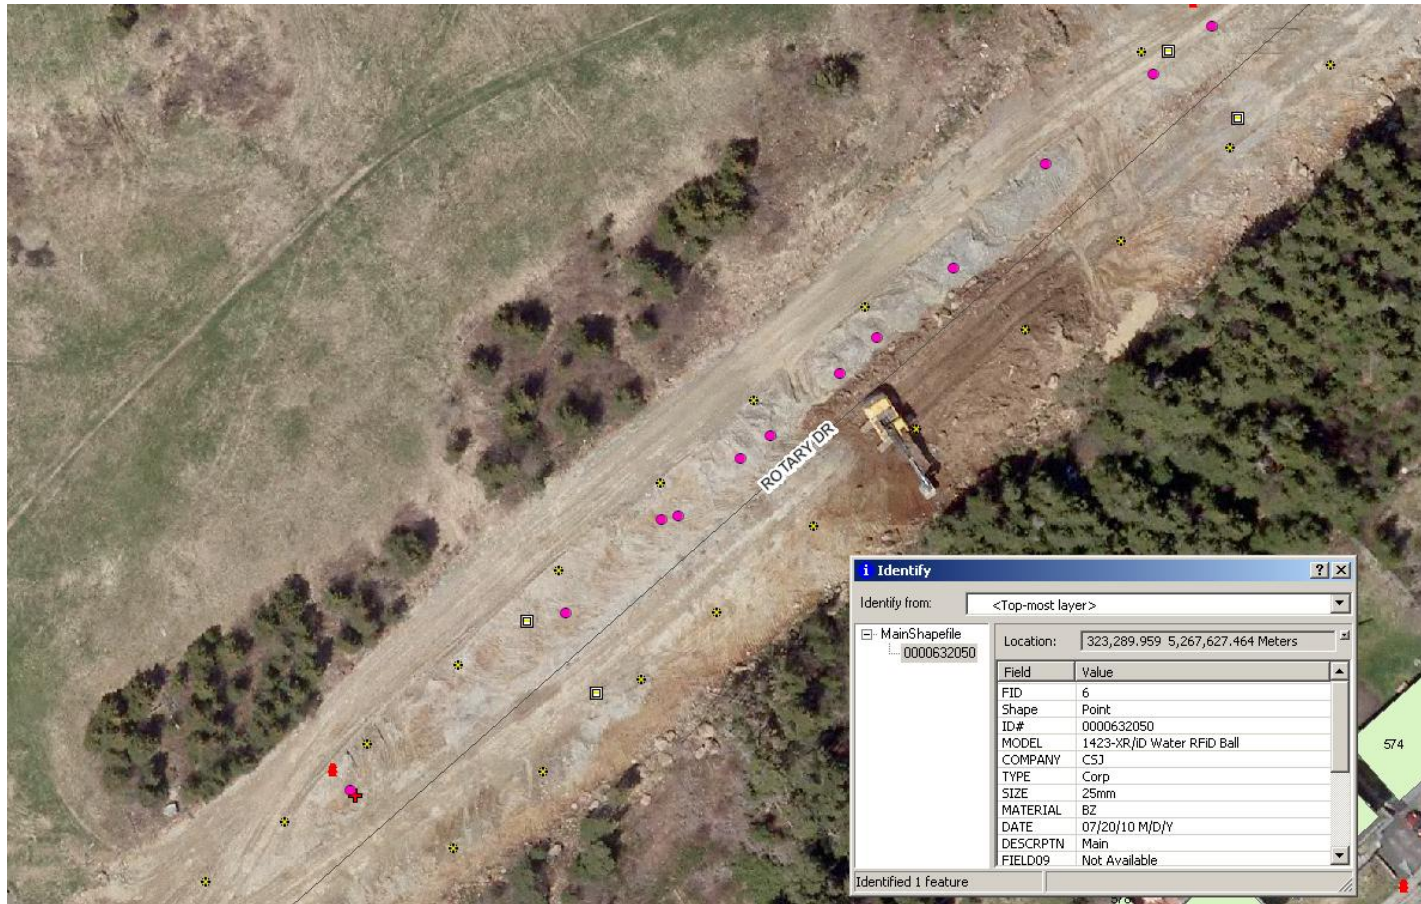
Data collected from Locator can be received by a GPS Unit and Transferred to GIS System

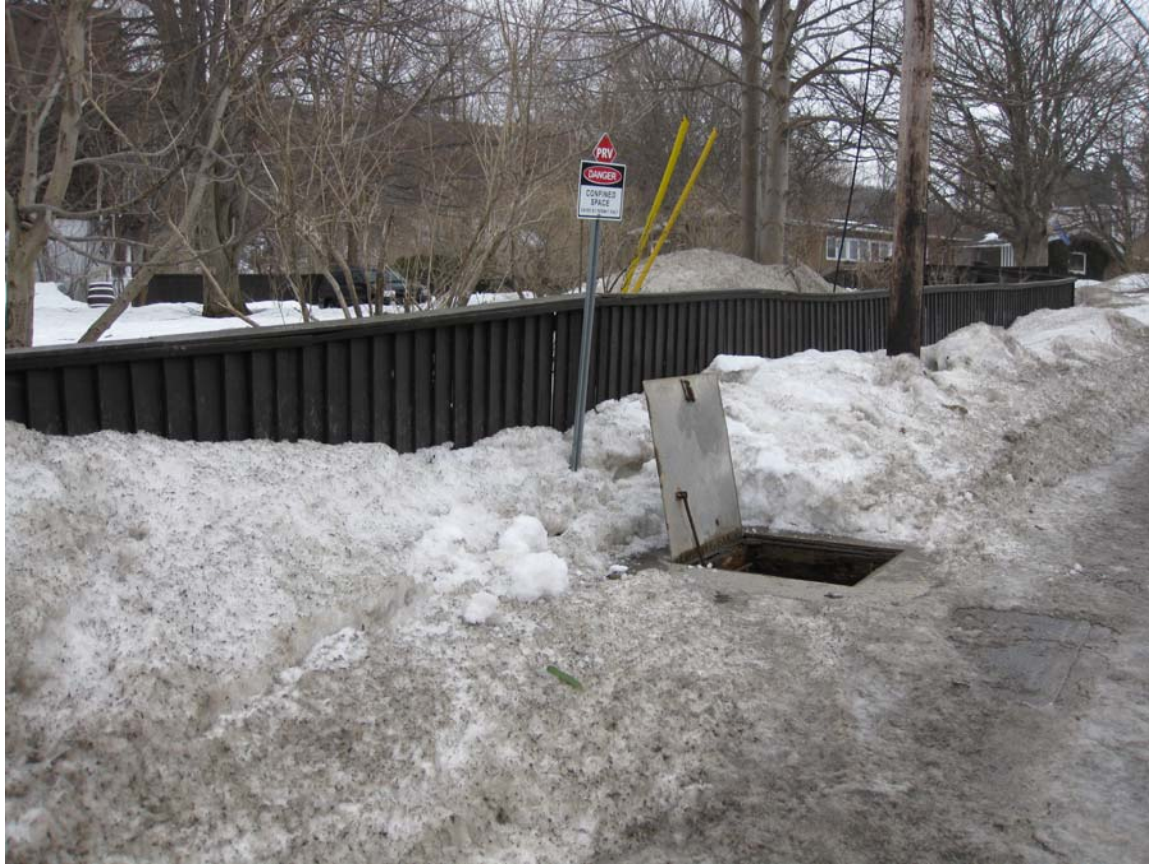
Replacement of Aging Infrastructure – PRV Station

- Waterford Bridge Road – PRV Station

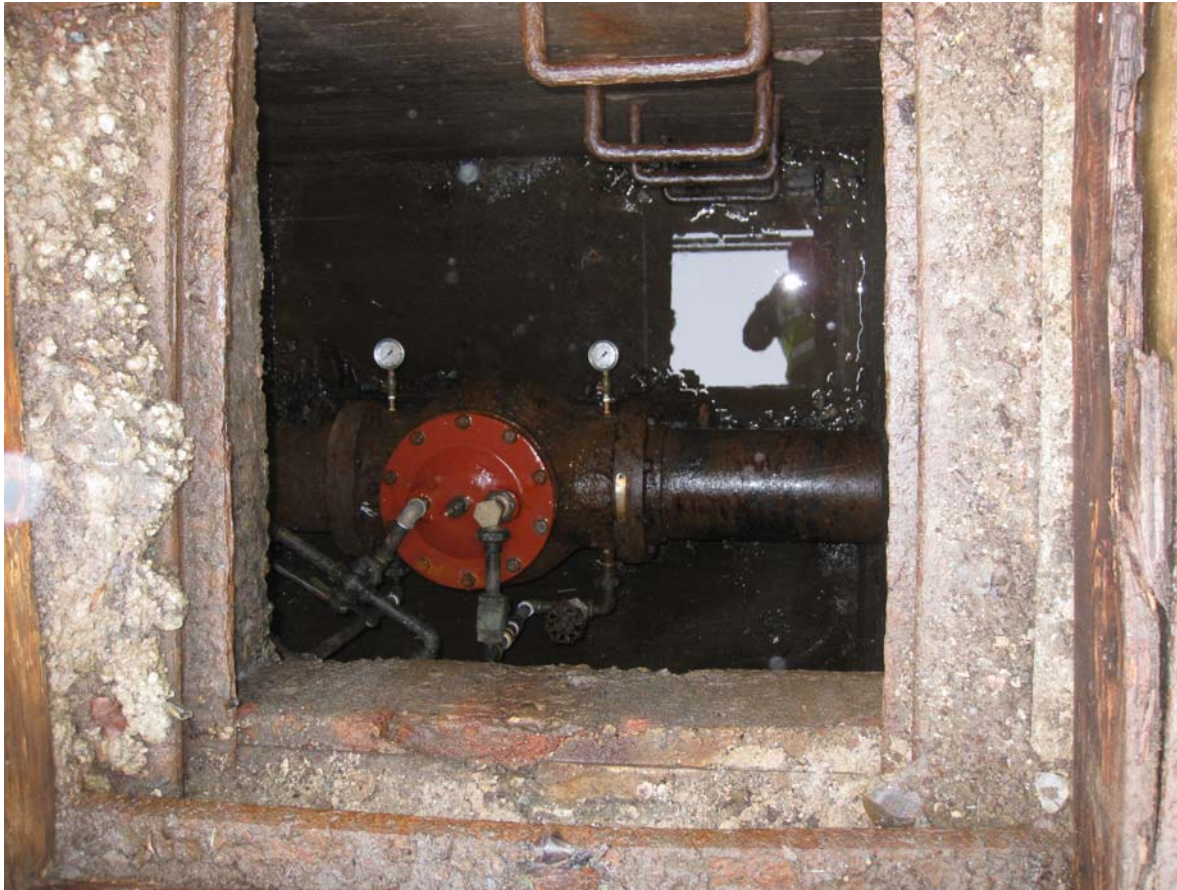
## WBR PRV

- Constructed 1950's
- Single 200mm PRV
- Small Chamber
- No Electricity
- Confined Space Entry

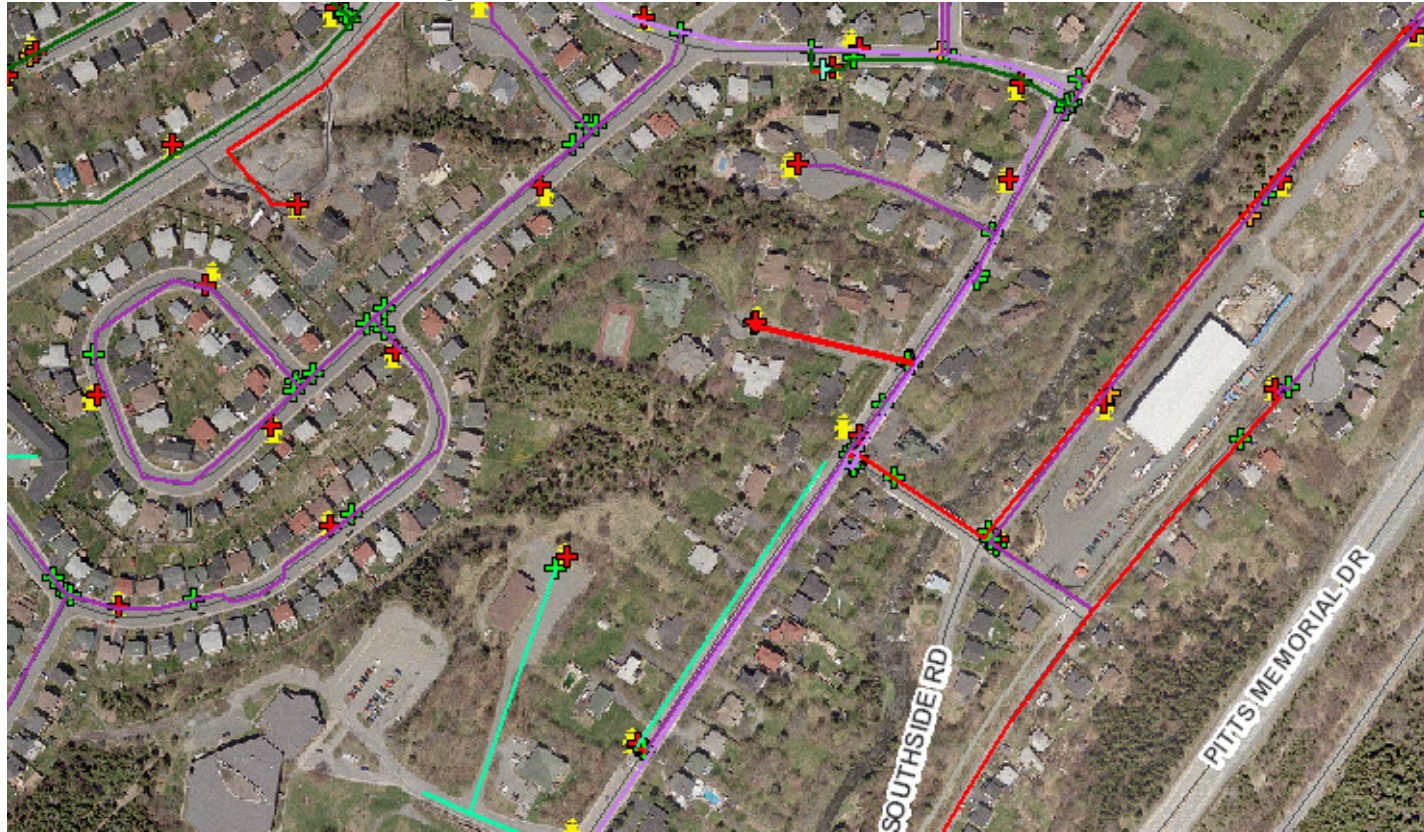
## Site Selection

- Limited Space along Waterford Bridge Road
- Site Search Expanded
