GOVERNMENT OF NEWFOUNDLAND AND LABRADOR Department of Transportation and Infrastructure	<b>BRIDGE INSPECTION REPORT</b> <b>B08202021-1</b>	
<b>Date:</b> 8/12/2021	<b>Inspected By:</b> Mike Button	<b>Category:</b> Office - Bridge Office	
<b>BRIDGE INFORMATION</b>			
<b>Site:</b>	1-249 - BLACKDUCK POND BRIDGE		
<b>Route:</b>	72	<b>Overall Length:</b>	8.7 m
<b>Year Built:</b>	1970	<b>Est: Yes</b>	<b>Overall Width:</b> 8.8 m
<b>Year Last Rehab.:</b>		<b>Est: No</b>	<b>Roadway Width:</b> 7.9 m
<b>Region:</b>	AVALON PENINSULA	<b>Sidewalk Width:</b>	0 m
<b>Jurisdiction:</b>	Provincial	<b>Clearance to R.D. or N.W.L.:</b>	1.1 m
<b>Type of Structure:</b>	04 - Rigid Frame	<b>Max Depth of N.W.L.:</b>	0 m
<b>Purpose of Structure:</b>	04 - Over Non-Navigable Waters	<b>Spans:</b>	
<b>Type of Handrail:</b>	02 - Concrete Rail	<b>Span No.:</b>	<b>Length</b>
<b>Roadway Surface:</b>	02 - Asphalt	<b>Span No.:</b>	<b>Length</b>

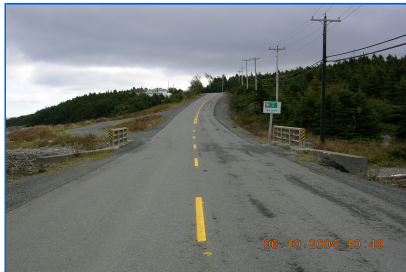
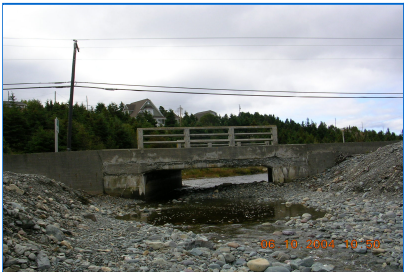
<b>Alignment Vertical:</b>	01 - Good	1	5.7
<b>Alignment Horizontal:</b>	01 - Good	2	0
<b>Restrictions:</b>	No	3	0
		4	0
		5	0
		6	0
<b>BRIDGE PHOTOS</b>

<b>SUBSTRUCTURE</b>			
<b>Condition:</b>	P1 - Poor	<b>Bearings:</b>	I - Inapplicable
		<b>Bearing Seat:</b>	I - Inapplicable
<b>Comments:</b>	- ~3m extension to upstream side. - Frame leg faces under structure have mild cracking with efflorescence. Erosion of concrete is mild but looking abrasive. - Medium cracking with efflorescence at frame leg connection to deck. - Entire downstream face of structure has severe disintegration from the west frame leg across the fascia to the east frame leg. - Northeast wingwall has light weathering with a large-wide crack propagating from a frame leg spall to top of concrete (P3). - Northwest wingwall has a large horizontal crack with efflorescence. Rest in good condition (P3). - Southwest wingwall has heavy cracking with efflorescence and AAR near top of concrete. Large cold joint visible and opening up near bottom. Joint continues on an angle through the west frame leg face under the structure (P3). - Southeast wingwall has two horizontal joints opening up (possible construction joints?). Large-wide crack extending from top to bottom of the wall with discontinuities. Appears the wingwall is cracking off from the main structure. The wingwall should have been poured with a construction joint and not poured monolithically with the main frame (P1).

<b>Condition:</b>	P3 - Poor	<b>Expansion Joints:</b>	I - Inapplicable
<b>Comments:</b>	- Expansion joints not inspectable. - Medium cracking at frame leg connection to underside of deck with efflorescence (P3). - AAR evident on underside of deck with limited spalling.		
<b>DECK</b>			
<b>Condition:</b>	P1 - Poor	<b>Curbs:</b>	P1 - Poor
<b>Hand Rail:</b>	P1 - Poor	<b>Roadway Condition:</b>	P1 - Poor
<b>Approach Rail:</b>	I - Inapplicable		
<b>Comments:</b>	- South fascia has construction joints opening up with large cracks, likely AAR. Large spall to fascia and underside of deck transition. - North fascia is ~50% disintegrated with extremely large spalls extending from the west frame leg across the fascia to the east frame leg. Ends of transverse reinforcement bars all exposed with no hooks (not rebar). Full length of helical bar exposed with severe corrosion and looks to be a form of twisted round stock instead of rebar (P). - Curb disintegrated on roadway but better on exterior of structure. - Concrete handrail has severe spalling with exposed helical steel. Northwest post bent. All handrails have large cracks exposing helical steel (not rebar). - No approach/exit rail or hazard markers. - Asphalt ok on west side (F1), east side has potholes and medium cracking (P3).
