GOVERNMENT OF NEWFOUNDLAND AND LABRADOR Department of Transportation and Infrastructure	BRIDGE INSPECTION REPORT B06202019-1	
Date: 6/20/2019	Inspected By: Pickett R	Category: Eng. - Engineering	
BRIDGE INFORMATION			
Site:	1-332 - COUNTRY ROAD OVERPASS		
Route:	75	Overall Length:	20.4 m
Year Built:	1999	Est: No	Overall Width: 14 m
Year Last Rehab.:		Est: No	Roadway Width: 13.2 m
Region:	AVALON PENINSULA	Sidewalk Width:	1.25 m
Jurisdiction:	Provincial	Clearance to R.D. or N.W.L.:	5.5 m
Type of Structure:	03 - Reinforced Concrete Beam/Slab	Max Depth of N.W.L.:	0 m
Purpose of Structure:	01 - Highway Grade Separation	Spans:	
Type of Handrail:	05 - Concrete Barrier	<u>Span No.:</u>	<u>Length</u>
Roadway Surface:	01 - Concrete	1	14.7
Alignment Vertical:	01 - Good	2	0
Alignment Horizontal:	01 - Good	3	0
Restrictions:	No	Span No.:	Length
		4	0
		5	0
		6	0
BRIDGE PHOTOS

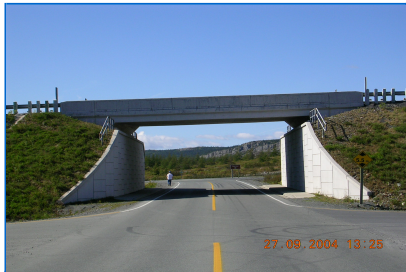
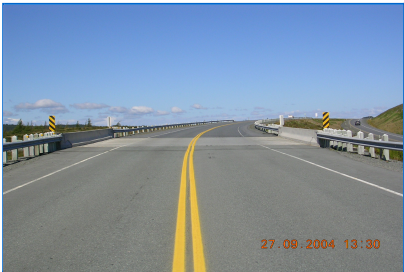
Bearing Seat:	G - Good
Comments:	Medium cracks in deck footings. Narrow alligator cracks in some M.S.E wall panels. Narrow vertical transverse cracks in fascia and coping.		
SUPERSTRUCTURE			
Condition:	F2 - Fair	Expansion Joints:	F2 - Fair
Comments:	Light spalling and wearing to expansion joint dams. Light corrosion to joints.		
DECK			
Condition:	F2 - Fair	Curbs:	F2 - Fair
Hand Rail:	F2 - Fair	Roadway Condition:	F2 - Fair

Approach Rail:	F2 - Fair		
Comments:	Medium long cracks in deck soffit. Narrow alligator cracks in deck soffit. Medium cracks in barrier walls and end blocks. Severe cracks in asphalt along approach slab edges. Medium corrosion on handrails. Potholes on approach slab.		
HYDROLOGY			
Water Velocity:	0 m/s	Ice Problem:	NA - Not Applicable
Water Depth:	0 m	Scour Problem:	NA - Not Applicable
Waterway:	03 - Not Applicable	Debris Problem:	NA - Not Applicable
Comments:			
REPLACEMENT/REHABILITATION			
Next Rehab. Date:	2024	Replacement Year:	2049
Antic. Rehab. Cost:	\$100	Replacement Cost:	\$600
Recommendations:			
OBSERVATIONS			
Overall Condition:	F2 - Fair	Requires Further Inspection:	No
Additional Observations:	One hazard marker missing. Cone sidewalk, curb and gutter structure on country road.		
LEGEND:			
Condition Definitions:		Problem Definitions:	
1 - *Good - [discontinued code].	F2 - Fair.	C - Unsafe (Closed to Public).	N - No Problem.
