GOVERNMENT OF NEWFOUNDLAND AND LABRADOR Department of Transportation and Infrastructure	<b>BRIDGE INSPECTION REPORT</b> <b>B07232018-10</b>	
<b>Date:</b> 5/1/2018	<b>Inspected By:</b> Chris Lyver	<b>Category:</b> Eng. - Engineering	
<b>BRIDGE INFORMATION</b>			
<b>Site:</b>	1-339 - LESTERS FIELD OVERPASS SERVICE RD		
<b>Route:</b>	3	<b>Overall Length:</b>	18.9 m
<b>Year Built:</b>	1999	<b>Est:</b> No	<b>Overall Width:</b> 13.5 m
<b>Year Last Rehab.:</b>		<b>Est:</b> No	<b>Roadway Width:</b> 12.6 m
<b>Region:</b>	AVALON PENINSULA	<b>Sidewalk Width:</b>	0 m
<b>Jurisdiction:</b>	Provincial	<b>Clearance to R.D. or N.W.L.:</b>	4.4 m
<b>Type of Structure:</b>	04 - Rigid Frame	<b>Max Depth of N.W.L.:</b>	0 m
<b>Purpose of Structure:</b>	01 - Highway Grade Separation	<b>Spans:</b>	
<b>Type of Handrail:</b>	05 - Concrete Barrier	<u>Span No.:</u>	<u>Length</u>
<b>Roadway Surface:</b>	02 - Asphalt	1	6.4
<b>Alignment Vertical:</b>	01 - Good	2	0

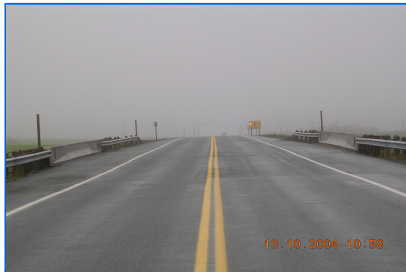
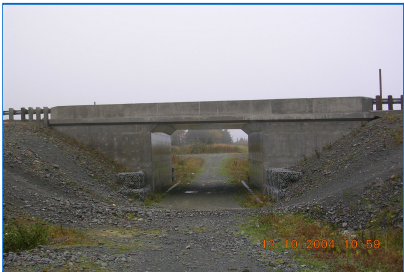
<b>Alignment Horizontal:</b>	01 - Good	3	0
<b>Restrictions:</b>	No	<b>Span No.:</b>	<b>Length</b>
		4	0
		5	0
		6	0
<b>BRIDGE PHOTOS</b>
