GOVERNMENT OF NEWFOUNDLAND AND LABRADOR Department of Transportation and Infrastructure	BRIDGE INSPECTION REPORT B09102021-4																	
Date: 8/26/2021	Inspected By: Michael Button	Category: Office - Bridge Office																	
BRIDGE INFORMATION																			
Site:	1-057 - NEW BRIDGE, CAPE BROYLE																		
Route:		Overall Length:	25 m																
Year Built:	1970	Est: Yes	Overall Width: 8.9 m																
Year Last Rehab.:	1991	Est: No	Roadway Width: 7.3 m																
Region:	AVALON PENINSULA		Sidewalk Width: 0.75 m																
Jurisdiction:	Provincial		Clearance to R.D. or N.W.L.: 4 m																
Type of Structure:	02 - Double Tee		Max Depth of N.W.L.: 0 m																
Purpose of Structure:	04 - Over Non-Navigable Waters		Spans:																
Type of Handrail:	01 - Aluminum Rail

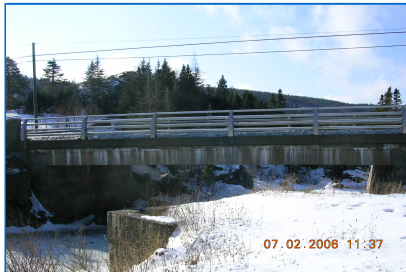
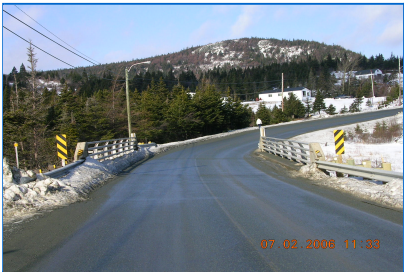
<u>Span No.:</u>	<u>Length</u>	<u>Span No.:</u>	<u>Length</u>	1	13.9	4	0	2	0	5	0	3	0	6	0
<u>Span No.:</u>	<u>Length</u>	<u>Span No.:</u>	<u>Length</u>																
1	13.9	4	0																
2	0	5	0																
3	0	6	0																
Roadway Surface:	02 - Asphalt																		
Alignment Vertical:	01 - Good																		
Alignment Horizontal:	02 - Adequate																		
Restrictions:	No																		
BRIDGE PHOTOS																			
<div style="display: flex; justify-content: space-around;">
