GOVERNMENT OF NEWFOUNDLAND AND LABRADOR Department of Transportation and Infrastructure	BRIDGE INSPECTION REPORT B06042019-3	
Date: 6/4/2019	Inspected By: Pickett R	Category: Eng. - Engineering	
BRIDGE INFORMATION			
Site:	1-291 - ROBINSONS RIVER BRIDGE		
Route:	20	Overall Length:	11.8 m
Year Built:	1960	Est: Yes	Overall Width: 8.5 m
Year Last Rehab.:	1975	Est: Yes	Roadway Width: 7.5 m
Region:	AVALON PENINSULA		Sidewalk Width: 0 m
Jurisdiction:	Provincial	Clearance to R.D. or N.W.L.:	2.1 m
Type of Structure:	04 - Rigid Frame	Max Depth of N.W.L.:	0.3 m
Purpose of Structure:	04 - Over Non-Navigable Waters		Spans:
Type of Handrail:	02 - Concrete Rail	<u>Span No.:</u>	<u>Length</u>
Roadway Surface:	02 - Asphalt	1	7.7
Alignment Vertical:	01 - Good	2	0
Alignment Horizontal:	02 - Adequate	3	0
Restrictions:	No	<u>Span No.:</u>	<u>Length</u>
		4	0
		5	0
		6	0
BRIDGE PHOTOS

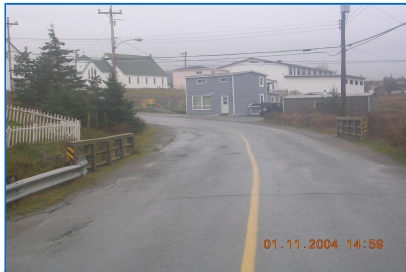
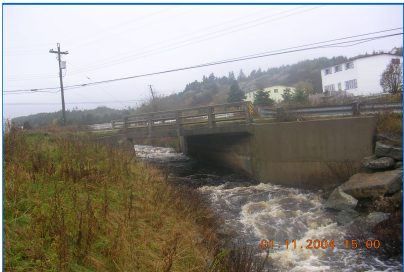
Bearing Seat:	I - Inapplicable
Comments:	Original structure has been extended approximately 6m downstream. Structure rehabbed 2017. Medium erosion along bottom of North frame leg extensions.		
SUPERSTRUCTURE			
Condition:	F1 - Fair	Expansion Joints:	I - Inapplicable
Comments:	Wide cracks North East /North West frame leg cover, light honey combing and flow lines on North face leg. Medium honey combing in face of original south frame leg. Effloresce deposits upstream deck soffit. Structure rehabbed 2017.		
DECK			
Condition:	F1 - Fair	Curbs:	F1 - Fair
