GOVERNMENT OF NEWFOUNDLAND AND LABRADOR Department of Transportation and Infrastructure	<b>BRIDGE INSPECTION REPORT</b> <b>B05242024-11</b>	
<b>Date:</b> 5/22/2024	<b>Inspected By:</b> Trevor Upshall	<b>Category:</b> Eng. - Engineering	
<b>BRIDGE INFORMATION</b>			
<b>Site:</b>	1-030 - SOUTH RIVER BRIDGE		
<b>Route:</b>	70	<b>Overall Length:</b>	28.6 m
<b>Year Built:</b>	1998	<b>Est:</b> No	<b>Overall Width:</b> 10.7 m
<b>Year Last Rehab.:</b>		<b>Est:</b> No	<b>Roadway Width:</b> 8 m
<b>Region:</b>	AVALON PENINSULA		<b>Sidewalk Width:</b> 1.9 m
<b>Jurisdiction:</b>	Provincial		<b>Clearance to R.D. or N.W.L.:</b> 2.6 m
<b>Type of Structure:</b>	04 - Rigid Frame		<b>Max Depth of N.W.L.:</b> 2.4 m
<b>Purpose of Structure:</b>	03 - Over Navigable Waters		<b>Spans:</b>
<b>Type of Handrail:</b>	01 - Aluminum Rail		<b>Span No.:</b> <b>Length</b> <b>Span No.:</b> <b>Length</b>
<b>Roadway Surface:</b>	02 - Asphalt		1            14.6      4            0

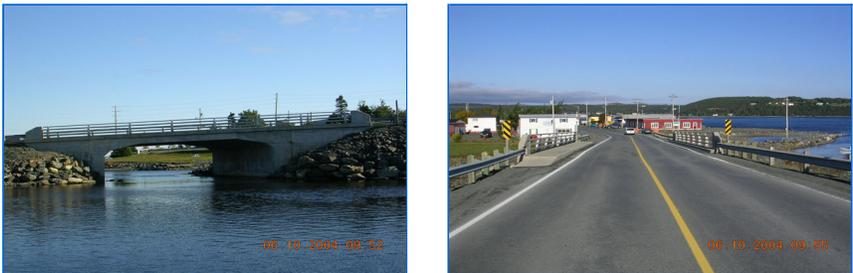
<b>Alignment Vertical:</b>	01 - Good		2            0            5            0
<b>Alignment Horizontal:</b>	01 - Good		3            0            6            0
<b>Restrictions:</b>	No		
<b>BRIDGE PHOTOS</b>
