GOVERNMENT OF NEWFOUNDLAND AND LABRADOR Department of Transportation and Infrastructure	BRIDGE INSPECTION REPORT B09132021-3	
Date: 2/27/2020	Inspected By: Hunt R	Category: Eng. - Engineering	
BRIDGE INFORMATION			
Site:	1-165 - STEVE GOSES MILL BRIDGE		
Route:	81	Overall Length:	10.3 m
Year Built:	1987	Est: Yes	Overall Width: 10 m
Year Last Rehab.:		Est: No	Roadway Width: 9 m
Region:	AVALON PENINSULA	Sidewalk Width:	0.5 m
Jurisdiction:	Provincial	Clearance to R.D. or N.W.L.:	1 m
Type of Structure:	04 - Rigid Frame	Max Depth of N.W.L.:	0.5 m
Purpose of Structure:	04 - Over Non-Navigable Waters	Spans:	
Type of Handrail:	01 - Aluminum Rail	Span No.:	Length
Roadway Surface:	01 - Concrete	1	5.1
Alignment Vertical:	01 - Good	2	0
Alignment Horizontal:	01 - Good	3	0
Restrictions:	No	Span No.:	Length
		4	0
		5	0
		6	0
BRIDGE PHOTOS

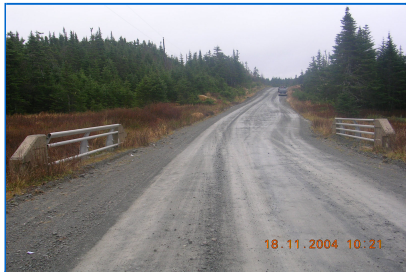
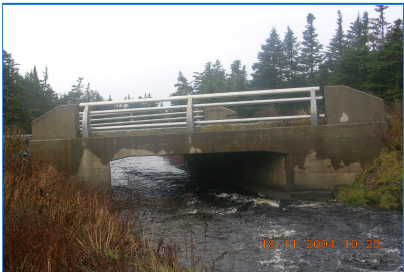
Comments:	- Original structure extended approx. 3m U/S and D/S. - Medium erosion to ends, faces and tops of frame leg footings.		
SUPERSTRUCTURE			
Condition:	F2 - Fair	Expansion Joints:	I - Inapplicable
Comments:	- Some medium vert. cracks in faces of original structure frame legs. - Medium vert. cracks with light/medium efflor. deposits along construction joints. - Medium alligator cracks in all 4 wingwalls.		
DECK			
Condition:	F2 - Fair	Curbs:	F1 - Fair

Hand Rail:	P1 - Poor	Roadway Condition:	F1 - Fair
Approach Rail:	I - Inapplicable		
Comments:	- No approach or exit rail or hazard markers - Rail missing and parts bent on aluminum handrail on both D/S and U/S ends. - Medium long. cracks with light/medium efflor. deposits and some minor honeycombing in deck soffit. - Some narrow alligator cracks in all 4 end blocks.
