GOVERNMENT OF NEWFOUNDLAND AND LABRADOR Department of Transportation and Infrastructure	<b>BRIDGE INSPECTION REPORT</b> <b>B10042023-7</b>	
<b>Date:</b> 5/28/2023	<b>Inspected By:</b> JDawe	<b>Category:</b> Office - Bridge Office	
<b>BRIDGE INFORMATION</b>			
<b>Site:</b>	TCH-189 - THORBURN ROAD STRUCTURE WEST		
<b>Route:</b>	1	<b>Overall Length:</b>	68.5 m
<b>Year Built:</b>	1998	<b>Est: No</b>	<b>Overall Width:</b> 10.6 m
<b>Year Last Rehab.:</b>		<b>Est: No</b>	<b>Roadway Width:</b> 9.7 m
<b>Region:</b>	AVALON PENINSULA	<b>Sidewalk Width:</b>	0 m
<b>Jurisdiction:</b>	Provincial	<b>Clearance to R.D. or N.W.L.:</b>	5.1 m
<b>Type of Structure:</b>	05 - Pre-stressed Concrete Slab	<b>Max Depth of N.W.L.:</b>	0 m
<b>Purpose of Structure:</b>	01 - Highway Grade Separation	<b>Spans:</b>	
<b>Type of Handrail:</b>	05 - Concrete Barrier	<b>Span No.:</b>	<b>Length</b>
<b>Roadway Surface:</b>	02 - Asphalt	1	15.3

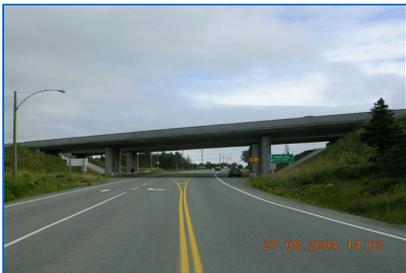
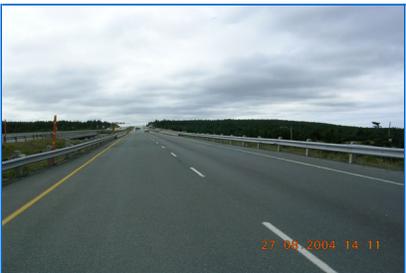
<b>Alignment Vertical:</b>	01 - Good	2	28.3
<b>Alignment Horizontal:</b>	01 - Good	3	15.3
<b>Restrictions:</b>	No	4	0
		5	0
		6	0
<b>BRIDGE PHOTOS</b>
