GOVERNMENT OF NEWFOUNDLAND AND LABRADOR Department of Transportation and Infrastructure	<b>BRIDGE INSPECTION REPORT</b> <b>B07202021-8</b>	
<b>Date:</b> 7/8/2021	<b>Inspected By:</b> McCaw J	<b>Category:</b> Eng. - Engineering	
<b>BRIDGE INFORMATION</b>			
<b>Site:</b>	TCH-046 - BADGER BROOK BRIDGE		
<b>Route:</b>		<b>Overall Length:</b>	68.6 m
<b>Year Built:</b>	1964	<b>Est:</b> No	<b>Overall Width:</b> 9.9 m
<b>Year Last Rehab.:</b>	1998	<b>Est:</b> No	<b>Roadway Width:</b> 8.3 m
<b>Region:</b>	CENTRAL WEST	<b>Sidewalk Width:</b>	0 m
<b>Jurisdiction:</b>	Provincial	<b>Clearance to R.D. or N.W.L.:</b>	2.5 m
<b>Type of Structure:</b>	01 - AASH to Girder	<b>Max Depth of N.W.L.:</b>	2 m
<b>Purpose of Structure:</b>	04 - Over Non-Navigable Waters	<b>Spans:</b>	
<b>Type of Handrail:</b>	01 - Aluminum Rail	<u>Span No.:</u>	<u>Length</u>
<b>Roadway Surface:</b>	02 - Asphalt	1	28.4
<b>Alignment Vertical:</b>	01 - Good	2	0

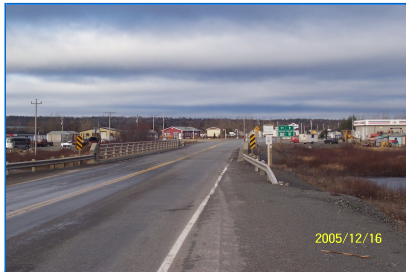
<b>Alignment Horizontal:</b>	01 - Good	3	0
<b>Restrictions:</b>	No	6	0
<b>BRIDGE PHOTOS</b>
