GOVERNMENT OF NEWFOUNDLAND AND LABRADOR Department of Transportation and Infrastructure	<b>BRIDGE INSPECTION REPORT</b> <b>B09162021-9</b>	
<b>Date:</b> 9/2/2021	<b>Inspected By:</b> Mike Button	<b>Category:</b> Office - Bridge Office	
<b>BRIDGE INFORMATION</b>			
<b>Site:</b>	3-047 - BAY D'ESPOIR CAUSEWAY BRIDGE		
<b>Route:</b>	361	<b>Overall Length:</b>	89 m
<b>Year Built:</b>	1966	<b>Est:</b> No	<b>Overall Width:</b> 8.7 m
<b>Year Last Rehab.:</b>	1998	<b>Est:</b> No	<b>Roadway Width:</b> 7.4 m
<b>Region:</b>	CENTRAL WEST	<b>Sidewalk Width:</b>	0 m
<b>Jurisdiction:</b>	Provincial	<b>Clearance to R.D. or N.W.L.:</b>	4.5 m
<b>Type of Structure:</b>	01 - AASH to Girder	<b>Max Depth of N.W.L.:</b>	3.4 m
<b>Purpose of Structure:</b>	03 - Over Navigable Waters	<b>Spans:</b>	
<b>Type of Handrail:</b>	01 - Aluminum Rail	<b>Span No.:</b>	<b>Length</b>
<b>Roadway Surface:</b>	02 - Asphalt	1	22.5
<b>Alignment Vertical:</b>	01 - Good	2	0

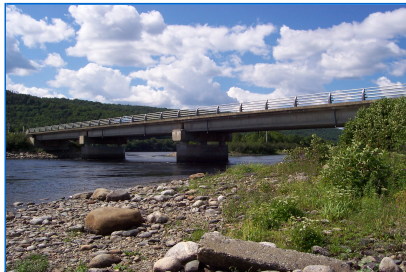
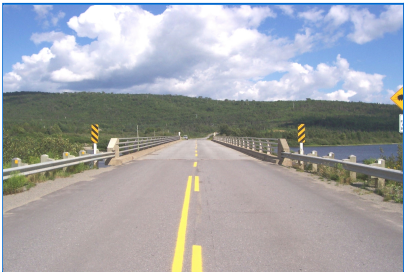
<b>Alignment Horizontal:</b>	01 - Good	3	0
<b>Restrictions:</b>	No	6	0
<b>BRIDGE PHOTOS</b>
