GOVERNMENT OF NEWFOUNDLAND AND LABRADOR Department of Transportation and Infrastructure	BRIDGE INSPECTION REPORT B01202020-38	
Date: 9/4/2019	Inspected By: Lynch R / Martin L	Category: Eng. - Engineering	
BRIDGE INFORMATION			
Site:	3-077 - DOTING COVE BROOK CULVERT		
Route:		Overall Length:	16 m
Year Built:	1962	Est: No	Overall Width: 3.7 m
Year Last Rehab.:		Est: No	Roadway Width: 8 m
Region:	CENTRAL WEST	Sidewalk Width:	0 m
Jurisdiction:	Provincial	Clearance to R.D. or N.W.L.:	1.6 m
Type of Structure:	13 - Other	Max Depth of N.W.L.:	0.5 m
Purpose of Structure:	04 - Over Non-Navigable Waters		
Type of Handrail:	06 - None		
Roadway Surface:	02 - Asphalt	Spans:	
Alignment Vertical:	01 - Good	<u>Span No.:</u>	<u>Length</u>
Alignment Horizontal:	01 - Good	<u>Span No.:</u>	<u>Length</u>
Restrictions:	No	1	0
		2	0
		3	0
		4	0
		5	0
		6	0
BRIDGE PHOTOS

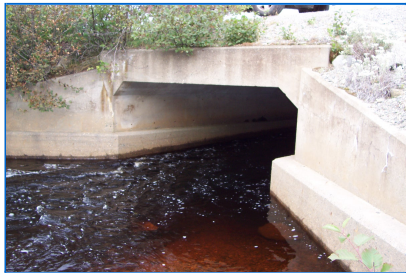
Bearing Seat:	I - Inapplicable
Comments:	Some cracking in wing walls (medium). Some cracking (medium) in footing 2 RHS and footing 1 LHS.		
SUPERSTRUCTURE			
Condition:	F2 - Fair	Expansion Joints:	I - Inapplicable
Comments:	Open footed box. Rebar exposed on LHS top of headwall (spalled concrete).		
DECK			
Condition:	I - Inapplicable	Curbs:	I - Inapplicable
Hand Rail:	I - Inapplicable	Roadway Condition:	I - Inapplicable
