GOVERNMENT OF NEWFOUNDLAND AND LABRADOR Department of Transportation and Infrastructure	BRIDGE INSPECTION REPORT B01162020-1	
Date: 8/20/2019	Inspected By: Lynch R / Martin L	Category: Eng. - Engineering	
BRIDGE INFORMATION			
Site:	3-057 - MIDDLE BROOK BRIDGE (GAMBO)		
Route:		Overall Length:	41.5 m
Year Built:	1970	Est: No	Overall Width: 12 m
Year Last Rehab.:		Est: No	Roadway Width: 9.6 m
Region:	CENTRAL WEST	Sidewalk Width:	0 m
Jurisdiction:	Provincial	Clearance to R.D. or N.W.L.:	1.8 m
Type of Structure:	01 - AASH to Girder	Max Depth of N.W.L.:	1 m
Purpose of Structure:	04 - Over Non-Navigable Waters	Spans:	
Type of Handrail:	04 - Steel Rail	<u>Span No.:</u>	<u>Length</u>
Roadway Surface:	02 - Asphalt	<u>Span No.:</u>	<u>Length</u>
Alignment Vertical:	01 - Good	1	31.7
Alignment Horizontal:	02 - Adequate	2	0
Restrictions:	No	3	0
		4	0
		5	0
		6	0
BRIDGE PHOTOS

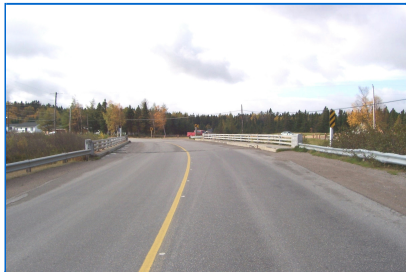
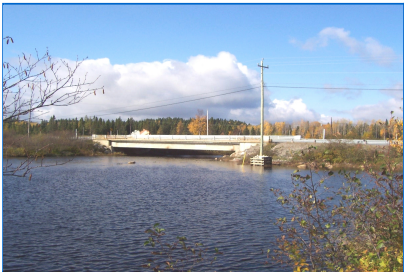
Bearing Seat:	F2 - Fair
Comments:	Debris on bearing seats. Minor cracking in abutments. Footing #2 is exposed; minor scour on LHS (upstream). Minor cracking in creep blocks.		
SUPERSTRUCTURE			
Condition:	F2 - Fair	Expansion Joints:	F2 - Fair
Comments:	Expansion joints need to be cleaned out; not leaking currently. Rehabilitated in 2009		
DECK			
Condition:	F2 - Fair	Curbs:	F2 - Fair
Hand Rail:	F2 - Fair	Roadway Condition:	F2 - Fair

Comments: Potholes in surface; leaking underneath deck in spots. Settlement at joints and approaches. Spall on curb/soffit at abutment #2 RHS. Soffit/curb interface leaking with efflorescence. Minor cracks with efflorescence on deck bottom (stalactites - minor). Approach rail missing buried end at abutment #1. Bolts too short in guide rail posts on exit rail at abutment #1. Guide rail damaged at abutment #2.

Water Velocity:	0 m/s	Ice Problem:	N - No Problem
Water Depth:	1.2 m	Scour Problem:	N - No Problem
Waterway:	01 - Adequate	Debris Problem:	N - No Problem
Comments:	Footing exposed at abutment #2 LHS; minor scour of concrete.

Next Rehab. Date:		Replacement Year:	
Antic. Rehab. Cost:	\$0	Replacement Cost:	\$0
Recommendations:	Clean bridge, repair guide rail, install additional rip rap to footing(s), Repair potholes/spalls in deck/curb.
