GOVERNMENT OF NEWFOUNDLAND AND LABRADOR Department of Transportation and Infrastructure	<b>BRIDGE INSPECTION REPORT</b> <b>B07232021-6</b>	
<b>Date:</b> 7/7/2021	<b>Inspected By:</b> McCaw J	<b>Category:</b> Eng. - Engineering	
<b>BRIDGE INFORMATION</b>			
<b>Site:</b>	3-116 - PACQUET BRIDGE		
<b>Route:</b>		<b>Overall Length:</b>	15.2 m
<b>Year Built:</b>	1968	<b>Est: Yes</b>	<b>Overall Width:</b> 11.1 m
<b>Year Last Rehab.:</b>	1990	<b>Est: No</b>	<b>Roadway Width:</b> 9.2 m
<b>Region:</b>	CENTRAL WEST	<b>Sidewalk Width:</b>	0 m
<b>Jurisdiction:</b>	Provincial	<b>Clearance to R.D. or N.W.L.:</b>	2 m
<b>Type of Structure:</b>	02 - Double Tee	<b>Max Depth of N.W.L.:</b>	1 m
<b>Purpose of Structure:</b>	04 - Over Non-Navigable Waters		
<b>Type of Handrail:</b>	02 - Concrete Rail	<b>Spans:</b>	
<b>Roadway Surface:</b>	02 - Asphalt	<u>Span No.:</u>	<u>Length</u>
<b>Alignment Vertical:</b>	01 - Good	1	8.1

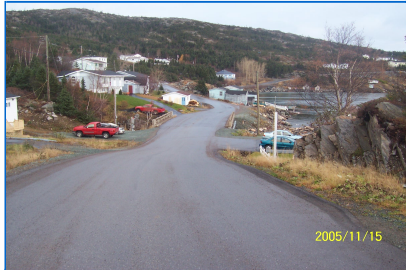
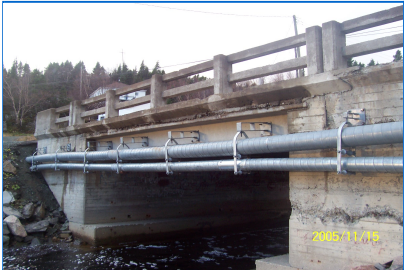
<b>Alignment Horizontal:</b>	02 - Adequate	2	0
<b>Restrictions:</b>	No	3	0
		<u>Span No.:</u>	<u>Length</u>
		4	0
		5	0
		6	0
<b>BRIDGE PHOTOS</b>

<b>SUBSTRUCTURE</b>			
<b>Condition:</b>	P1 - Poor	<b>Bearings:</b>	U - Uninspectable
		<b>Bearing Seat:</b>	F2 - Fair
<b>Comments:</b>	Section of footing missing completely. Erosion at wingwalls		
<b>SUPERSTRUCTURE</b>			
<b>Condition:</b>	F2 - Fair	<b>Expansion Joints:</b>	U - Uninspectable
<b>Comments:</b>	Double tees have some efflorescence. Some water leaking through decks		
<b>DECK</b>			
<b>Condition:</b>	F1 - Fair	<b>Curbs:</b>	P3 - Poor
<b>Hand Rail:</b>	P3 - Poor	<b>Roadway Condition:</b>	P3 - Poor

<b>Approach Rail:</b>	I - Inapplicable		
<b>Comments:</b>	Curbs badly deteriorating. Handrails have deteriorated. Approaches appear to be settling. No approach rails installed.		
<b>HYDROLOGY</b>			
<b>Water Velocity:</b>	0.3 m/s	<b>Ice Problem:</b>	N - No Problem
<b>Water Depth:</b>	0.4 m	<b>Scour Problem:</b>	K - Known Problem
<b>Waterway:</b>	02 - Inadequate	<b>Debris Problem:</b>	N - No Problem
<b>Comments:</b>	Erosion around wingwalls. Could not see bottom of footings.		
<b>REPLACEMENT/REHABILITATION</b>			
<b>Next Rehab. Date:</b>	2022	<b>Replacement Year:</b>	2040
<b>Antic. Rehab. Cost:</b>	\$100000	<b>Replacement Cost:</b>	\$1500000
<b>Recommendations:</b>	Repair concrete footing. Tremie around wingwalls and correct erosion. Install hazard markers. Install new curbs, handrails, and end blocks.		
<b>OBSERVATIONS</b>			
<b>Overall Condition:</b>	P1 - Poor	<b>Requires Further Inspection:</b>	No
<b>Additional Observations:</b>	Local resident informed inspectors that water level has reached the bottom of the beam before. Parking ok. Hazards: traffic, slipping, water
