GOVERNMENT OF NEWFOUNDLAND AND LABRADOR Department of Transportation and Infrastructure	BRIDGE INSPECTION REPORT B01202020-8																	
Date: 10/11/2019	Inspected By: Lynch R / Martin L	Category: Eng. - Engineering																	
BRIDGE INFORMATION																			
Site:	3-026 - TOTE RIVER BRIDGE																		
Route:	360	Overall Length:	45 m																
Year Built:	1966	Est: No	Overall Width: 11.4 m																
Year Last Rehab.:		Est: No	Roadway Width: 9.7 m																
Region:	CENTRAL WEST	Sidewalk Width:	0 m																
Jurisdiction:	Provincial	Clearance to R.D. or N.W.L.:	8 m																
Type of Structure:	01 - AASH to Girder	Max Depth of N.W.L.:	2 m																
Purpose of Structure:	04 - Over Non-Navigable Waters																		
Type of Handrail:	01 - Aluminum Rail																		
Roadway Surface:	01 - Concrete

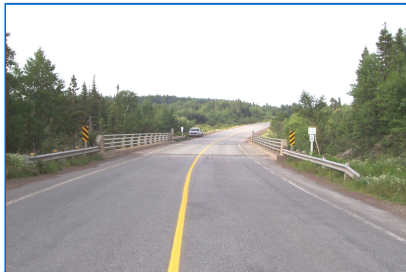
<u>Span No.:</u>	<u>Length</u>	<u>Span No.:</u>	<u>Length</u>	1	28.9	4	0	2	0	5	0	3	0	6	0
<u>Span No.:</u>	<u>Length</u>	<u>Span No.:</u>	<u>Length</u>																
1	28.9	4	0																
2	0	5	0																
3	0	6	0																
Alignment Vertical:	01 - Good	2	0																
Alignment Horizontal:	02 - Adequate	3	0																
Restrictions:	No																		
BRIDGE PHOTOS

SUBSTRUCTURE																			
Condition:	F2 - Fair	Bearings:	U - Uninspectable																
		Bearing Seat:	U - Uninspectable																
Comments:	Spalling / Delaminating at abutment corners and wide crack with rust staining and delaminating - abutment 2, footing separated from abutment 2.																		
SUPERSTRUCTURE																			
Condition:	F2 - Fair	Expansion Joints:	F2 - Fair																
Comments:	Some spalling and delaminating in girder # 5.																		
DECK																			
Condition:	F2 - Fair	Curbs:	F2 - Fair																
Hand Rail:	F2 - Fair	Roadway Condition:	F2 - Fair

Approach Rail:	F2 - Fair		
Comments:	Potholes in concrete deck with rebar exposed. Large amount of sand on deck. Settlement at approaches.		
HYDROLOGY			
Water Velocity:	0 m/s	Ice Problem:	N - No Problem
Water Depth:	0 m	Scour Problem:	N - No Problem
Waterway:	01 - Adequate	Debris Problem:	N - No Problem
Comments:	Washouts at abutment 2 curb ends.		
REPLACEMENT/REHABILITATION			
Next Rehab. Date:		Replacement Year:	
Antic. Rehab. Cost:	\$0	Replacement Cost:	\$0
Recommendations:	Repair deck, girder #5 washouts, curb ends, abutment, wing walls.		
OBSERVATIONS			
Overall Condition:	F2 - Fair	Requires Further Inspection:	Yes
Additional Observations:	Unable to inspect bearings.		
LEGEND:			
Condition Definitions:			
1 - *Good - [discontinued code].	F2 - Fair.	C - Unsafe (Closed to Public).	Problem Definitions:
2 - *Fair - [discontinued code].	F1 - Fair.	U - Uninspectable.	N - No Problem.
3 - *Poor - [discontinued code].	P3 - Poor.	I - Inapplicable.	P - Possible Problem.
