GOVERNMENT OF NEWFOUNDLAND AND LABRADOR Department of Transportation and Infrastructure	<b>BRIDGE INSPECTION REPORT</b> <b>B05292020-23</b>	
<b>Date:</b> 5/28/2020	<b>Inspected By:</b> AB	<b>Category:</b> Eng. - Engineering	
<b>BRIDGE INFORMATION</b>			
<b>Site:</b>	2-101 - ARNOLD'S COVE STATION BRIDGE		
<b>Route:</b>	2-1-04	<b>Overall Length:</b>	19 m
<b>Year Built:</b>	2005	<b>Est:</b> No	<b>Overall Width:</b> 5 m
<b>Year Last Rehab.:</b>		<b>Est:</b> No	<b>Roadway Width:</b> 3.4 m
<b>Region:</b>	CENTRAL EAST	<b>Sidewalk Width:</b>	0 m
<b>Jurisdiction:</b>	Provincial	<b>Clearance to R.D. or N.W.L.:</b>	1.5 m
<b>Type of Structure:</b>	09 - Bailey Bridge	<b>Max Depth of N.W.L.:</b>	1 m
<b>Purpose of Structure:</b>	04 - Over Non-Navigable Waters	<b>Spans:</b>	
<b>Type of Handrail:</b>	06 - None	<u>Span No.:</u>	<u>Length</u>
<b>Roadway Surface:</b>	03 - Timber	1	18.3
<b>Alignment Vertical:</b>	01 - Good	2	0

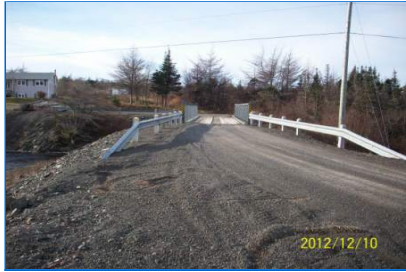
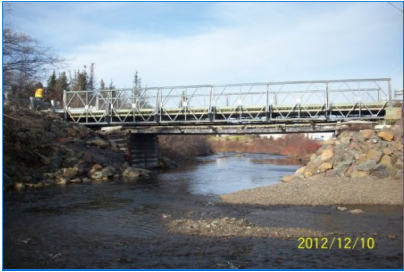
<b>Alignment Horizontal:</b>	02 - Adequate	3	0
<b>Restrictions:</b>	Yes	<u>Span No.:</u>	<u>Length</u>
<b>Describe Restrictions:</b>	Bridge is one lane only.		
<b>BRIDGE PHOTOS</b>

<b>SUBSTRUCTURE</b>			
<b>Condition:</b>	F2 - Fair	<b>Bearings:</b>	F2 - Fair
		<b>Bearing Seat:</b>	F2 - Fair
<b>Comments:</b>	Treated timber abutments and bearing seat. Concrete scour repairs made following Hurricane Igor. Old creosote abutments and superstructure left in place under new structure is in unsafe condition but cannot be accessed.		
<b>SUPERSTRUCTURE</b>			
<b>Condition:</b>	F2 - Fair	<b>Expansion Joints:</b>	F2 - Fair
<b>Comments:</b>	Six panel Mabey Compact 200 single lane bridge. Treated timber stringers.		
<b>DECK</b>			
<b>Condition:</b>	F2 - Fair	<b>Curbs:</b>	F2 - Fair
<b>Hand Rail:</b>	I - Inapplicable	<b>Roadway Condition:</b>	F2 - Fair

<b>Approach Rail:</b>	F2 - Fair		
<b>Comments:</b>	100mm x 150mm treated timber chesses, 50mm raceway. 150mm x 150mm treated timber curbs. Approach to abutment one paved 2014, approach to abutment two gravel. Timber runway is deteriorated with potholes present and more forming.		
<b>HYDROLOGY</b>			
<b>Water Velocity:</b>	.5 m/s	<b>Ice Problem:</b>	N - No Problem
<b>Water Depth:</b>	.3 m	<b>Scour Problem:</b>	N - No Problem
<b>Waterway:</b>	01 - Adequate	<b>Debris Problem:</b>	N - No Problem
<b>Comments:</b>	Gabion adjacent to Abutment 2 left damaged by ice.		
<b>REPLACEMENT/REHABILITATION</b>			
<b>Next Rehab. Date:</b>		<b>Replacement Year:</b>	
<b>Antic. Rehab. Cost:</b>	\$0	<b>Replacement Cost:</b>	\$0
<b>Recommendations:</b>	Replace raceway.		
<b>OBSERVATIONS</b>			
<b>Overall Condition:</b>	F2 - Fair	<b>Requires Further Inspection:</b>	No
<b>Additional Observations:</b>	Hydraulic rip rap placed all four corners. Upstream gabions toppled during Hurricane Igor and are buried under rip rap.
