GOVERNMENT OF NEWFOUNDLAND AND LABRADOR Department of Transportation and Infrastructure	<b>BRIDGE INSPECTION REPORT</b> <b>B10132021-7</b>	
<b>Date:</b> 10/6/2021	<b>Inspected By:</b> Mike Button	<b>Category:</b> Office - Bridge Office	
<b>BRIDGE INFORMATION</b>			
<b>Site:</b>	2-073 - CHAPEL ARM BRIDGE		
<b>Route:</b>	201-10	<b>Overall Length:</b>	20 m
<b>Year Built:</b>	1988	<b>Est:</b> No	<b>Overall Width:</b> 11 m
<b>Year Last Rehab.:</b>		<b>Est:</b> No	<b>Roadway Width:</b> 9.5 m
<b>Region:</b>	CENTRAL EAST	<b>Sidewalk Width:</b>	0 m
<b>Jurisdiction:</b>	Provincial	<b>Clearance to R.D. or N.W.L.:</b>	1.5 m
<b>Type of Structure:</b>	03 - Reinforced Concrete Beam/Slab	<b>Max Depth of N.W.L.:</b>	2 m
<b>Purpose of Structure:</b>	03 - Over Navigable Waters	<b>Spans:</b>	
<b>Type of Handrail:</b>	01 - Aluminum Rail	<u>Span No.:</u>	<u>Length</u>
<b>Roadway Surface:</b>	02 - Asphalt	<u>Span No.:</u>	<u>Length</u>

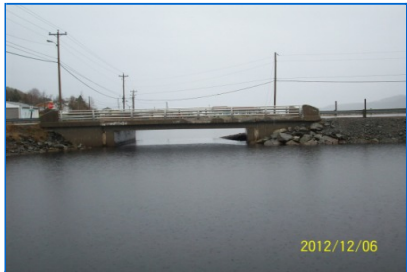
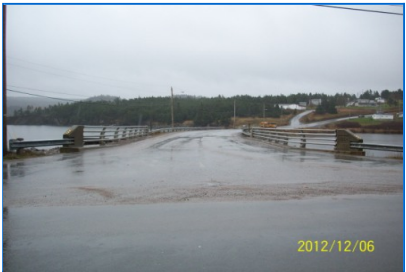
<b>Alignment Vertical:</b>	01 - Good	1	12
<b>Alignment Horizontal:</b>	01 - Good	2	0
<b>Restrictions:</b>	No	3	0
		4	0
		5	0
		6	0
<b>BRIDGE PHOTOS</b>
