GOVERNMENT OF NEWFOUNDLAND AND LABRADOR Department of Transportation and Infrastructure	BRIDGE INSPECTION REPORT B09222017-5	
Date: 9/13/2017	Inspected By: AB	Category: Eng. - Engineering	
BRIDGE INFORMATION			
Site:	2-063 - ENGLISH HARBOUR EAST BRIDGE		
Route:	211	Overall Length:	36.6 m
Year Built:	2013	Est: No	Overall Width: 6.1 m
Year Last Rehab.:		Est: No	Roadway Width: 4.1 m
Region:	CENTRAL EAST	Sidewalk Width:	0 m
Jurisdiction:	Provincial	Clearance to R.D. or N.W.L.:	3 m
Type of Structure:	09 - Bailey Bridge	Max Depth of N.W.L.:	5 m
Purpose of Structure:	03 - Over Navigable Waters	Spans:	
Type of Handrail:	04 - Steel Rail	<u>Span No.:</u>	<u>Length</u>
Roadway Surface:	03 - Timber	1	36.6
Alignment Vertical:	01 - Good	2	0
Alignment Horizontal:	01 - Good	3	0
Restrictions:	Yes	<u>Span No.:</u>	<u>Length</u>
Describe Restrictions:	One lane only.	4	0
		5	0
		6	0
BRIDGE PHOTOS

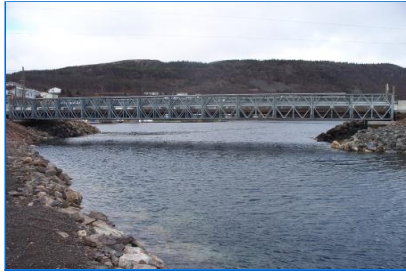
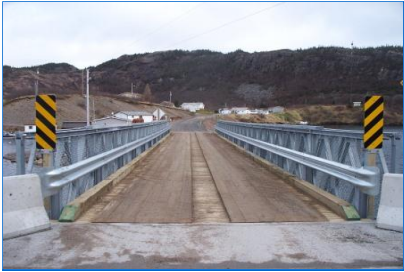
Bearing Seat:	F2 - Fair
Comments:	Pressure treated timber cribwork abutments with concrete slab bearing seat. Some debris, sand and salt on bearing seat.		
SUPERSTRUCTURE			
Condition:	F2 - Fair	Expansion Joints:	I - Inapplicable
Comments:	36.6m (12 panel) Mabey Compact 200 extra wide DSHR1++ panel bridge.		
DECK			
Condition:	F2 - Fair	Curbs:	F2 - Fair
Hand Rail:	F2 - Fair	Roadway Condition:	F2 - Fair

Approach Rail:	F2 - Fair		
Comments:	75mm timber decking with 50mm timber wearing surface. Some damage to end of raceway abutment one from plow. Hand rail is flex beam mounted on steel posts. Some minor settlement of asphalt approaches.		
HYDROLOGY			
Water Velocity:	2.0 m/s	Ice Problem:	N - No Problem
Water Depth:	4 m	Scour Problem:	N - No Problem
Waterway:	01 - Adequate	Debris Problem:	N - No Problem
Comments:	Tidal zone. Some rocks rolled into channel downstream of bridge, issues for boats at low tide. Onsite discussions with locals has identified that the chanel re-alignment has caused a change in sedimentation deposits downstream which is affecting boats mooring there.		
REPLACEMENT/REHABILITATION			
Next Rehab. Date:		Replacement Year:	
Antic. Rehab. Cost:	\$0	Replacement Cost:	\$0
Recommendations:	Remove rocks from navigation channel downstream of structure. Remove sand and salt buildup from the abutments and bearings.
