GOVERNMENT OF NEWFOUNDLAND AND LABRADOR Department of Transportation and Infrastructure	BRIDGE INSPECTION REPORT B11282023-8																	
Date: 11/28/2023	Inspected By: Darrell Avery	Category: Eng. - Engineering																	
BRIDGE INFORMATION																			
Site: 2-171 - GOOBIES MABEY BRIDGE																			
Route: 210	Overall Length: 25 m																		
Year Built: 2011	Est: No	Overall Width: 7 m																	
Year Last Rehab.:	Est: No	Roadway Width: 4.1 m																	
Region: CENTRAL EAST		Sidewalk Width: 0 m																	
Jurisdiction: Provincial		Clearance to R.D. or N.W.L.: 2 m																	
Type of Structure: 09 - Bailey Bridge		Max Depth of N.W.L.: 1 m																	
Purpose of Structure: 03 - Over Navigable Waters		Spans:																	
Type of Handrail: 06 - None		<table border="1" style="width: 100%; border-collapse: collapse;"> <thead> <tr> <th style="text-align: left;">Span No.:</th> <th style="text-align: left;">Length</th> <th style="text-align: left;">Span No.:</th> <th style="text-align: left;">Length</th> </tr> </thead> <tbody> <tr> <td>1</td> <td>24.4</td> <td>4</td> <td>0</td> </tr> <tr> <td>2</td> <td>0</td> <td>5</td> <td>0</t

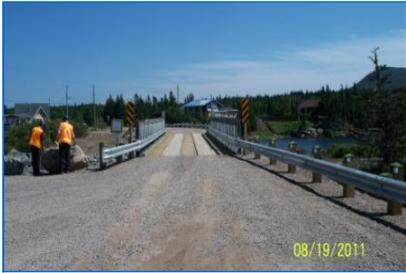
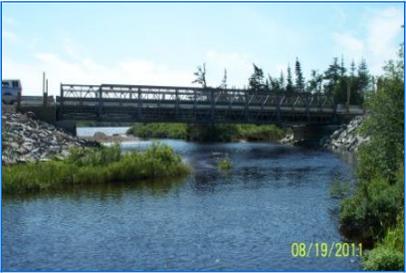
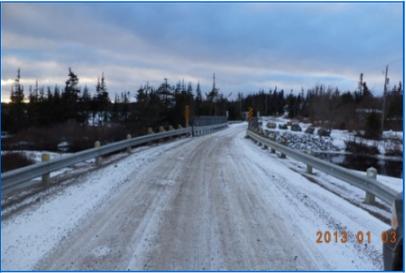
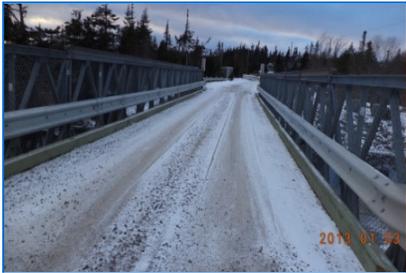
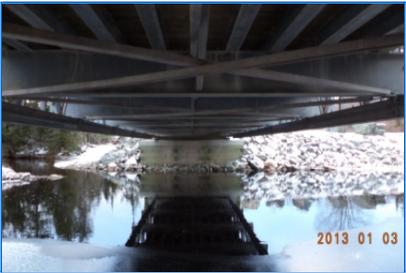
Span No.:	Length	Span No.:	Length																
1	24.4	4	0																
2	0	5	0																
3	0	6	0																
Roadway Surface: 03 - Timber																			
Alignment Vertical: 01 - Good																			
Alignment Horizontal: 01 - Good																			
Restrictions: Yes																			
Describe Restrictions: Bridge is one lane only. Mabeys Compact 200 SSHR++ Extra Wide, 8 panels long.																			
BRIDGE PHOTOS																			
<table style="width: 100%; border: none;"> <tr> <td style="width: 33%; text-align: center;">

SUBSTRUCTURE																			
Condition: F2 - Fair	Bearings: F2 - Fair																		
	Bearing Seat: F2 - Fair																		
Previous inspection - Pressure treated timber crib abutments with concrete bearing seats. Some debris on

Comments:	bearing seat. Rusting starting on Girders.		
SUPERSTRUCTURE			
Condition:	F2 - Fair	Expansion Joints:	I - Inapplicable
Comments:	Eight panel single lane Mabey bridge.		
DECK			
Condition:	F2 - Fair	Curbs:	F2 - Fair
Hand Rail:	F2 - Fair	Roadway Condition:	F2 - Fair
Approach Rail:	P1 - Poor		
Comments:	Previous inspection - 75mm timber deck with 50mm timber wearing surface. Timber chesses are too closely spaced, allowing gravel and sand to remain on the deck collecting moisture. Raceway timbers worn. Some light impact damage on approach rail and right side wheel guard over abutment 1. impact damage to chain link fencing and bridge rail over abutment 1 left side. Approach 2 left buried end is broken. New inspection - also damage to left wheel guard.		
HYDROLOGY			
Water Velocity:	1.0 m/s	Ice Problem:	N - No Problem
Water Depth:	0.5 m	Scour Problem:	N - No Problem
Waterway:	01 - Adequate	Debris Problem:	N - No Problem
