GOVERNMENT OF
NEWFOUNDLAND
AND LABRADOR
Department of Transportation and Infrastructure

BRIDGE INSPECTION REPORT
B02032020-6

Site:	2-042 - LITTLE ST. LAWRENCE CAUSEWAY BRIDGE		
Route:	220	Overall Length:	43.3 m
Year Built:	1971	Est: No	Overall Width: 10.5 m
Year Last Rehab.:	2006	Est: No	Roadway Width: 9.3 m
Region:	CENTRAL EAST	Sidewalk Width:	0 m
Jurisdiction:	Provincial	Clearance to R.D. or N.W.L.:	3 m
Type of Structure:	01 - AASH to Girder	Max Depth of N.W.L.:	2.5 m
Purpose of Structure:	03 - Over Navigable Waters	Spans:	
Type of Handrail:	01 - Aluminum Rail	Span No.:	Length
Roadway Surface:	01 - Concrete	1	36.6
Alignment Vertical:	01 - Good	2	0
Alignment Horizontal:	01 - Good	3	0
Restrictions:	No	4	0
		5	0
		6	0

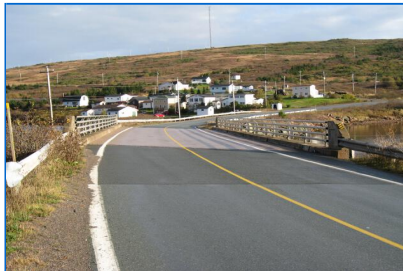
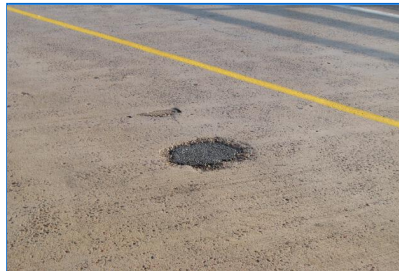
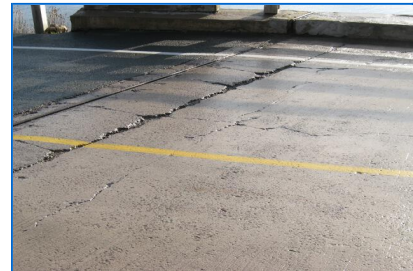
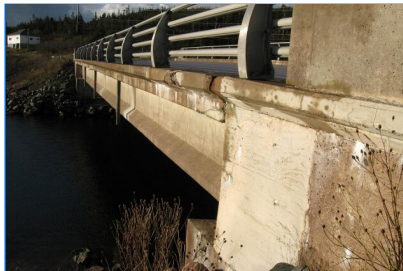
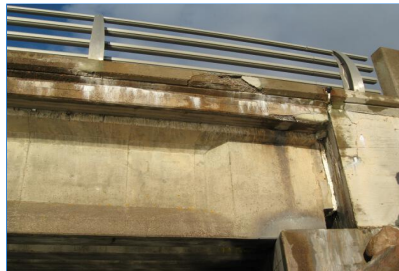
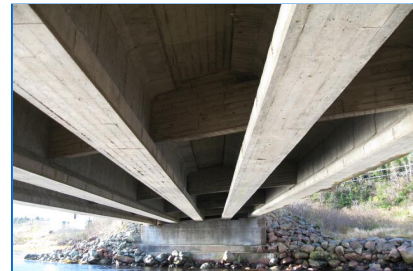
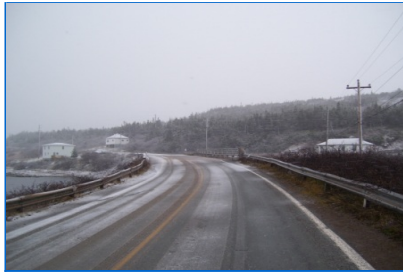
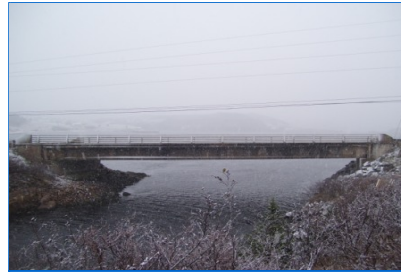
BRIDGE PHOTOS

Condition:	F2 - Fair	Bearings:	F2 - Fair
		Bearing Seat:	F2 - Fair
Comments:	Concrete abutments and wingwalls. Minor concrete erosion in the tidal zone, light cracking. Bearing pads are squat under some girders. Significant debris on beam seats (sand, formwork).

Condition:	F2 - Fair	Expansion Joints:	P1 - Poor
Comments:	5 AASHTO girders, some minor exposed rebar with small spalls. Expansion joints are leaking, damaged - severe deterioration around the curb sections.

Condition:	P3 - Poor	Curbs:	P3 - Poor
Hand Rail:	P1 - Poor	Roadway Condition:	P3 - Poor
Approach Rail:	F2 - Fair		
Comments:	Exposed concrete deck, some potholes, cracking and exposed rebar, u/s deck has active wet areas with cracking, spalls and efflorescence especially between girders 3-4-5. Aluminum 4 rail system with concrete endblocks, many anchor bolts have loose or missing nuts and washers, several missing or loose rail nuts. Approach rail has no end shoes, no structure rail at bridge. Curbs have disintegration, cracking and efflorescence. Hazard markers in poor condition.

Water Velocity:	m/s	Ice Problem:	N - No Problem
Water Depth:	m	Scour Problem:	K - Known Problem
Waterway:	01 - Adequate	Debris Problem:	N - No Problem
Comments:	Tidal. Depth and Velocity vary. Minor scour at abutment one 100mm average depth, no issues.
