GOVERNMENT OF
NEWFOUNDLAND
AND LABRADOR
Department of Transportation and Infrastructure

**BRIDGE INSPECTION REPORT
B02032020-2**

Site:	2-087 - POINT MAY BRIDGE				
Route:	220	Overall Length:	17.5 m		
Year Built:	1965	Est: No	Overall Width:	9 m	
Year Last Rehab.:	1995	Est: No	Roadway Width:	7.4 m	
Region:	CENTRAL EAST				
Jurisdiction:	Provincial				
Type of Structure:	03 - Reinforced Concrete Beam/Slab	Clearance to R.D. or N.W.L.:	3.5 m		
Purpose of Structure:	04 - Over Non-Navigable Waters	Max Depth of N.W.L.:	1.5 m		
Type of Handrail:	01 - Aluminum Rail	Spans:			
Roadway Surface:	01 - Concrete	<u>Span No.:</u>	<u>Length</u>	<u>Span No.:</u>	<u>Length</u>
Alignment Vertical:	01 - Good	1	10	4	0
Alignment Horizontal:	01 - Good	2	0	5	0
Restrictions:	No	3	0	6	0

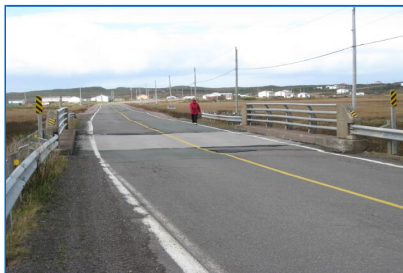
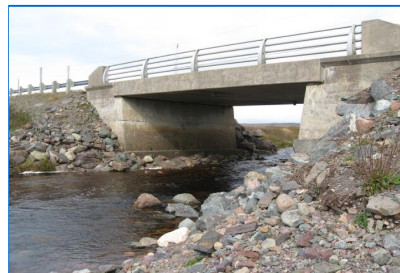
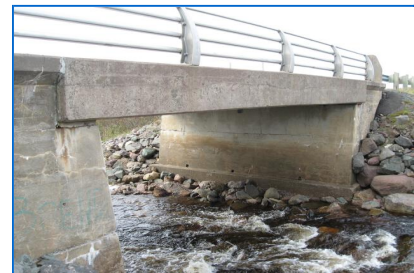
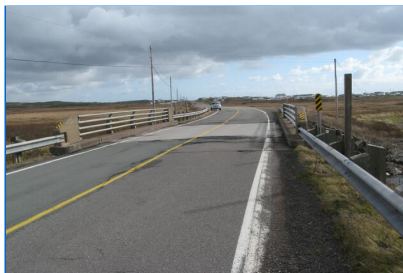
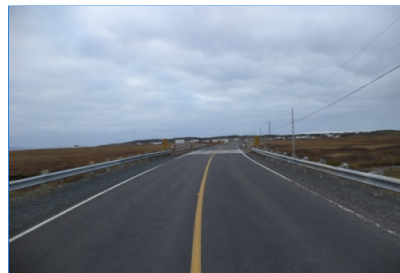
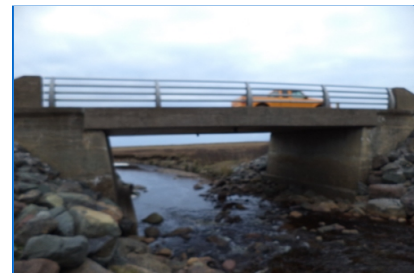
BRIDGE PHOTOS

Condition:	F2 - Fair	Bearings:	I - Inapplicable
		Bearing Seat:	F2 - Fair
Comments:	Concrete abutments and wingwalls. Minor cracking with efflorescence. Construction joint in both abutments and wingwalls is poor - some deterioration and efflorescence. Edges of bearing seats have some deterioration from

leaking curb joint.

Condition: F2 - Fair **Expansion Joints:** I - Inapplicable
Comments: Reinforced concrete deck. Minor spalls with exposed rebar. Dymeric in curbs poor/missing causing leakage.

Condition: P3 - Poor **Curbs:** F2 - Fair
Hand Rail: F2 - Fair **Roadway Condition:** F2 - Fair
Approach Rail: F2 - Fair
Comments: Exposed concrete deck - some cracking and small holes, repairs made 2012 with set45 but deck is rough, Abutment one end repair is in poor condition now. Paved approaches minor cracking. 4 rail aluminum system with concrete end blocks - minor scrapes. Curb dymeric poor. Bottom of deck under curbs has significant scaling starting. Approach rail minor post rot.
