BRIDGE INSPECTION REPORT
B05292020-7

| Site: | 2-122 - RUSHOON BAILEY BRIDGE | | | | | |
| Type of Structure: | 09 - Bailey Bridge | | Max Depth of N.W.L.: | 1 m | | |

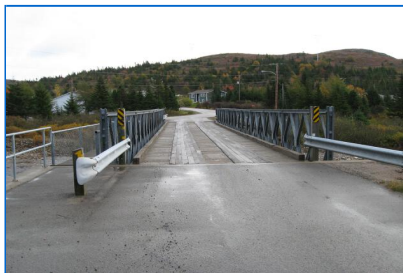
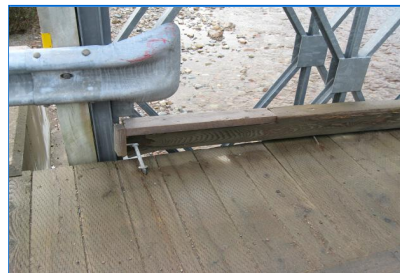
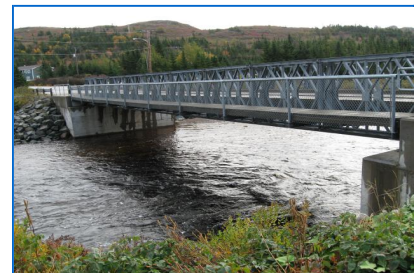
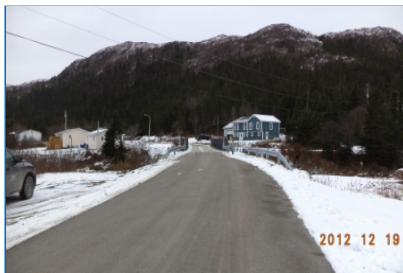
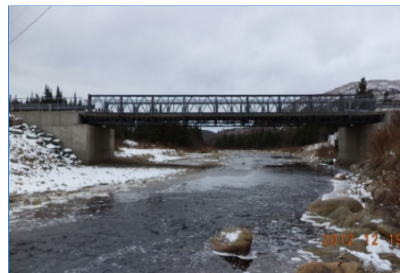
BRIDGE PHOTOS

| Comments: | Concrete abutments and wingwalls. Some light cracks with efflorescence and minor honeycombing from construction. Washout inside abutment one wingwall left side, fill may be escaping under wingwall. | | |

| Comments: | Single lane mabeby compact 200, 9 panels long, sidewalk attached right side. Some isolate spot rust. | | | | |
| Comments: | 75mm timber decking with 50mm timber wearing surface, some wear, splits and light rot to raceway and wheelguards. Chain link fencing attached to sidewalk rail, repairs to tie wires poor - tie wires attached to top rail and stuck up. Minor rusting of sidewalk rail. Approach rail broken post abutment one right side - embedded in asphalt. 150mm x 150mm timber curbs, repair made right side, some wear. All hazard markers old and worn. Approach rail 2 left side has a broken weld. | | | | |

| Recommendations: | Minor rehab. Replace damage raceway timbers, fix tie wires on fencing, fix broken guide rail post, fill washout, place new rip rap along abutment two face. Replace hazard markers. Repair approach rail. | | | | |
