GOVERNMENT OF NEWFOUNDLAND AND LABRADOR Department of Transportation and Infrastructure	<b>BRIDGE INSPECTION REPORT</b> <b>B08112023-4</b>	
<b>Date:</b> 8/4/2023	<b>Inspected By:</b> Darrell Avery	<b>Category:</b> Eng. - Engineering	
<b>BRIDGE INFORMATION</b>			
<b>Site:</b>	TCH-024 - SALMON RIVER BRIDGE (PORT BLANDFORD)		
<b>Route:</b>	1	<b>Overall Length:</b>	31.5 m
<b>Year Built:</b>	1960	<b>Est:</b> No	<b>Overall Width:</b> 22 m
<b>Year Last Rehab.:</b>	1987	<b>Est:</b> No	<b>Roadway Width:</b> 20 m
<b>Region:</b>	CENTRAL EAST	<b>Sidewalk Width:</b>	0 m
<b>Jurisdiction:</b>	Provincial	<b>Clearance to R.D. or N.W.L.:</b>	10 m
<b>Type of Structure:</b>	04 - Rigid Frame	<b>Max Depth of N.W.L.:</b>	1 m
<b>Purpose of Structure:</b>	04 - Over Non-Navigable Waters		
<b>Type of Handrail:</b>	01 - Aluminum Rail	<b>Spans:</b>	
<b>Roadway Surface:</b>	02 - Asphalt	<b>Span No.:</b>	<b>Length</b>
<b>Alignment Vertical:</b>	01 - Good	1	12.2

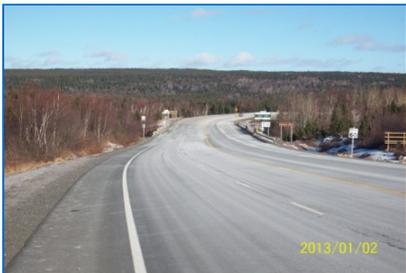
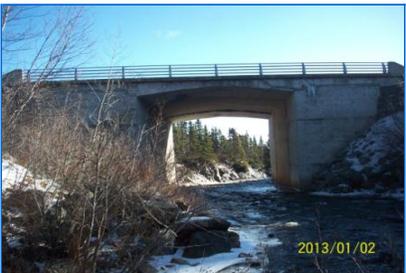
<b>Alignment Horizontal:</b>	01 - Good	2	0
<b>Restrictions:</b>	No	3	0
		4	0
		5	0
		6	0
<b>BRIDGE PHOTOS</b>
