GOVERNMENT OF NEWFOUNDLAND AND LABRADOR Department of Transportation and Infrastructure	BRIDGE INSPECTION REPORT B04282021-16	
Date: 4/22/2021	Inspected By: Butler	Category: Eng. - Engineering	
BRIDGE INFORMATION			
Site:	TCH-021 - SOUTHWEST RIVER BRIDGE		
Route:	1	Overall Length:	69.3 m
Year Built:	1964	Est: No	Overall Width: 10 m
Year Last Rehab.:	2014	Est: No	Roadway Width: 8.6 m
Region:	CENTRAL EAST	Sidewalk Width:	0 m
Jurisdiction:	Provincial	Clearance to R.D. or N.W.L.:	7 m
Type of Structure:	01 - AASH to Girder	Max Depth of N.W.L.:	1 m
Purpose of Structure:	03 - Over Navigable Waters	Spans:	
Type of Handrail:	01 - Aluminum Rail	<u>Span No.:</u>	<u>Length</u>
Roadway Surface:	02 - Asphalt	1	30.5
Alignment Vertical:	02 - Adequate	2	30.5
Alignment Horizontal:	02 - Adequate	3	0
Restrictions:	No	Span No.:	Length
		4	0
		5	0
		6	0
BRIDGE PHOTOS

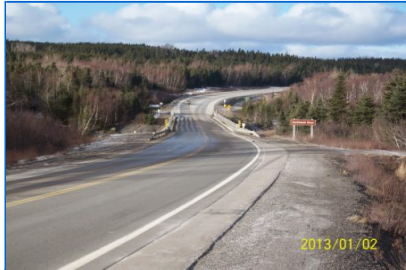
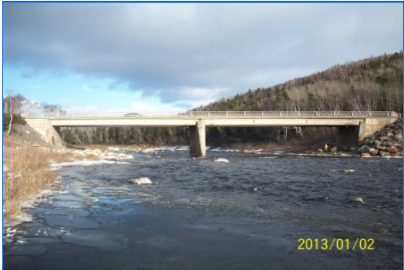
Bearing Seat:	U - Uninspectable
Comments:	Concrete abutments, wing walls and centre pier. Abutments and wingwalls have scaling, cracking, delaminations and disintegration in several areas. Centre pier has some disintegration of the upper sections with some sections of the upstream side repaired in 2014 and some erosion in the flow zone. Abutment 2 upstream has lose of concrete over icebreaker. Icebreaker missing from center pier, and now is on the shoreline downstream.		
SUPERSTRUCTURE			
Condition:	F2 - Fair	Expansion Joints:	F2 - Fair
Comments:	Five AASHTO girders. Some light cracking of all girders. Span two girder five has exposed rebar due to cover issues. Delamination, disintegration and exposed rebar girder five, span one, near abutment one and girder one span two. Some staining of all girders due to cover issues. Expansion joints (three) replaced in 2014.		
DECK

Condition:	F2 - Fair	Curbs:	F2 - Fair
Hand Rail:	F2 - Fair	Roadway Condition:	F2 - Fair
Approach Rail:	P1 - Poor		
Comments:	Full concrete deck rehab and new asphalt wearing surface installed in 2014, good condition. Curb faces and top rehab in 2007 with several sections of the left soffit and fascia repaired in 2014, some minor cracking and disintegration remains on the fascia of both curbs. Four rail aluminum bridge rail with concrete end blocks repaired in 2014, good condition. Approach rail is too short at all corners to cover hazards. Approach #2 information sign requires replacement. Approach #2 right has a damaged rail post. There is a large settlement on Approach #1 right causing a hazard to traffic. Approach 2 potholed and there are old core holes from previously installed detour signs placed during re-hab. Deck Pavement is potholed. Facia on Abutment 1 left near the expansion joint is spalling.
