GOVERNMENT OF NEWFOUNDLAND AND LABRADOR Department of Transportation and Infrastructure	<b>BRIDGE INSPECTION REPORT</b> <b>B10202017-4</b>	
<b>Date:</b> 10/20/2017	<b>Inspected By:</b> AB	<b>Category:</b> Eng. - Engineering	
<b>BRIDGE INFORMATION</b>			
<b>Site:</b>	2-005 - WALKHAM'S BROOK BRIDGE		
<b>Route:</b>	235	<b>Overall Length:</b>	29 m
<b>Year Built:</b>	2006	<b>Est:</b> No	<b>Overall Width:</b> 11.5 m
<b>Year Last Rehab.:</b>		<b>Est:</b> No	<b>Roadway Width:</b> 7.8 m
<b>Region:</b>	CENTRAL EAST		<b>Sidewalk Width:</b> 1.4 m
<b>Jurisdiction:</b>	Provincial		<b>Clearance to R.D. or N.W.L.:</b> 3 m
<b>Type of Structure:</b>	01 - AASH to Girder		<b>Max Depth of N.W.L.:</b> 4 m
<b>Purpose of Structure:</b>	03 - Over Navigable Waters		<b>Spans:</b>
<b>Type of Handrail:</b>	01 - Aluminum Rail		<b>Span No.:</b> <b>Length</b> <b>Span No.:</b> <b>Length</b>
<b>Roadway Surface:</b>	02 - Asphalt	1	13.2   4   0

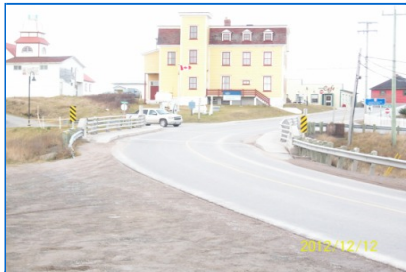
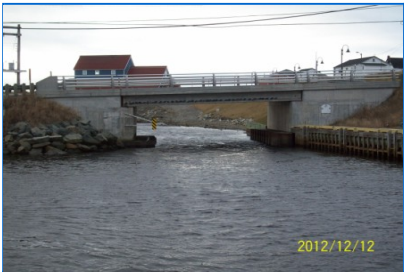
<b>Alignment Vertical:</b>	01 - Good	2	0   5   0
<b>Alignment Horizontal:</b>	01 - Good	3	0   6   0
<b>Restrictions:</b>	No		
<b>BRIDGE PHOTOS</b>
