GOVERNMENT OF NEWFOUNDLAND AND LABRADOR Department of Transportation and Infrastructure	<b>BRIDGE INSPECTION REPORT</b> <b>B12082021-3</b>	
<b>Date:</b> 10/29/2021	<b>Inspected By:</b> Mike Button	<b>Category:</b> Office - Bridge Office	
<b>BRIDGE INFORMATION</b>			
<b>Site:</b>	5-016 - NORTH WEST RIVER		
<b>Route:</b>	520	<b>Overall Length:</b>	188.7 m
<b>Year Built:</b>	1981	<b>Est:</b> No	<b>Overall Width:</b> 11.8 m
<b>Year Last Rehab.:</b>		<b>Est:</b> No	<b>Roadway Width:</b> 8.8 m
<b>Region:</b>	LABRADOR	<b>Sidewalk Width:</b>	1.2 m
<b>Jurisdiction:</b>	Provincial	<b>Clearance to R.D. or N.W.L.:</b>	8.9 m
<b>Type of Structure:</b>	08 - Steel Bridge	<b>Max Depth of N.W.L.:</b>	5.8 m
<b>Purpose of Structure:</b>	03 - Over Navigable Waters	<b>Spans:</b>	
<b>Type of Handrail:</b>	01 - Aluminum Rail	<b>Span No.:</b>	<b>Length</b>
<b>Roadway Surface:</b>	01 - Concrete	1	68
<b>Alignment Vertical:</b>	02 - Adequate	2	0

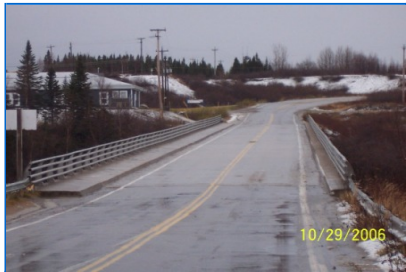
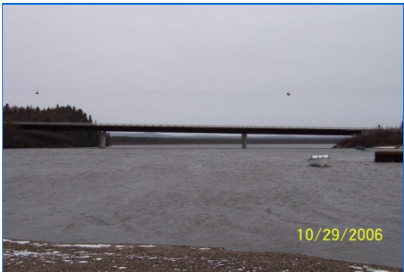
<b>Alignment Horizontal:</b>	02 - Adequate	3	0
<b>Restrictions:</b>	No	<b>Span No.:</b>	<b>Length</b>
		4	0
		5	0
		6	0
<b>BRIDGE PHOTOS</b>
