GOVERNMENT OF NEWFOUNDLAND AND LABRADOR Department of Transportation and Infrastructure	BRIDGE INSPECTION REPORT B01192021-21	
Date: 5/26/2020	Inspected By: Mike Fleming	Category: Eng. - Engineering	
BRIDGE INFORMATION			
Site:	4-129 - BALAM'S RIVER BRIDGE		
Route:	440	Overall Length:	61.5 m
Year Built:	1955	Est: No	Overall Width: 9.1 m
Year Last Rehab.:	1998	Est: No	Roadway Width: 7.3 m
Region:	WEST COAST/NORTHERN		Sidewalk Width: 0.8 m
Jurisdiction:	Provincial	Clearance to R.D. or N.W.L.:	4 m
Type of Structure:	03 - Reinforced Concrete Beam/Slab		Max Depth of N.W.L.: 5 m
Purpose of Structure:	03 - Over Navigable Waters		Spans:
Type of Handrail:	01 - Aluminum Rail		<u>Span No.:</u> <u>Length</u> <u>Span No.:</u> <u>Length</u>
Roadway Surface:	02 - Asphalt	1	18.2 4 0
Alignment Vertical:	01 - Good	2	24.5 5 0
Alignment Horizontal:	03 - Poor	3	18.2 6 0
Restrictions:	No		
BRIDGE PHOTOS

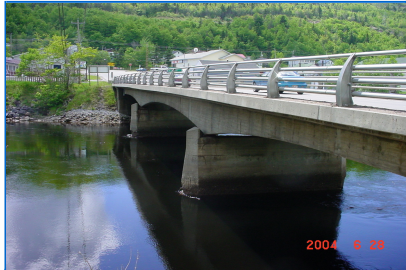
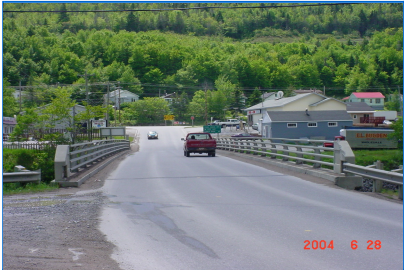
Condition:	P3 - Poor	Bearings:	P3 - Poor
		Bearing Seat:	P3 - Poor
Comments:	Corrosion on all bearings, piers, severely scoured, severe vertical crack extending through center pier near center bearing, delamination and cracking on both abutment wall, efflorescence present		
SUPERSTRUCTURE			
Condition:	P3 - Poor	Expansion Joints:	G - Good
Comments:	Cracking through superstructure, longitudinal cracking girders, severe deterioration of center piers, moderate to severe cracking of abutments		
DECK			
Condition:	G - Good	Curbs:	G - Good
