GOVERNMENT OF NEWFOUNDLAND AND LABRADOR Department of Transportation and Infrastructure	BRIDGE INSPECTION REPORT B02062023-3																	
Date: 5/2/2022	Inspected By: Mike Fleming	Category: Eng. - Engineering																	
BRIDGE INFORMATION																			
Site:	4-068 - BLACK DUCK BROOK BRIDGE																		
Route:		Overall Length:	18.8 m																
Year Built:	1966	Est: No	Overall Width: 9.1 m																
Year Last Rehab.:	1988	Est: No	Roadway Width: 8.1 m																
Region:	WEST COAST/NORTHERN		Sidewalk Width: 0 m																
Jurisdiction:	Provincial	Clearance to R.D. or N.W.L.:	1.9 m																
Type of Structure:	03 - Reinforced Concrete Beam/Slab		Max Depth of N.W.L.: 0.5 m																
Purpose of Structure:	03 - Over Navigable Waters		Spans:																
Type of Handrail:	01 - Aluminum Rail

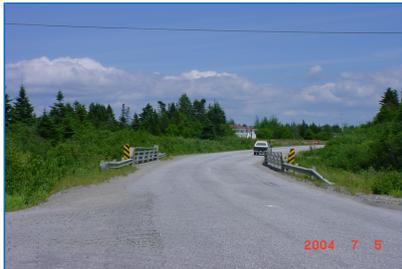
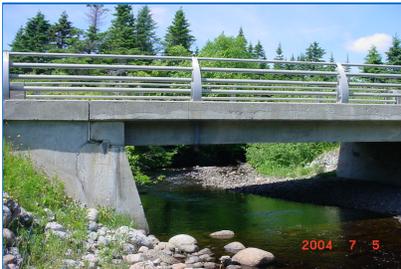
<u>Span No.:</u>	<u>Length</u>	<u>Span No.:</u>	<u>Length</u>	1	11.6	4	0	2	0	5	0	3	0	6	0
<u>Span No.:</u>	<u>Length</u>	<u>Span No.:</u>	<u>Length</u>																
1	11.6	4	0																
2	0	5	0																
3	0	6	0																
Roadway Surface:	02 - Asphalt																		
Alignment Vertical:	01 - Good																		
Alignment Horizontal:	02 - Adequate																		
Restrictions:	No																		
BRIDGE PHOTOS

SUBSTRUCTURE																			
Condition:	F2 - Fair	Bearings:	G - Good																
		Bearing Seat:	F1 - Fair																
Comments:	Light/minor scouring and undermining noted on the West abutment footing. Light to moderate deterioration of bearing seats noted.																		
SUPERSTRUCTURE																			
Condition:	G - Good	Expansion Joints:	I - Inapplicable																
Comments:																			
DECK																			
Condition:	F2 - Fair	Curbs:	F2 - Fair																
Hand Rail:	F1 - Fair	Roadway Condition:	F2 - Fair

Approach Rail:	P3 - Poor		
Comments:	Damage noted on handrail. Deck drains are severely deteriorated. Approach rails are damaged		
HYDROLOGY			
Water Velocity:	0 m/s	Ice Problem:	K - Known Problem
Water Depth:	0 m	Scour Problem:	K - Known Problem
Waterway:	01 - Adequate	Debris Problem:	K - Known Problem
Comments:			
REPLACEMENT/REHABILITATION			
Next Rehab. Date:	2023	Replacement Year:	
Antic. Rehab. Cost:	\$0	Replacement Cost:	\$0
Recommendations:	Replace approach rail, repair handrail, and repair bearing seats.		
OBSERVATIONS			
Overall Condition:	F2 - Fair	Requires Further Inspection:	No
Additional Observations:	Significant accumulation of winter sand along curbs. One Hazard Marker is damaged. Pics on file.		
LEGEND:			
Condition Definitions:			
1 - *Good - [discontinued code].	F2 - Fair.	C - Unsafe (Closed to Public).	Problem Definitions:
2 - *Fair - [discontinued code].	F1 - Fair.	U - Uninspectable.	N - No Problem.
