GOVERNMENT OF NEWFOUNDLAND AND LABRADOR Department of Transportation and Infrastructure	<b>BRIDGE INSPECTION REPORT</b> <b>B01182021-22</b>																	
<b>Date:</b> 5/19/2020	<b>Inspected By:</b> Terrance Coates	<b>Category:</b> Eng. - Engineering																	
<b>BRIDGE INFORMATION</b>																			
<b>Site:</b>	TCH-056 - BOOT BROOK BRIDGE																		
<b>Route:</b>		<b>Overall Length:</b>	19.2 m																
<b>Year Built:</b>	1965	<b>Est:</b> No	<b>Overall Width:</b> 14.3 m																
<b>Year Last Rehab.:</b>	2000	<b>Est:</b> No	<b>Roadway Width:</b> 12.5 m																
<b>Region:</b>	WEST COAST/NORTHERN		<b>Sidewalk Width:</b> 0 m																
<b>Jurisdiction:</b>	Provincial		<b>Clearance to R.D. or N.W.L.:</b> 3.6 m																
<b>Type of Structure:</b>	03 - Reinforced Concrete Beam/Slab		<b>Max Depth of N.W.L.:</b> 0 m																
<b>Purpose of Structure:</b>	03 - Over Navigable Waters		<b>Spans:</b>																
<b>Type of Handrail:</b>	01 - Aluminum Rail

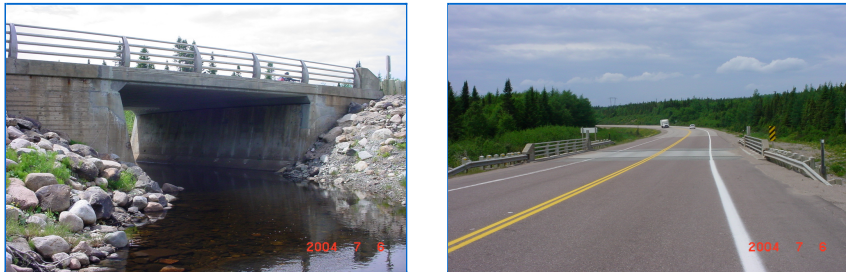
<u>Span No.:</u>	<u>Length</u>	<u>Span No.:</u>	<u>Length</u>	1	9.4	4	0	2	0	5	0	3	0	6	0
<u>Span No.:</u>	<u>Length</u>	<u>Span No.:</u>	<u>Length</u>																
1	9.4	4	0																
2	0	5	0																
3	0	6	0																
<b>Roadway Surface:</b>	01 - Concrete																		
<b>Alignment Vertical:</b>	01 - Good																		
<b>Alignment Horizontal:</b>	01 - Good																		
<b>Restrictions:</b>	No																		
<b>BRIDGE PHOTOS</b>

<b>SUBSTRUCTURE</b>																			
<b>Condition:</b>	F2 - Fair	<b>Bearings:</b>	G - Good																
		<b>Bearing Seat:</b>	G - Good																
<b>Comments:</b>	Deterioration of concrete on corner of abutments/wing walls and abutment walls.																		
<b>SUPERSTRUCTURE</b>																			
<b>Condition:</b>	G - Good	<b>Expansion Joints:</b>	I - Inapplicable																
<b>Comments:</b>	No expansion joints. Rubberized asphalt compound poured between concrete deck and asphalt approaches.																		
<b>DECK</b>																			
<b>Condition:</b>	G - Good	<b>Curbs:</b>	G - Good																
<b>Hand Rail:</b>	G - Good	<b>Roadway Condition:</b>	G - Good
