GOVERNMENT OF NEWFOUNDLAND AND LABRADOR Department of Transportation and Infrastructure	<b>BRIDGE INSPECTION REPORT</b> <b>B02062023-9</b>																	
<b>Date:</b> 5/4/2022	<b>Inspected By:</b> Mike Fleming	<b>Category:</b> Eng. - Engineering																	
<b>BRIDGE INFORMATION</b>																			
<b>Site:</b>	TCH-101 - CORNER BROOK STREAM BRIDE (ON CB INTERCHANGE)																		
<b>Route:</b>		<b>Overall Length:</b>	30.1 m																
<b>Year Built:</b>	1981	<b>Est:</b> No	<b>Overall Width:</b> 10.7 m																
<b>Year Last Rehab.:</b>	1987	<b>Est:</b> No	<b>Roadway Width:</b> 8.9 m																
<b>Region:</b>	WEST COAST/NORTHERN		<b>Sidewalk Width:</b> 0 m																
<b>Jurisdiction:</b>	Provincial	<b>Clearance to R.D. or N.W.L.:</b>	3.4 m																
<b>Type of Structure:</b>	02 - Double Tee	<b>Max Depth of N.W.L.:</b>	1.5 m																
<b>Purpose of Structure:</b>	03 - Over Navigable Waters		<b>Spans:</b>																
<b>Type of Handrail:</b>	01 - Aluminum Rail

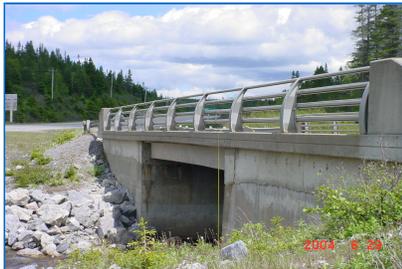
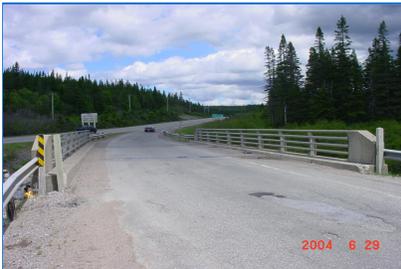
<u>Span No.:</u>	<u>Length</u>	<u>Span No.:</u>	<u>Length</u>	1	12.2	4	0	2	0	5	0	3	0	6	0
<u>Span No.:</u>	<u>Length</u>	<u>Span No.:</u>	<u>Length</u>																
1	12.2	4	0																
2	0	5	0																
3	0	6	0																
<b>Roadway Surface:</b>	02 - Asphalt																		
<b>Alignment Vertical:</b>	01 - Good																		
<b>Alignment Horizontal:</b>	02 - Adequate																		
<b>Restrictions:</b>	No																		
<b>BRIDGE PHOTOS</b>
