GOVERNMENT OF NEWFOUNDLAND AND LABRADOR Department of Transportation and Infrastructure	BRIDGE INSPECTION REPORT B06212019-2	
Date: 6/21/2019	Inspected By: lyver C	Category: Eng. - Engineering	
BRIDGE INFORMATION			
Site:	1-075 - ARNEY'S POND BRIDGE, BAY ROBERTS		
Route:	70	Overall Length:	18.9 m
Year Built:	1969	Est: No	Overall Width: 10.9 m
Year Last Rehab.:		Est: No	Roadway Width: 8.5 m
Region:	AVALON PENINSULA	Sidewalk Width:	1.2 m
Jurisdiction:	Provincial	Clearance to R.D. or N.W.L.:	2 m
Type of Structure:	02 - Double Tee	Max Depth of N.W.L.:	1.5 m
Purpose of Structure:	04 - Over Non-Navigable Waters	Spans:	
Type of Handrail:	02 - Concrete Rail	Span No.:	Length
Roadway Surface:	02 - Asphalt	1	9.8
Alignment Vertical:	01 - Good	2	0
Alignment Horizontal:	01 - Good	3	0
Restrictions:	No	Span No.:	Length
		4	0
		5	0
		6	0
BRIDGE PHOTOS

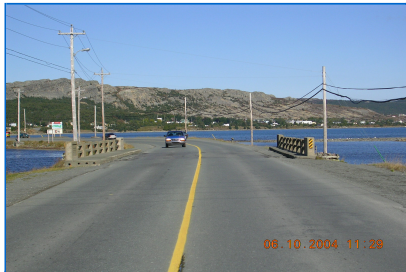
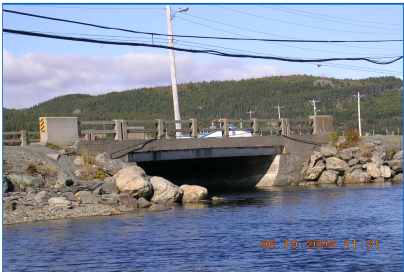
Comments:	Assumed condition of buried concrete reinforcement at abutment footing. Pigeon content on bearing seats and girders. Hairline alligator cracks in all four wing walls. Light erosion along bottom faces of both abutments.		
SUPERSTRUCTURE			
Condition:	G - Good	Expansion Joints:	G - Good
Comments:	Girders remain in good condition.		
DECK			
Condition:	G - Good	Curbs:	F2 - Fair
Hand Rail:	G - Good	Roadway Condition:	F2 - Fair

Approach Rail:	F2 - Fair		
Comments:	Medium rusting in asphalt in deck and approaches. No hazard marker at North East end but the post still in place. Narrow vertical cracks in deck/curb/sidewalk exterior faces and interior faces. Medium sized severe potholes and severe rusting in asphalt on South approach slab.		
HYDROLOGY			
Water Velocity:	0 m/s	Ice Problem:	N - No Problem
Water Depth:	0 m	Scour Problem:	P - Possible Problem
Waterway:	01 - Adequate	Debris Problem:	N - No Problem
Comments:	Water velocity and water depth specified as tidal. Light medium slope erosion along wingwall faces. Medium erosion under end of South West rock embedded gutter.		
REPLACEMENT/REHABILITATION			
Next Rehab. Date:	2047	Replacement Year:	2084
Antic. Rehab. Cost:	\$150	Replacement Cost:	\$2000
Recommendations:	Resurface deck and short sections of approaches, install pigeon screens and install new hazard marker		
OBSERVATIONS
