GOVERNMENT OF NEWFOUNDLAND AND LABRADOR Department of Transportation and Infrastructure	BRIDGE INSPECTION REPORT B06062019-3	
Date: 6/6/2019	Inspected By: Hunt R	Category: Eng. - Engineering	
BRIDGE INFORMATION			
Site:	1-186 - BAULINE BROOK BRIDGE NO. 1		
Route:		Overall Length:	8.3 m
Year Built:	1951	Est: No	Overall Width: 8 m
Year Last Rehab.:		Est: No	Roadway Width: 7.2 m
Region:	AVALON PENINSULA	Sidewalk Width:	0 m
Jurisdiction:	Provincial	Clearance to R.D. or N.W.L.:	1.2 m
Type of Structure:	04 - Rigid Frame	Max Depth of N.W.L.:	0.3 m
Purpose of Structure:	04 - Over Non-Navigable Waters		
Type of Handrail:	02 - Concrete Rail	Spans:	
Roadway Surface:	02 - Asphalt	<u>Span No.:</u>	<u>Length</u>
Alignment Vertical:	02 - Adequate	1	4.5
Alignment Horizontal:	02 - Adequate	2	0
Restrictions:	No	3	0
		<u>Span No.:</u>	<u>Length</u>
		4	0
		5	0
		6	0
BRIDGE PHOTOS

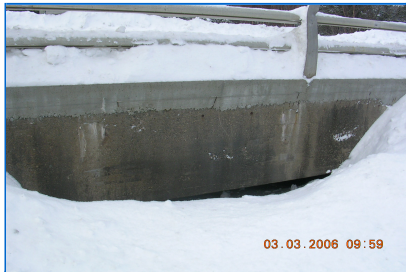
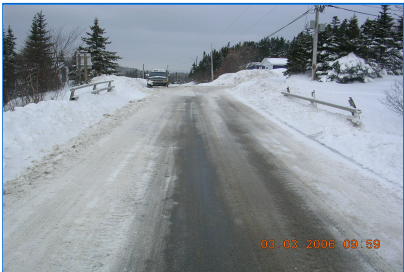
Bearing Seat:	I - Inapplicable
Comments:	Original structure extended approximately 4meters upstream. New curb at the top of the short retaining wall at the top of the original deck downstream. New curb at the top of the retaining wall. Curb moved in approximately 2meters from original deck. Assume no frame leg footing on original structure legs pounded directly onto bedrock on upstream extension.		
SUPERSTRUCTURE			
Condition:	F1 - Fair	Expansion Joints:	I - Inapplicable
Comments:	P1 - original frame legs and wingwalls. F1 - exterior. Numerous wide vertical cracks and horizontal cracks with medium efflor deposits in faces of original frame legs and wingwalls downstream. Light scaling/ honeycombing to upstream wingwall. Severe delamination/ spalling/disintegration to tops of downstream wing walls.		
DECK

Condition:	F1 - Fair	Curbs:	G - Good
Hand Rail:	F2 - Fair	Roadway Condition:	G - Good
Approach Rail:	G - Good		
Comments:	P1 - original deck. F1 - extension. Original deck and facias remains same as before. Rehab done in 2017 consisted of new curb on downstream end with new aluminum rail and approach exit rail upstream consisted of new partial curbs. New aluminum rail and new approach and exit rail.
