GOVERNMENT OF NEWFOUNDLAND AND LABRADOR Department of Transportation and Infrastructure	<b>BRIDGE INSPECTION REPORT</b> <b>B05312019-1</b>	
<b>Date:</b> 5/31/2019	<b>Inspected By:</b> Pickett R	<b>Category:</b> Eng. - Engineering	
<b>BRIDGE INFORMATION</b>			
<b>Site:</b>	1-110 - DANIEL'S BROOK BRIDGE EXTENSION		
<b>Route:</b>	90	<b>Overall Length:</b>	20.8 m
<b>Year Built:</b>	1960	<b>Est: Yes</b>	<b>Overall Width:</b> 10.5 m
<b>Year Last Rehab.:</b>	1973	<b>Est: No</b>	<b>Roadway Width:</b> 9.2 m
<b>Region:</b>	AVALON PENINSULA	<b>Sidewalk Width:</b>	0.65 m
<b>Jurisdiction:</b>	Provincial	<b>Clearance to R.D. or N.W.L.:</b>	1.5 m
<b>Type of Structure:</b>	02 - Double Tee	<b>Max Depth of N.W.L.:</b>	0.4 m
<b>Purpose of Structure:</b>	04 - Over Non-Navigable Waters		
<b>Type of Handrail:</b>	02 - Concrete Rail		
<b>Roadway Surface:</b>	02 - Asphalt	<b>Spans:</b>	
<b>Alignment Vertical:</b>	01 - Good	<u>Span No.:</u>	<u>Length</u>

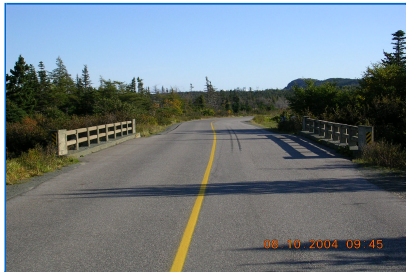
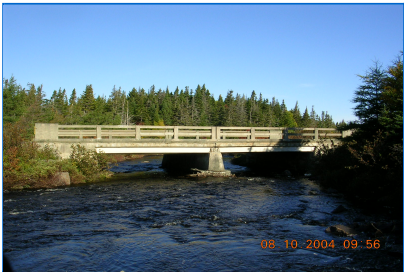
<b>Alignment Horizontal:</b>	01 - Good	1	6.7
<b>Restrictions:</b>	No	2	6.7
		3	0
		4	0
		5	0
		6	0
<b>BRIDGE PHOTOS</b>

<b>SUBSTRUCTURE</b>			
<b>Condition:</b>	P3 - Poor	<b>Bearings:</b>	P3 - Poor
		<b>Bearing Seat:</b>	P3 - Poor
<b>Comments:</b>	Original structure extended approximately 2m upstream and 3m downstream. Wide vertical horizontal cracks in original pier. Narrow medium cracks in faces of abutments/pier extensions and wing walls. Concrete disintegration with corrosion to exposed rebar on pier retaining block. Spalling to bearing seats on original pier sever erosion to upstream pier footing extension joints to new exciting abud are opened up.		
<b>SUPERSTRUCTURE</b>			
<b>Condition:</b>	P1 - Poor	<b>Expansion Joints:</b>	F1 - Fair
<b>Comments:</b>	Extension double ties have light spalling due to insufficient cover. Light corrosion on exposed rebar . Spalling /narrow cracks at drainage locations reinforced beam on original structure has wide cracks, delamination and spalling rebar exposed and corroded.

<b>Condition:</b>	P3 - Poor	<b>Curbs:</b>	P3 - Poor
<b>Hand Rail:</b>	P3 - Poor	<b>Roadway Condition:</b>	P3 - Poor
<b>Approach Rail:</b>	G - Good		
<b>Comments:</b>	Severe spalling to downstream deck/curb fascia. Medium narrow cracks, medium/ light spalling on remainder deck/ curb fascia. Effloresce deposits cracks on deck soffit on original section. Section of concrete hand rail spalled off. Remainder narrow cracks and light spalling including the end blocks.

<b>Water Velocity:</b>	0.2 m/s	<b>Ice Problem:</b>	N - No Problem
<b>Water Depth:</b>	0.4 m	<b>Scour Problem:</b>	K - Known Problem
<b>Waterway:</b>	01 - Adequate	<b>Debris Problem:</b>	N - No Problem
<b>Comments:</b>	Severe erosion along bottom of abutments at North East and South West ends.
