GOVERNMENT OF NEWFOUNDLAND AND LABRADOR Department of Transportation and Infrastructure	<b>BRIDGE INSPECTION REPORT</b> <b>B11052015-12</b>	
<b>Date:</b> 9/23/2015	<b>Inspected By:</b> Rodger Hussey	<b>Category:</b> Eng. - Engineering	
<b>BRIDGE INFORMATION</b>			
<b>Site:</b>	TCH-141 - FOXTRAP ACCESS ROAD OVERPASS WEST		
<b>Route:</b>	1	<b>Overall Length:</b>	41.7 m
<b>Year Built:</b>	1986	<b>Est:</b> No	<b>Overall Width:</b> 14.4 m
<b>Year Last Rehab.:</b>		<b>Est:</b> No	<b>Roadway Width:</b> 12.9 m
<b>Region:</b>	AVALON PENINSULA	<b>Sidewalk Width:</b>	0.75 m
<b>Jurisdiction:</b>	Provincial	<b>Clearance to R.D. or N.W.L.:</b>	5.3 m
<b>Type of Structure:</b>	01 - AASH to Girder	<b>Max Depth of N.W.L.:</b>	0 m
<b>Purpose of Structure:</b>	01 - Highway Grade Separation	<b>Spans:</b>	
<b>Type of Handrail:</b>	01 - Aluminum Rail	<b>Span No.:</b>	<b>Length</b>
<b>Roadway Surface:</b>	02 - Asphalt	1	29.9

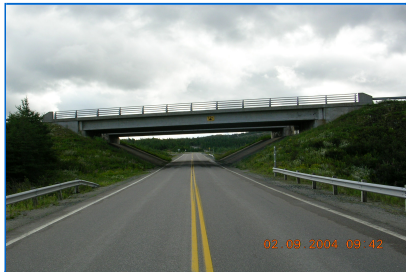
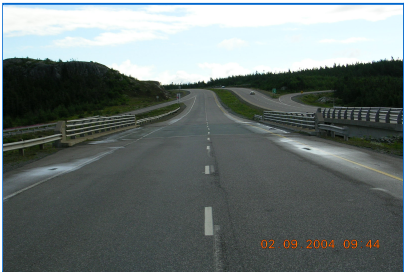
<b>Alignment Vertical:</b>	01 - Good	2	0
<b>Alignment Horizontal:</b>	01 - Good	3	0
<b>Restrictions:</b>	No	<b>Span No.:</b>	<b>Length</b>
		4	0
		5	0
		6	0
<b>BRIDGE PHOTOS</b>

<b>SUBSTRUCTURE</b>			
<b>Condition:</b>	F2 - Fair	<b>Bearings:</b>	F2 - Fair
		<b>Bearing Seat:</b>	F2 - Fair
<b>Comments:</b>	Minor/moderate cracking throughout abutment walls, headwalls, end blocks, and creep blocks; Section of moderate spalling at the top of one abutment wall.		
<b>SUPERSTRUCTURE</b>			
<b>Condition:</b>	P3 - Poor	<b>Expansion Joints:</b>	P3 - Poor
<b>Comments:</b>	Honeycombing, delamination, and spalling along the bottom of several girders near bearing seat. Expansion joints leaking.		
<b>DECK</b>			
<b>Condition:</b>	F2 - Fair	<b>Curbs:</b>	F2 - Fair

<b>Hand Rail:</b>	F2 - Fair	<b>Roadway Condition:</b>	F2 - Fair
<b>Approach Rail:</b>	P3 - Poor		
<b>Comments:</b>	One section of approach rail damaged by snow equipment; Rough driving surface, large areas of asphalt patching; Minor spalling along soffit, minor corrosion to exposed reinforcement.		
<b>HYDROLOGY</b>			
<b>Water Velocity:</b>	0 m/s	<b>Ice Problem:</b>	NA - Not Applicable
<b>Water Depth:</b>	0 m	<b>Scour Problem:</b>	NA - Not Applicable
<b>Waterway:</b>	03 - Not Applicable	<b>Debris Problem:</b>	NA - Not Applicable
<b>Comments:</b>			
<b>REPLACEMENT/REHABILITATION</b>			
<b>Next Rehab. Date:</b>	2015	<b>Replacement Year:</b>	2015
<b>Antic. Rehab. Cost:</b>	\$0	<b>Replacement Cost:</b>	\$0
<b>Recommendations:</b>	Replace expansion joints; Repave driving surface; Repair damaged approach rail; Repair girder ends; Repair abutment spalling; Repair soffit; Install hazard marker (1).		
<b>OBSERVATIONS</b>
