GOVERNMENT OF NEWFOUNDLAND AND LABRADOR Department of Transportation and Infrastructure	BRIDGE INSPECTION REPORT B09152021-6	
Date: 3/31/2021	Inspected By: Paul Lawrence	Category: Eng. - Engineering	
BRIDGE INFORMATION			
Site:	1-159 - HEART'S CONTENT BRIDGE		
Route:		Overall Length:	20.5 m
Year Built:	1996	Est: No	Overall Width: 12 m
Year Last Rehab.:		Est: No	Roadway Width: 9 m
Region:	AVALON PENINSULA	Sidewalk Width:	1.5 m
Jurisdiction:	Provincial	Clearance to R.D. or N.W.L.:	3 m
Type of Structure:	05 - Pre-stressed Concrete Slab	Max Depth of N.W.L.:	0.5 m
Purpose of Structure:	04 - Over Non-Navigable Waters	Spans:	
Type of Handrail:	01 - Aluminum Rail	<u>Span No.:</u>	<u>Length</u>
Roadway Surface:	02 - Asphalt	1	9.2
Alignment Vertical:	01 - Good	2	0
Alignment Horizontal:	02 - Adequate	3	0
Restrictions:	No	6	0
BRIDGE PHOTOS

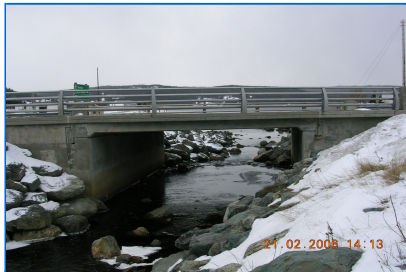
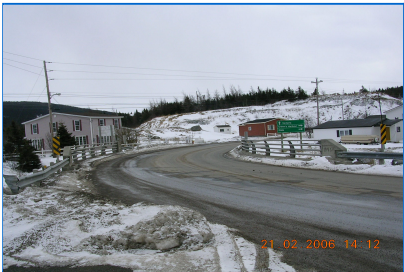
Comments:	- Assumed buried/submerged sections in good cond. - Reinforced abutments in good cond. - Some narrow vertical cracks in abutment faces - Small narrow surface cracks in all 4 wingwall faces		
SUPERSTRUCTURE			
Condition:	F2 - Fair	Expansion Joints:	F2 - Fair
Comments:	- No mechanical expansion joints - Some chalking and backer rod missing from expansion gaps in extensions faces of deck abutments		
DECK			
Condition:	F2 - Fair	Curbs:	F2 - Fair

Hand Rail:	F2 - Fair	Roadway Condition:	F2 - Fair
Approach Rail:	F2 - Fair		
Comments:	- Deck soffit concrete has many small surface cracking areas - Some deck curb has concrete delineation and spalling areas - All deck end blocks have medium concrete cracking - Asphalt deck surface has several small potholes		
HYDROLOGY			
Water Velocity:	0.3 m/s	Ice Problem:	N - No Problem
Water Depth:	0.5 m	Scour Problem:	N - No Problem
Waterway:	01 - Adequate	Debris Problem:	N - No Problem
Comments:	Still minor slope erosion at harsh end of structure		
REPLACEMENT/REHABILITATION			
Next Rehab. Date:	2021	Replacement Year:	2021
Antic. Rehab. Cost:	\$0	Replacement Cost:	\$0
Recommendations:			
OBSERVATIONS			
Overall Condition:	F1 - Fair	Requires Further Inspection:	No
Additional Observations:			
LEGEND:			
Condition Definitions:			
1 - *Good - [discontinued code].	F2 - Fair.	C - Unsafe (Closed to Public).	Problem Definitions:
