GOVERNMENT OF NEWFOUNDLAND AND LABRADOR Department of Transportation and Infrastructure	BRIDGE INSPECTION REPORT B09172021-3	
Date: 3/13/2019	Inspected By: Pickett R	Category: Eng. - Engineering	
BRIDGE INFORMATION			
Site:	TCH-157 - HODGEWATER LINE OVERPASS - WESTBOUND		
Route:	1	Overall Length:	28.5 m
Year Built:	1996	Est: No	Overall Width: 13.4 m
Year Last Rehab.:		Est: No	Roadway Width: 11.4 m
Region:	AVALON PENINSULA	Sidewalk Width:	1 m
Jurisdiction:	Provincial	Clearance to R.D. or N.W.L.:	5.1 m
Type of Structure:	04 - Rigid Frame	Max Depth of N.W.L.:	0 m
Purpose of Structure:	01 - Highway Grade Separation	Spans:	
Type of Handrail:	01 - Aluminum Rail	<u>Span No.:</u>	<u>Length</u>
Roadway Surface:	02 - Asphalt	1	12.5
Alignment Vertical:	01 - Good	2	0
Alignment Horizontal:	01 - Good	3	0
Restrictions:	No	4	0
		5	0
		6	0
BRIDGE PHOTOS

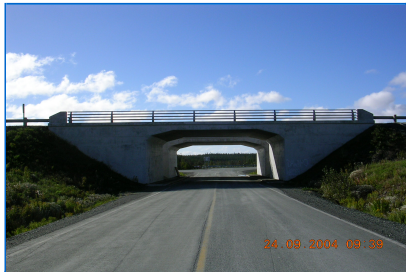
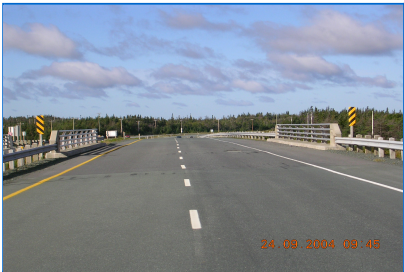
Bearing Seat:	I - Inapplicable
Comments:	- Assumed cond. of buried frame leg footings - Narrow transv. cracks in slope paving		
SUPERSTRUCTURE			
Condition:	F2 - Fair	Expansion Joints:	I - Inapplicable
Comments:	_ med. vert. cracks in faces of frame legs with efflor. deposits - Narrow alligator cracks in all wingwall (AIL) - Wide cracks in all end blocks		
DECK			
Condition:	F2 - Fair	Curbs:	F1 - Fair
Hand Rail:	F2 - Fair	Roadway Condition:	F1 - Fair

Approach Rail:	G - Good		
Comments:	- Med. longit. cracks with efflor. deposits in deck soffit; cracks extend up frame legs - Wide/medium cracks in curbs and fascias		
HYDROLOGY			
Water Velocity:	n/a m/s	Ice Problem:	NA - Not Applicable
Water Depth:	n/a m	Scour Problem:	NA - Not Applicable
Waterway:	03 - Not Applicable	Debris Problem:	NA - Not Applicable
Comments:			
REPLACEMENT/REHABILITATION			
Next Rehab. Date:	2021	Replacement Year:	2046
Antic. Rehab. Cost:	\$100	Replacement Cost:	\$750
Recommendations:			
OBSERVATIONS			
Overall Condition:	F2 - Fair	Requires Further Inspection:	No
Additional Observations:	Majority of maint. coating worn off Graffiti on frame legs		
LEGEND:			
Condition Definitions:		Problem Definitions:	
1 - *Good - [discontinued code].	F2 - Fair.	C - Unsafe (Closed to Public).	N - No Problem.
2 - *Fair - [discontinued code].	F1 - Fair.	U - Uninspectable.	P - Possible Problem.
3 - *Poor - [discontinued code].	P3 - Poor.	I - Inapplicable.	K - Known Problem.
