GOVERNMENT OF NEWFOUNDLAND AND LABRADOR Department of Transportation and Infrastructure	<b>BRIDGE INSPECTION REPORT</b> <b>B05302019-1</b>	
<b>Date:</b> 5/30/2019	<b>Inspected By:</b> Hunt R	<b>Category:</b> Eng. - Engineering	
<b>BRIDGE INFORMATION</b>			
<b>Site:</b>	1-309 - LAWRENCE BROOK BRIDGE		
<b>Route:</b>		<b>Overall Length:</b>	10.2 m
<b>Year Built:</b>	1973	<b>Est: Yes</b>	<b>Overall Width:</b> 13.8 m
<b>Year Last Rehab.:</b>		<b>Est: No</b>	<b>Roadway Width:</b> 12.8 m
<b>Region:</b>	AVALON PENINSULA		<b>Sidewalk Width:</b> 0 m
<b>Jurisdiction:</b>	Provincial		<b>Clearance to R.D. or N.W.L.:</b> 0.6 m
<b>Type of Structure:</b>	04 - Rigid Frame		<b>Max Depth of N.W.L.:</b> 0.4 m
<b>Purpose of Structure:</b>	04 - Over Non-Navigable Waters		<b>Spans:</b>
<b>Type of Handrail:</b>	01 - Aluminum Rail		<u>Span No.:</u> <u>Length</u> <u>Span No.:</u> <u>Length</u>
<b>Roadway Surface:</b>	02 - Asphalt	1	4   4   0

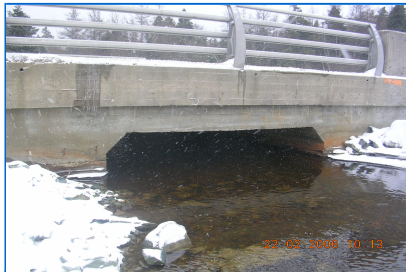
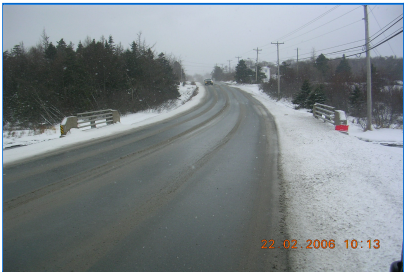
<b>Alignment Vertical:</b>	02 - Adequate	2	0   5   0
<b>Alignment Horizontal:</b>	02 - Adequate	3	0   6   0
<b>Restrictions:</b>	No		
<b>BRIDGE PHOTOS</b>

<b>SUBSTRUCTURE</b>			
<b>Condition:</b>	F2 - Fair	<b>Bearings:</b>	I - Inapplicable
		<b>Bearing Seat:</b>	I - Inapplicable
<b>Comments:</b>	Original structure extended approximately 2.0m upstream and downstream. Assumed condition of buried and submerged reinforcement concrete frame leg footings.		
<b>SUPERSTRUCTURE</b>			
<b>Condition:</b>	F2 - Fair	<b>Expansion Joints:</b>	I - Inapplicable
<b>Comments:</b>	Some light spalling and honey combing on all four wingwalls.		
<b>DECK</b>			
<b>Condition:</b>	F2 - Fair	<b>Curbs:</b>	F2 - Fair
<b>Hand Rail:</b>	F2 - Fair	<b>Roadway Condition:</b>	F2 - Fair

<b>Approach Rail:</b>	I - Inapplicable		
<b>Comments:</b>	Light scrapes and dents to aluminum hazards especially upstream. Small hazard markers on one corner of structure. No guide rail at approach or exit. Some narrow cracks and light efflon deposits in deck soffit.		
<b>HYDROLOGY</b>			
<b>Water Velocity:</b>	0.1 m/s	<b>Ice Problem:</b>	N - No Problem
<b>Water Depth:</b>	0.5 m	<b>Scour Problem:</b>	N - No Problem
<b>Waterway:</b>	01 - Adequate	<b>Debris Problem:</b>	N - No Problem
<b>Comments:</b>	Some light sholder erosion at corners of the structure. Slight gabion retaining walls on 3 corners of the structure. Some bulging in downstream gabion baskets.		
<b>REPLACEMENT/REHABILITATION</b>			
<b>Next Rehab. Date:</b>	2019	<b>Replacement Year:</b>	2030
<b>Antic. Rehab. Cost:</b>	\$40	<b>Replacement Cost:</b>	\$300
<b>Recommendations:</b>	Repair section of aluminum rail on upstream end. Install approach and exit rail C/W hazard markers. Repair asphalt on deck and approaches
