GOVERNMENT OF NEWFOUNDLAND AND LABRADOR Department of Transportation and Infrastructure	<b>BRIDGE INSPECTION REPORT</b> <b>B06032019-1</b>	
<b>Date:</b> 6/3/2019	<b>Inspected By:</b> Hunt R	<b>Category:</b> Eng. - Engineering	
<b>BRIDGE INFORMATION</b>			
<b>Site:</b>	1-282 - NORTH ARM RIVER BRIDGE		
<b>Route:</b>	90	<b>Overall Length:</b>	20.8 m
<b>Year Built:</b>	1973	<b>Est: No</b>	<b>Overall Width:</b> 10.5 m
<b>Year Last Rehab.:</b>		<b>Est: No</b>	<b>Roadway Width:</b> 9.3 m
<b>Region:</b>	AVALON PENINSULA	<b>Sidewalk Width:</b>	0.65 m
<b>Jurisdiction:</b>	Provincial	<b>Clearance to R.D. or N.W.L.:</b>	1.3 m
<b>Type of Structure:</b>	02 - Double Tee	<b>Max Depth of N.W.L.:</b>	0.4 m
<b>Purpose of Structure:</b>	04 - Over Non-Navigable Waters	<b>Spans:</b>	
<b>Type of Handrail:</b>	02 - Concrete Rail	<b>Span No.:</b>	<b>Length</b>
<b>Roadway Surface:</b>	02 - Asphalt	<b>Span No.:</b>	<b>Length</b>

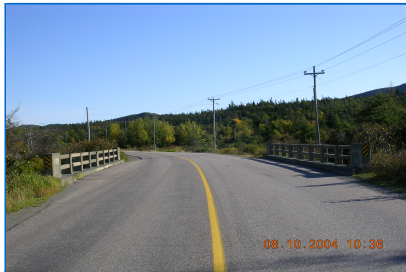
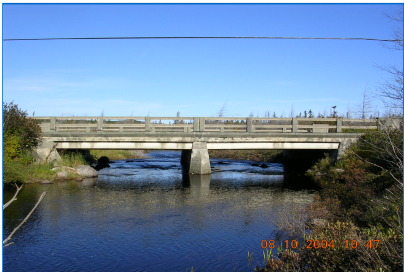
<b>Alignment Vertical:</b>	01 - Good	1	6.7
<b>Alignment Horizontal:</b>	02 - Adequate	2	6.7
<b>Restrictions:</b>	No	3	0
		4	0
		5	0
		6	0
<b>BRIDGE PHOTOS</b>

<b>SUBSTRUCTURE</b>			
<b>Condition:</b>	P3 - Poor	<b>Bearings:</b>	P3 - Poor
		<b>Bearing Seat:</b>	P3 - Poor
<b>Comments:</b>	Original structure extended by 3m upstream and downstream. Assumed condition of buried/submerged reinforced concrete abut and pier footings. Medium spacing to pear bearing seats. Medium concrete disintegration to upstream extension bearing seat. Numerous narrow wide horizontal vertical cracks to original abutment and piers. Narrow vertical horizontal cracks with light spacing to all four wingwalls. Medium-severe honeycomb/spalling to faces of abutments and pier extension.		
<b>SUPERSTRUCTURE</b>			
<b>Condition:</b>	P1 - Poor	<b>Expansion Joints:</b>	F1 - Fair
<b>Comments:</b>	Very severe delamination/spalling with medium-severe corrosion to exposed re-enforcements to bottom of original beams in north and south spans medium horizontal cracks in original beams. Construction joint between original structure and extension opening up with concrete spalling light decay/spalling with medium corrosion to exposed reinforcement on double tee extensions. Appears to be leakage in expansion joint onto pier.

<b>DECK</b>			
<b>Condition:</b>	F1 - Fair	<b>Curbs:</b>	F2 - Fair
<b>Hand Rail:</b>	F1 - Fair	<b>Roadway Condition:</b>	F2 - Fair
<b>Approach Rail:</b>	G - Good		
<b>Comments:</b>	Structure was resurfaced with asphalt in 2018 along with new approach and exit rail C/W hazard markers. Narrow vertical horizontal cracks with medium spacing to concrete handrails and end blocks. Some small sections of concrete. Handrail missing showing exposed re-enforcements. Narrow horizontal cracks in curb tops and facials. Construction joints between top of deck facials and bottom of extension curb facials are opening up.		
<b>HYDROLOGY</b>			
<b>Water Velocity:</b>	0.4 m/s	<b>Ice Problem:</b>	N - No Problem
<b>Water Depth:</b>	0.5 m	<b>Scour Problem:</b>	K - Known Problem
<b>Waterway:</b>	01 - Adequate	<b>Debris Problem:</b>	N - No Problem
<b>Comments:</b>	Assumed medium scouring continuing under upstream end of pier (submerged). Assumed medium erosion continuing at base of abutments and pier (submerged). Some minor erosion at all four corners of structure (wingwalls).
