GOVERNMENT OF NEWFOUNDLAND AND LABRADOR Department of Transportation and Infrastructure	BRIDGE INSPECTION REPORT B06192019-4	
Date: 6/19/2019	Inspected By: Pickett R	Category: Eng. - Engineering	
BRIDGE INFORMATION			
Site:	1-335 - TILTON OVERPASS CBN BY-PASS		
Route:	75	Overall Length:	32.9 m
Year Built:	2002	Est: No	Overall Width: 14.01 m
Year Last Rehab.:		Est: No	Roadway Width: 13.1 m
Region:	AVALON PENINSULA	Sidewalk Width:	1.5 m
Jurisdiction:	Provincial	Clearance to R.D. or N.W.L.:	5.4 m
Type of Structure:	05 - Pre-stressed Concrete Slab	Max Depth of N.W.L.:	0 m
Purpose of Structure:	01 - Highway Grade Separation	Spans:	
Type of Handrail:	05 - Concrete Barrier	Span No.:	Length
Roadway Surface:	01 - Concrete	1	26.3
Alignment Vertical:	01 - Good	2	0
Alignment Horizontal:	01 - Good	3	0
Restrictions:	No	Span No.:	Length
		4	0
		5	0
		6	0
BRIDGE PHOTOS

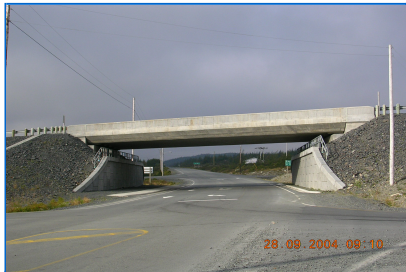
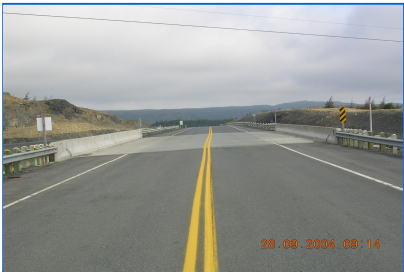
SUBSTRUCTURE			
Condition:	G - Good	Bearings:	F2 - Fair

Bearing Seat:	F2 - Fair
Comments:	Narrow crack in footing and abutments with light effloresce deposits. Narrow cracks with efflor deposits on ballast walls outside steel pot bearings have moderate rust. Remainder has light rust.		
SUPERSTRUCTURE			
Condition:	G - Good	Expansion Joints:	F2 - Fair
Comments:	Light effloresce deposits on exterior soffit. Light rust on safety railing. Narrow cracks in barrier wall with effloresce. Alligator and narrow cracks in end blocks.		
DECK			
Condition:	F2 - Fair	Curbs:	F2 - Fair
