GOVERNMENT OF NEWFOUNDLAND AND LABRADOR Department of Transportation and Infrastructure	<b>BRIDGE INSPECTION REPORT</b> <b>B07262021-3</b>	
<b>Date:</b> 7/5/2021	<b>Inspected By:</b> Justine Geddes	<b>Category:</b> Office - Bridge Office	
<b>BRIDGE INFORMATION</b>			
<b>Site:</b>	3-019 - INDIAN BAY BROOK BRIDGE		
<b>Route:</b>		<b>Overall Length:</b>	19.8 m
<b>Year Built:</b>	1975	<b>Est: No</b>	<b>Overall Width:</b> 11.4 m
<b>Year Last Rehab.:</b>		<b>Est: No</b>	<b>Roadway Width:</b> 11.4 m
<b>Region:</b>	CENTRAL WEST	<b>Sidewalk Width:</b>	0 m
<b>Jurisdiction:</b>	Provincial	<b>Clearance to R.D. or N.W.L.:</b>	2.3 m
<b>Type of Structure:</b>	02 - Double Tee	<b>Max Depth of N.W.L.:</b>	1 m
<b>Purpose of Structure:</b>	04 - Over Non-Navigable Waters		
<b>Type of Handrail:</b>	01 - Aluminum Rail		
<b>Roadway Surface:</b>	02 - Asphalt	<b>Spans:</b>	
<b>Alignment Vertical:</b>	01 - Good	<u>Span No.:</u>	<u>Length</u>

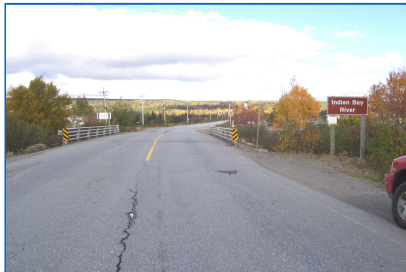
<b>Alignment Horizontal:</b>	01 - Good	<u>Span No.:</u>	<u>Length</u>
<b>Restrictions:</b>	No	1	15.8
		2	0
		3	0
		4	0
		5	0
		6	0
<b>BRIDGE PHOTOS</b>
