GOVERNMENT OF NEWFOUNDLAND AND LABRADOR Department of Transportation and Infrastructure	BRIDGE INSPECTION REPORT B01202020-35																					
Date: 9/3/2019	Inspected By: Lynch R / Martin L	Category: Eng. - Engineering																					
BRIDGE INFORMATION																							
Site:	3-005 - RAGGED HARBOUR RIVER BRIDGE																						
Route:		Overall Length:	40 m																				
Year Built:	1977	Est: No	Overall Width: 10.8 m																				
Year Last Rehab.:		Est: No	Roadway Width: 9.6 m																				
Region:	CENTRAL WEST	Sidewalk Width:	0 m																				
Jurisdiction:	Provincial	Clearance to R.D. or N.W.L.:	1.5 m																				
Type of Structure:	01 - AASH to Girder	Max Depth of N.W.L.:	1 m																				
Purpose of Structure:	04 - Over Non-Navigable Waters																						
Type of Handrail:	01 - Aluminum Rail																						
Roadway Surface:	02 - Asphalt

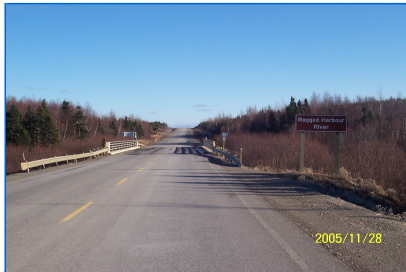
Spans:				<u>Span No.:</u>	<u>Length</u>	<u>Span No.:</u>	<u>Length</u>	1	32	4	0	2	0	5	0	3	0	6	0
Spans:																							
<u>Span No.:</u>	<u>Length</u>	<u>Span No.:</u>	<u>Length</u>																				
1	32	4	0																				
2	0	5	0																				
3	0	6	0																				
Alignment Vertical:	01 - Good	2	0																				
Alignment Horizontal:	01 - Good	3	0																				
Restrictions:	No																						
BRIDGE PHOTOS

SUBSTRUCTURE																							
Condition:	F2 - Fair	Bearings:	F2 - Fair																				
		Bearing Seat:	F2 - Fair																				
Comments:	Medium scour on abutments with scaling on wing walls, wide vertical cracks in abutment #1. Abutment 2 LHS wet during inspection.																						
SUPERSTRUCTURE																							
Condition:	F2 - Fair	Expansion Joints:	F1 - Fair																				
Comments:	Expansion joint #2 leaking LHS. All joints full of winter sand. Dams damaged by plow #2 worse than #1.																						
DECK																							
Condition:	F2 - Fair	Curbs:	F2 - Fair																				
Hand Rail:	F2 - Fair	Roadway Condition:	F2 - Fair

Approach Rail:	F2 - Fair		
Comments:	Asphalt cracked at joints. Worse at expansion joint #2. Settlement at approaches (patched). Narrow cracks in curbs. Hazard marker missing on abutment #2 RHS. Deck drains at abutment 2 bent towards downstream.		
HYDROLOGY			
Water Velocity:	0 m/s	Ice Problem:	N - No Problem
Water Depth:	0 m	Scour Problem:	P - Possible Problem
Waterway:	01 - Adequate	Debris Problem:	N - No Problem
Comments:	Scaling and abrasion on both abutments. Footings buried.		
REPLACEMENT/REHABILITATION			
Next Rehab. Date:		Replacement Year:	
Antic. Rehab. Cost:	\$0	Replacement Cost:	\$0
Recommendations:	Replace expansion joint #2, clean drains, repair asphalt approaches. Replace LHS guiderail abutment #1 (Tipped out), Install buried ends at exits. Install hazard marker at abutment #2 RHS. Place rip rap at all 4 corners.		
OBSERVATIONS			
Overall Condition:	F2 - Fair	Requires Further Inspection:	No
