GOVERNMENT OF NEWFOUNDLAND AND LABRADOR Department of Transportation and Infrastructure	BRIDGE INSPECTION REPORT B07232021-5																					
Date: 7/7/2021	Inspected By: McCaw J	Category: Eng. - Engineering																					
BRIDGE INFORMATION																							
Site:	3-105 - SOUTHWEST BROOK, BAIE VERTE																						
Route:		Overall Length:	22.5 m																				
Year Built:	1968	Est: Yes	Overall Width: 8.8 m																				
Year Last Rehab.:	1998	Est: No	Roadway Width: 7.4 m																				
Region:	CENTRAL WEST	Sidewalk Width:	0 m																				
Jurisdiction:	Provincial	Clearance to R.D. or N.W.L.:	4 m																				
Type of Structure:	02 - Double Tee	Max Depth of N.W.L.:	1 m																				
Purpose of Structure:	04 - Over Non-Navigable Waters																						
Type of Handrail:	01 - Aluminum Rail																						
Roadway Surface:	02 - Asphalt

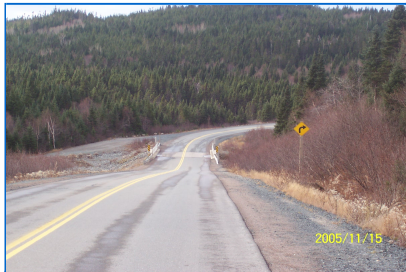
Spans:				<u>Span No.:</u>	<u>Length</u>	<u>Span No.:</u>	<u>Length</u>	1	13	4	0	2	0	5	0	3	0	6	0
Spans:																							
<u>Span No.:</u>	<u>Length</u>	<u>Span No.:</u>	<u>Length</u>																				
1	13	4	0																				
2	0	5	0																				
3	0	6	0																				
Alignment Vertical:	01 - Good																						
Alignment Horizontal:	02 - Adequate																						
Restrictions:	No																						
BRIDGE PHOTOS
