GOVERNMENT OF
NEWFOUNDLAND
AND LABRADOR
Department of Transportation and Infrastructure

BRIDGE INSPECTION REPORT
B01302020-20

Site:	2-079 - ALLAN'S ISLAND CAUSEWAY BRIDGE				
Route:	220-19	Overall Length:	26 m		
Year Built:	1986	Est: No	Overall Width:	10 m	
Year Last Rehab.:		Est: No	Roadway Width:	8.2 m	
Region:	CENTRAL EAST	Sidewalk Width:	0 m		
Jurisdiction:	Provincial	Clearance to R.D. or N.W.L.:	1.5 m		
Type of Structure:	01 - AASH to Girder	Max Depth of N.W.L.:	2.5 m		
Purpose of Structure:	03 - Over Navigable Waters	Spans:			
Type of Handrail:	01 - Aluminum Rail	<u>Span No.:</u>	<u>Length</u>	<u>Span No.:</u>	<u>Length</u>
Roadway Surface:	01 - Concrete	1	18.6	4	0
Alignment Vertical:	01 - Good	2	0	5	0
Alignment Horizontal:	01 - Good	3	0	6	0
Restrictions:	No

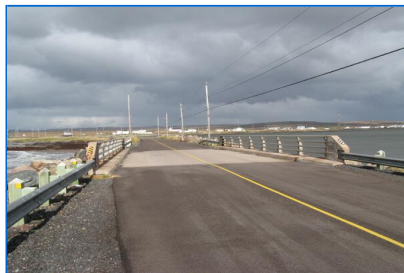
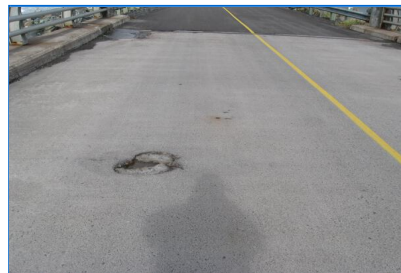
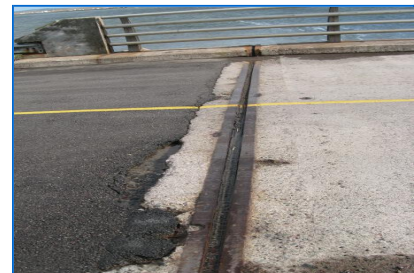
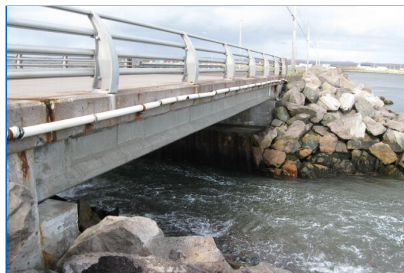
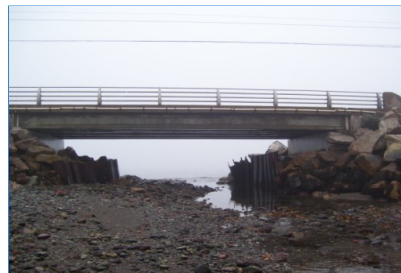
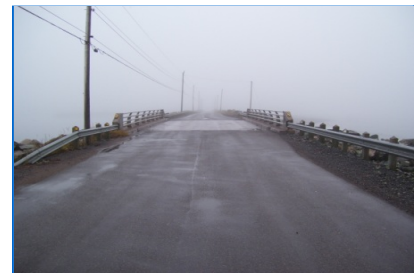
BRIDGE PHOTOS

Comments: Concrete abutments and wingwalls. Footing one has erosion with exposed rebar. Some cracking of abutment walls and wingwalls. Some bearing pads squat, exposed steel on pad three abutment two. Navigation channel

formed with sheet piles, mostly destroyed. Additional armor stone added in 2017.

Condition: F2 - Fair **Expansion Joints:** P3 - Poor
Comments: 6 AASHTO girders, all have significant exposed rebar with rusting, staining and some delaminations and spalls. deck soffits between girder two and three has significant spalling with exposed rebar - heavy rusting. Expansion joints are leaking, significant deterioration around curb sections (fascia/soffit). Deterioration and exposed rebar on the back walls due to leaking joints.

Condition: F2 - Fair **Curbs:** F2 - Fair
Hand Rail: F2 - Fair **Roadway Condition:** F2 - Fair
Approach Rail: F2 - Fair
Comments: Concrete deck with asphalt wearing surface. 4-5 potholes in the deck surface with exposed rebar. Asphalt is potholed/patched with cracking on approaches. 4 rail aluminum system with concrete end blocks, anchor bolts rusting in places. All end blocks have some cracking and deterioration. Approach #2 left, rail is lapped incorrectly. Object markers poor. Expansion Joints have been patched with asphalt.
