GOVERNMENT OF NEWFOUNDLAND AND LABRADOR Department of Transportation and Infrastructure	<b>BRIDGE INSPECTION REPORT</b> <b>B10192017-2</b>	
<b>Date:</b> 10/16/2017	<b>Inspected By:</b> AB	<b>Category:</b> Eng. - Engineering	
<b>BRIDGE INFORMATION</b>			
<b>Site:</b>	2-049 - BARBOUR BRIDGE (CHARLESTON)		
<b>Route:</b>	230	<b>Overall Length:</b>	32.8 m
<b>Year Built:</b>	1971	<b>Est:</b> No	<b>Overall Width:</b> 13.2 m
<b>Year Last Rehab.:</b>	1985	<b>Est:</b> No	<b>Roadway Width:</b> 11 m
<b>Region:</b>	CENTRAL EAST	<b>Sidewalk Width:</b>	1.2 m
<b>Jurisdiction:</b>	Provincial	<b>Clearance to R.D. or N.W.L.:</b>	5 m
<b>Type of Structure:</b>	01 - AASH to Girder	<b>Max Depth of N.W.L.:</b>	1 m
<b>Purpose of Structure:</b>	04 - Over Non-Navigable Waters		
<b>Type of Handrail:</b>	01 - Aluminum Rail	<b>Spans:</b>	
<b>Roadway Surface:</b>	02 - Asphalt	<u>Span No.:</u>	<u>Length</u>
<b>Alignment Vertical:</b>	01 - Good	1	14.8

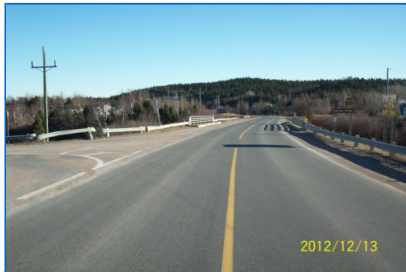
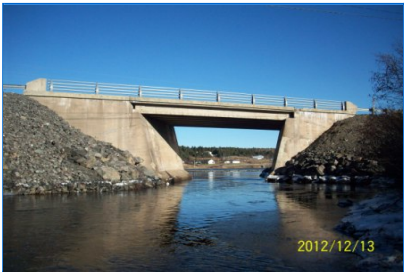
<b>Alignment Horizontal:</b>	01 - Good	2	0
<b>Restrictions:</b>	No	3	0
		<u>Span No.:</u>	<u>Length</u>
		4	0
		5	0
		6	0
<b>BRIDGE PHOTOS</b>
